# SPRINGFIELD ARMORY

Report: SA-TR19-1507

Report Title: Properties and Methods of Nondestructive Testing  
of Bolts for 7.62mm M14 Rifles

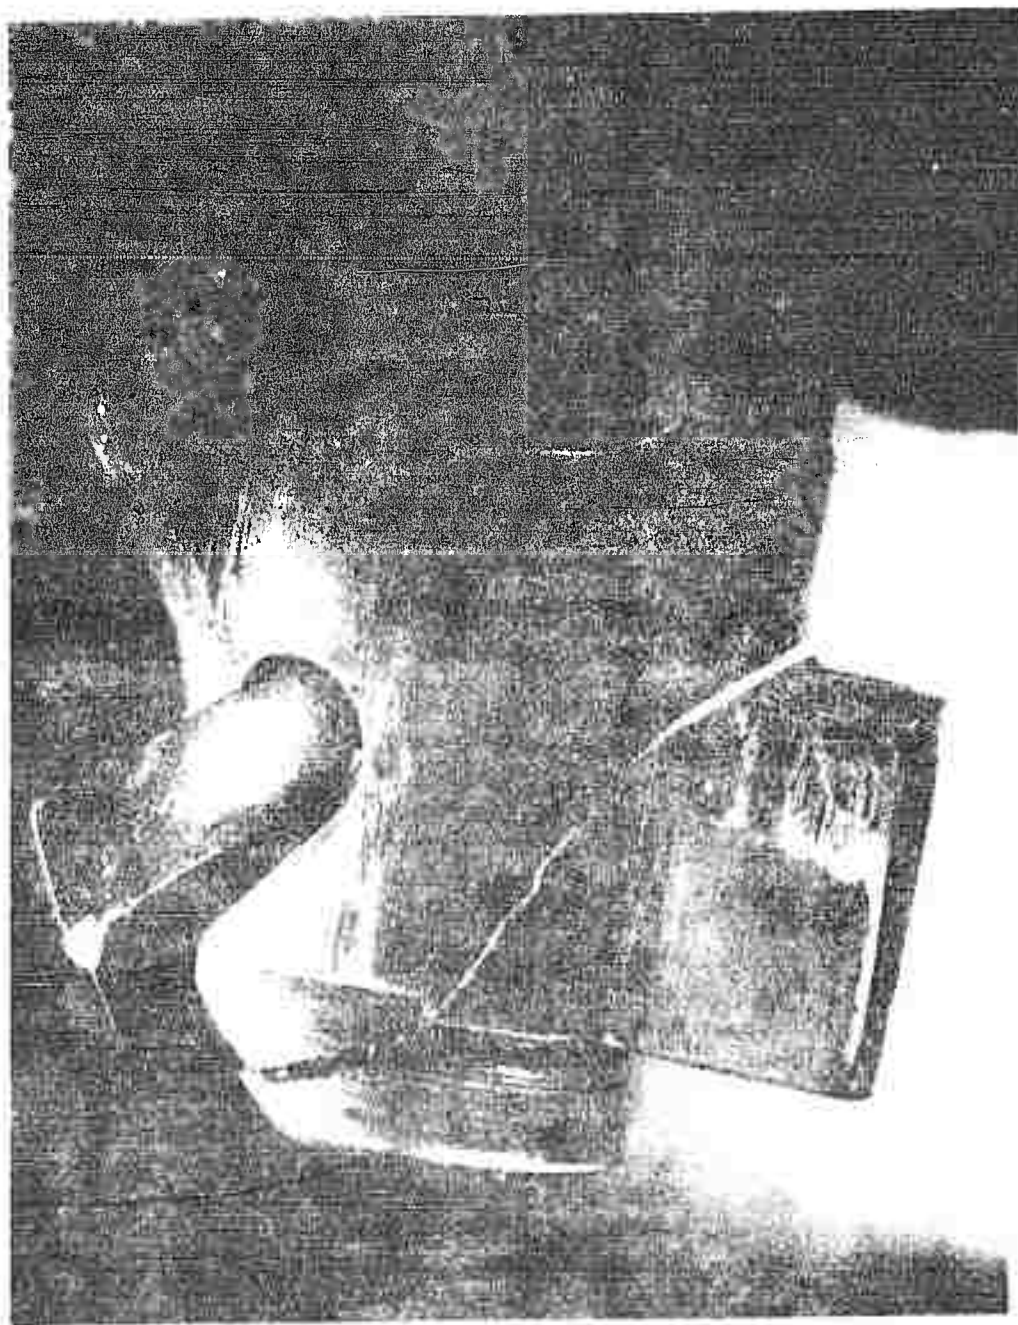
Figure 1

The right lug was sheared off completely. The origin of the fracture appeared to be at the rear radius of the lug. Cracking also initiated at the rear radius of the left lug extending diagonally into the head and terminating at the cartridge seat area (Figures 1 and 2). Fracture (Figure 3) initiated in the locking lug radius and progressed by fatigue to a depth of 0.060 to 0.100 inch when catastrophic failure occurred.

SPRINGFIELD ARMORY - ORDNANCE CORPS  
FRACTURED BOLT HEAD  
Rifle, 7.62mm, M14 - "Code WH", No. 19453

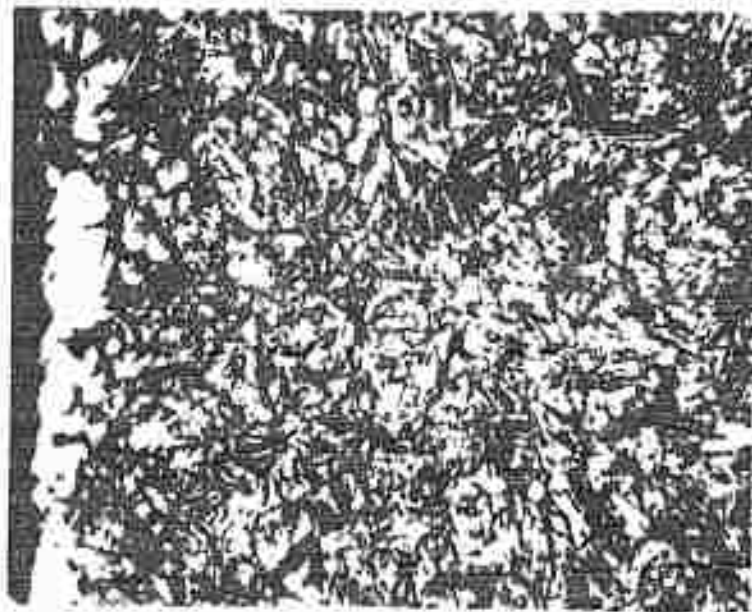
These failed bolts contained approximately 50 per cent proeutectoid ferrite in the core (Figure 4). Because of its occurrence with a microstructure containing a high percentage of martensite and low-temperature transformation products, it was concluded that these bolts had been held below, and quenched from, slightly below 1520°F, the AC<sub>3</sub> transformation temperature for 8620 steel. This conclusion was substantiated when Task Force groups reported that "Code WH" procedure involved carburizing followed by slow cooling, and reheating to 1475°F-1500°F for the final quenching operation.

FIGURE 4  
PHOTOMICROGRAPHS DISPLAYING CASE AND CORE MICROSTRUCTURES  
OF  
FRACTURED "CODE "WH" M14 BOLT - RIFLE 19453

Etchant: Nital Mag: 1000X

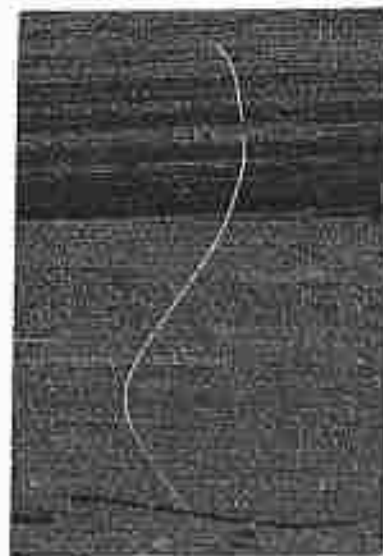
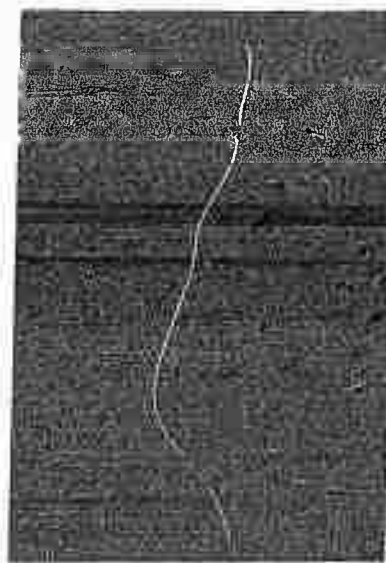
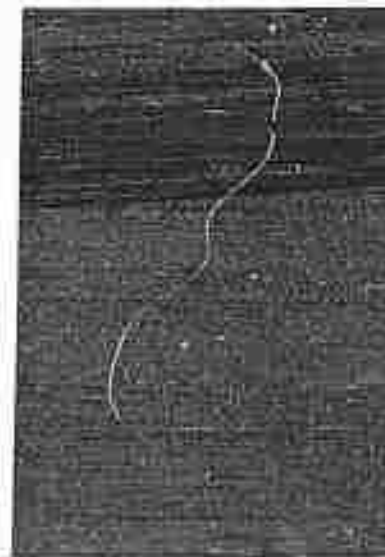
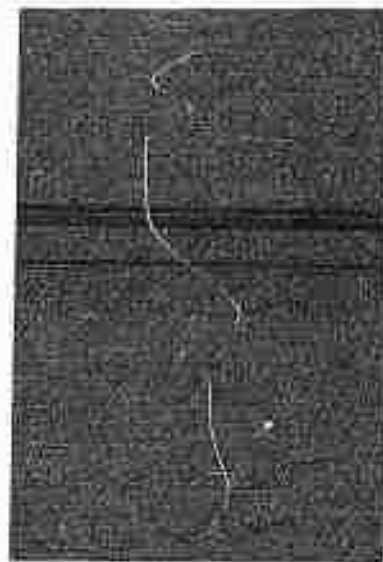
In the conducting of the magnetic permeability tests, similar characteristic wave form patterns were observed on the oscilloscope. Three basic patterns, with many variations of these, were apparent. Designated pattern 1 was an undistorted sine wave; pattern 2 had third harmonic distortion; and pattern 3 indicated severe distortion of the 60 cps fundamental on the negative portion of the display. Hardness measurements and microstructure examinations were made on bolts with above characteristic patterns. Table 5 lists hardness, magnetic reading, and pattern information gathered on 19 bolts. Other metallurgical data on these bolts, and additional magnetic and metallurgical investigations made in this study are compiled in Appendix, Section 5.

FIGURE 14 WAVE FORM PATTERNS CORRELATED WITH MATERIAL PROPERTIES

Based on results of all studies, a combination test method employing magnetic permeability readings, Rockwell C surface hardness measurements, and oscilloscope wave form patterns was used in bolt segregation. A Rockwell C hardness measurement was taken on the rear part of the bolt or on a lug area. The bolt was then subjected to magnetic test wherein amplitude and pattern were noted. The combination was evaluated and bolts were segregated into the following groups:

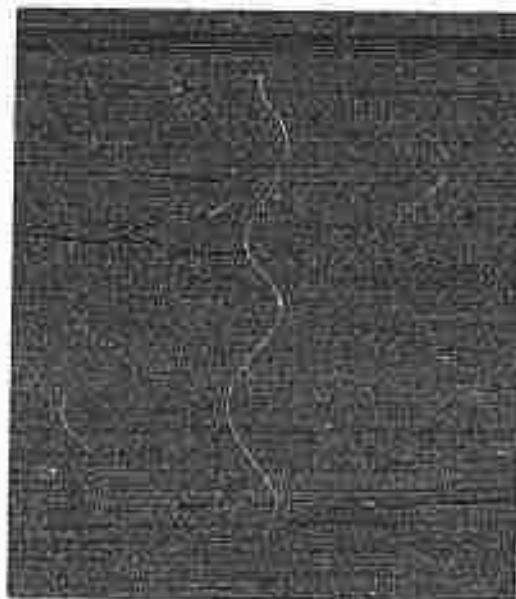
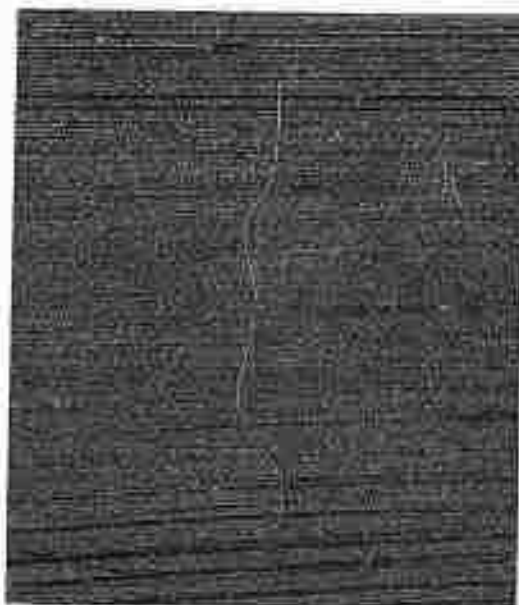
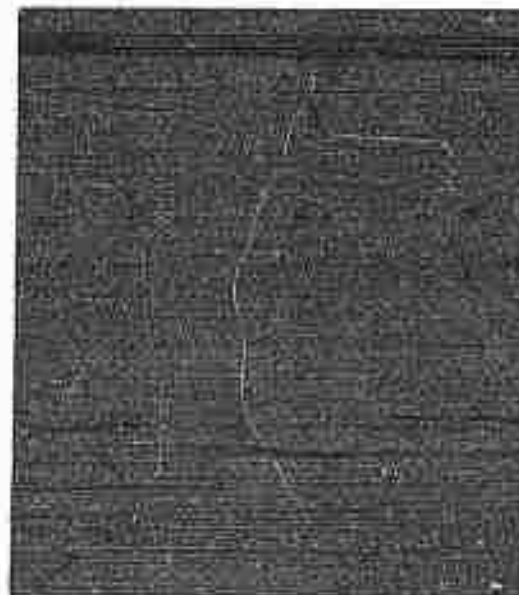
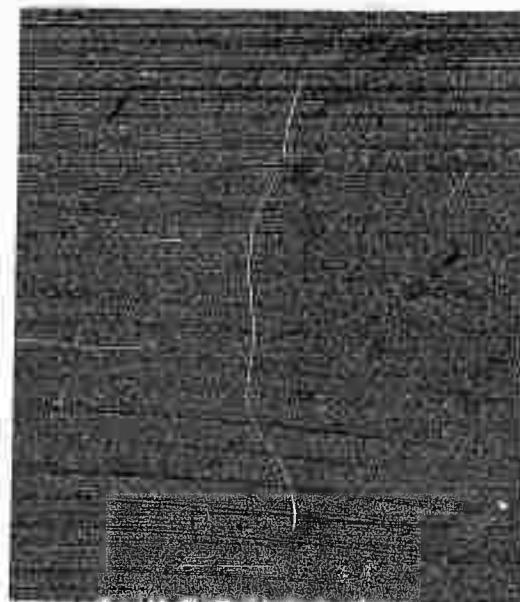
FIGURE 15

Because highly tempered and retempered magnetic patterns had large amplitudes with variations hard to detect, double exposure oscilloscope records were taken on bolts studied. The first exposure was taken with the bolt in its proper position within the coil; the second exposure was made with the bolt pulled out until the meter read zero. With this procedure, four basic patterns designated A1, B1, C1 and D1 were noted. Basic patterns are shown in Figure 15.

WAVE FORM PATTERNS OF HIGHLY TEMPERED  
OR RETEMPERED BOLTS

Simulated impact tests made on bolts with these various patterns employing an impact of 30 foot-pounds indicated that bolts with patterns A1 and B1 withstood the greater number of impact blows. Metallurgical results indicated that pattern A1 had fairly high percentages of free ferrite in the core (10 to 25%). Bolts with patterns C1 and D1 failed quickly (1-3 blows); corresponding core hardness was high. Impact test and metallurgical data are compiled in Appendix, Section 8.
