ASD-TDR-62-420

IRRADIATION OF A TELEMETERING SYSTEM  
AND RELATED RECONNAISSANCE SENSORSTECHNICAL DOCUMENTARY REPORT NR ASD-TDR-62-420  
May 1962Directorate of Advanced Systems Planning  
Aeronautical Systems Division  
Air Force Systems Command  
Wright-Patterson Air Force Base, Ohio

Project No. 655A

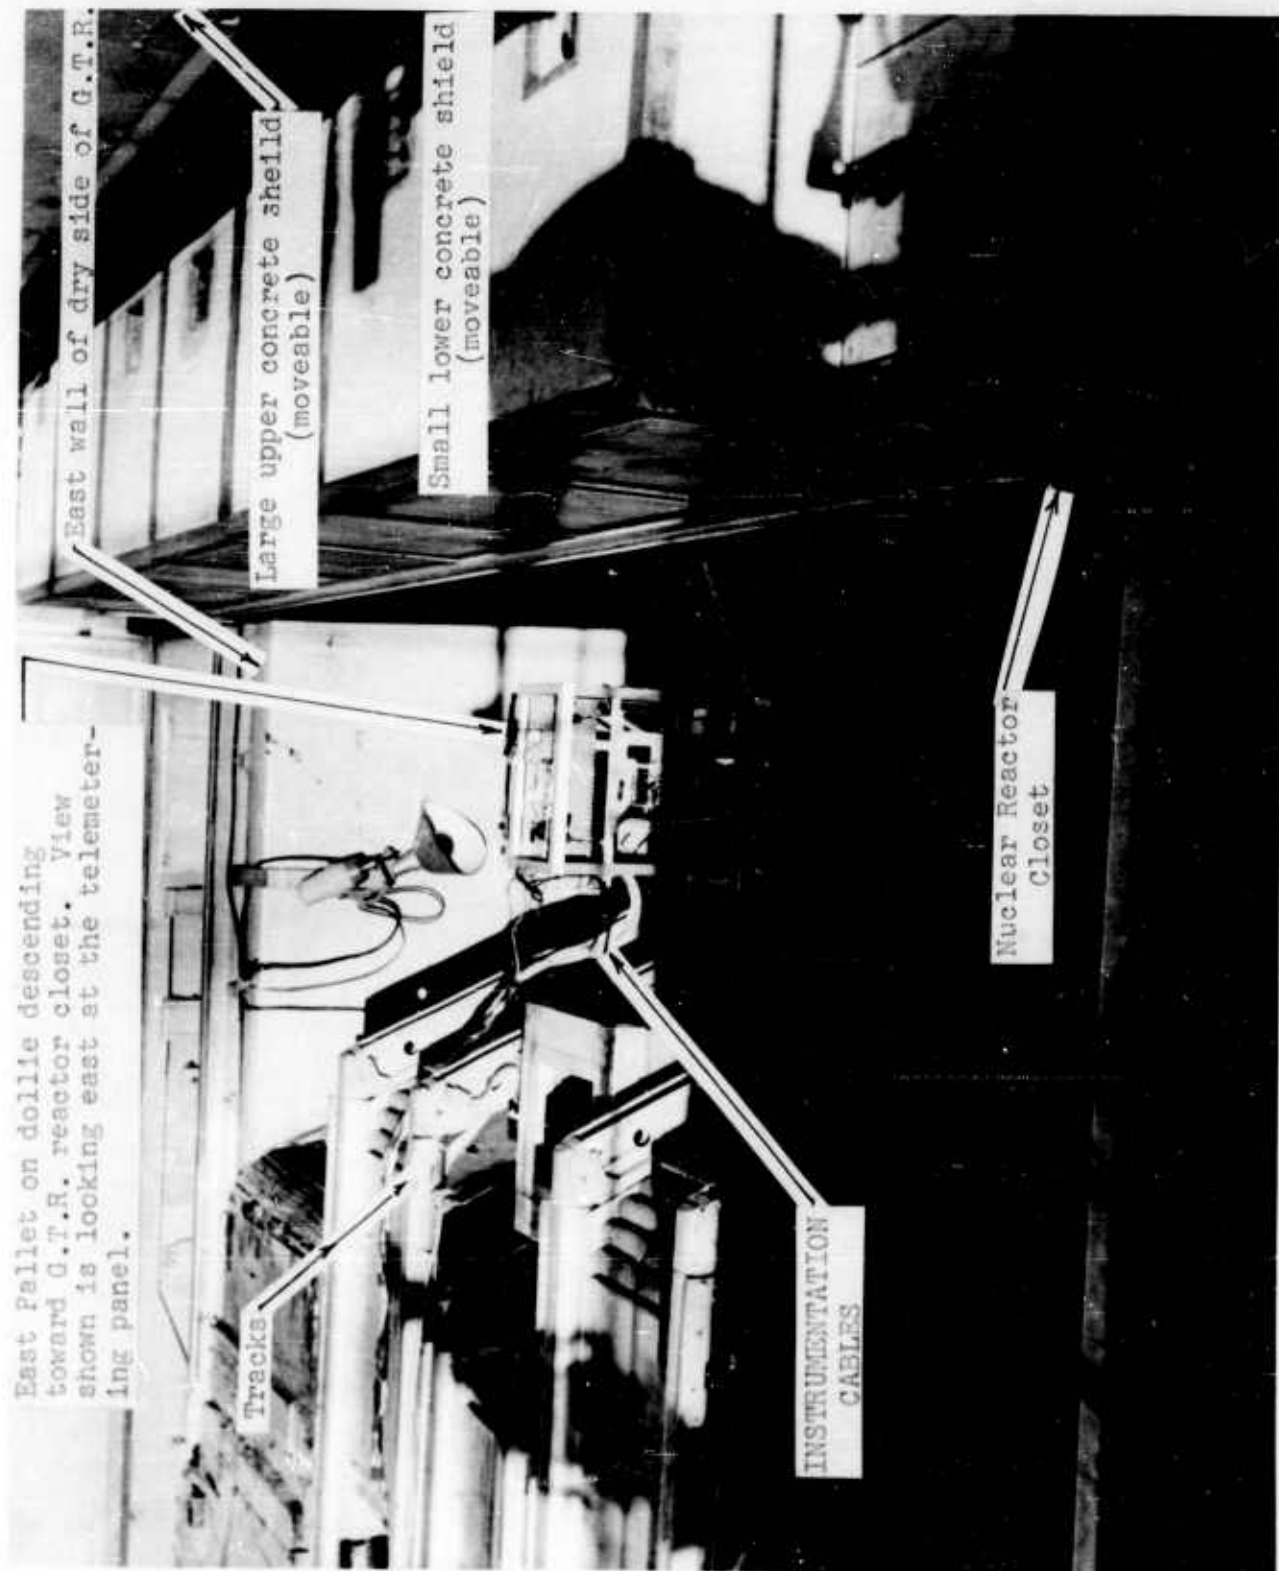
FIGURE 3 TELEMETRY TEST PANEL DESCENDING INTO THE GROUND TEST REACTOR

1961 for a total exposure time of approximately 81 hours (Figure 3). The integrated neutron and gamma photon dose exposures for each of the telemetering components shown in Figure 1 differ slightly because of physical location relative to the nuclear reactor. Radiation exposures for each component are presented with the discussion of each component.

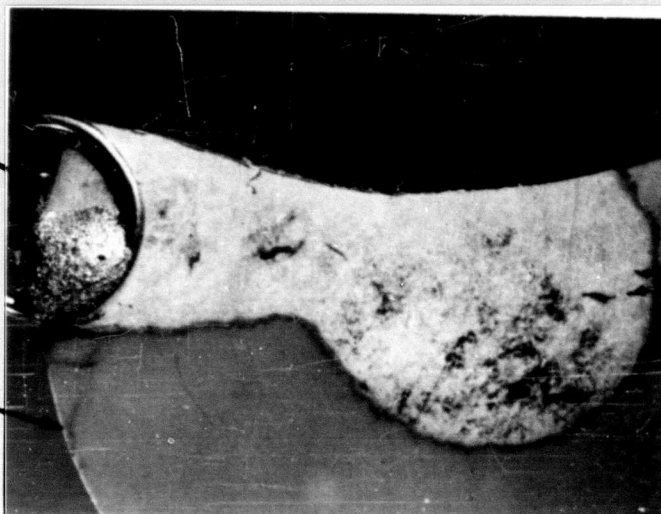
COMPLETE VIEW OF SILVER ELECTRODE

ENLARGED VIEW OF ELECTRODE

FIGURE 19 IRRADIATED TELECHROME QUARTZ CRYSTAL # SP-14114-1-2  
(HC-6/U)

EVEN DEPOSIT  
OF SILVER  
ON ELECTRODE  
AREA

plated electrode at the metal holder and the middle of the crystal indicated an open circuit. This condition existed for electrodes on both sides of the quartz crystal. Comparison with an unirradiated quartz crystal of the same type revealed that the silver plating on the irradiated sample was very much thinner and in spots almost gone as compared to the unirradiated quartz crystal. This contrast is illustrated by the photomicrograph, Figures 19 and 20, which are 150X magnifications of the silvered electrode area of the irradiated and non-irradiated quartz crystals. As discussed in Reference 1, this vanishing of the silver was actually an agglomeration; that is, the silver film actually clustered into small balls. This explains the translucent appearance of the electrodes, loss of conductivity, and loss of characteristic resonant frequency. Sufficient nuclear radiation environment testing of quartz crystals has been performed to establish the fact that there is a definite relationship between orientation of quartz crystal cut and nuclear radiation induced failure rate, Reference 2 and 3. Bottom and Nowicki (Ref. 2) found that AT cut quartz crystal plates irradiated to saturation with X-rays were little affected. BT cut quartz crystal plates on the other hand were appreciably affected by the same radiation. Confirmation of the BT results was obtained by Frondel (Ref. 3 and 4) and Johnson and Pease.
