DASA 1313

TECHNICAL PROGRESS REPORT

THE EXPOSURE OF GUINEA PIGS TO
PRESSURE-PULSES GENERATED DURING
THE END-TO-END TEST (NO. 2) OF
ATLAS MISSILE 8-D (MARCH 31, 1962)

Lovelace Foundation for Medical Education and Research
Albuquerque, New Mexico

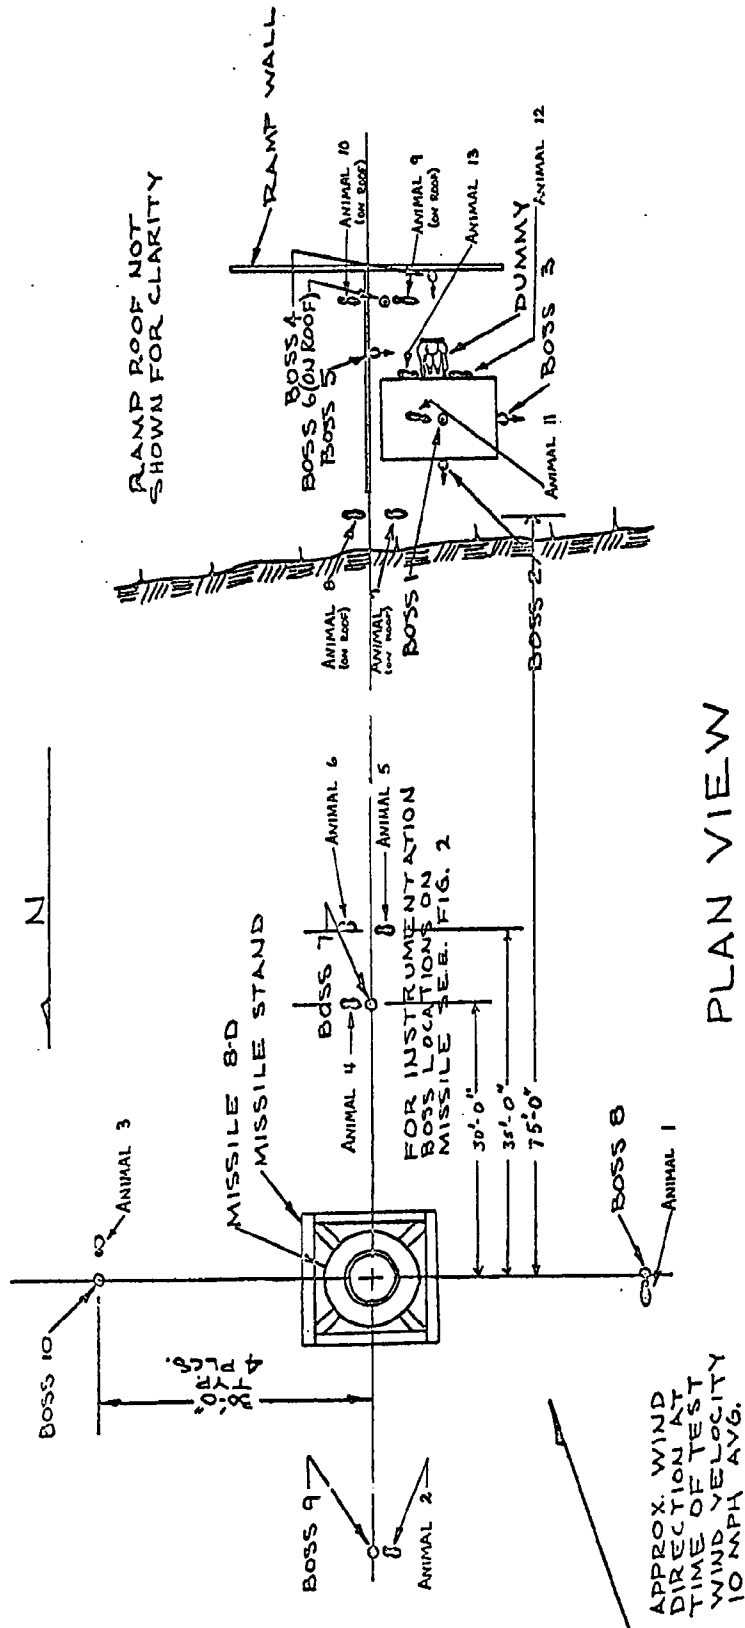
Figure 1

PLAN VIEW
OF TEST AREA
SHOWING BOSS LOCATIONS
AND TEST SPECIMEN

The general layout of the animal placement can be seen in Figures 1 and 2. Guinea pigs numbered "1", "2", "3" and "4" were respectively on the west, north, east and south sides of the missile--all at the 30-ft range. Also, to the south were animals numbered "5" and "6" at 35 ft; "7" and "8" at 75 ft; and "9" and "10" at the 94-ft ranges. Below the ramp, animal "11" was on top of the Pressure Control Unit, while animals "12" and "13" were on the operator's side of this unit.

The locations of the eleven pressure transducers (Wiancko Model P-1409) can be seen in Figures 1 and 2. Gauges (Boss) numbered 1 through 5 were in the Pressure Control Unit room beneath the ramp; gauge 6 was on the simulated ramp; and gauges 7 through 10 were on the surface 30 ft from the missile's center--one to the south, north, east and west, respectively. Gauge 31 was located on the missile.

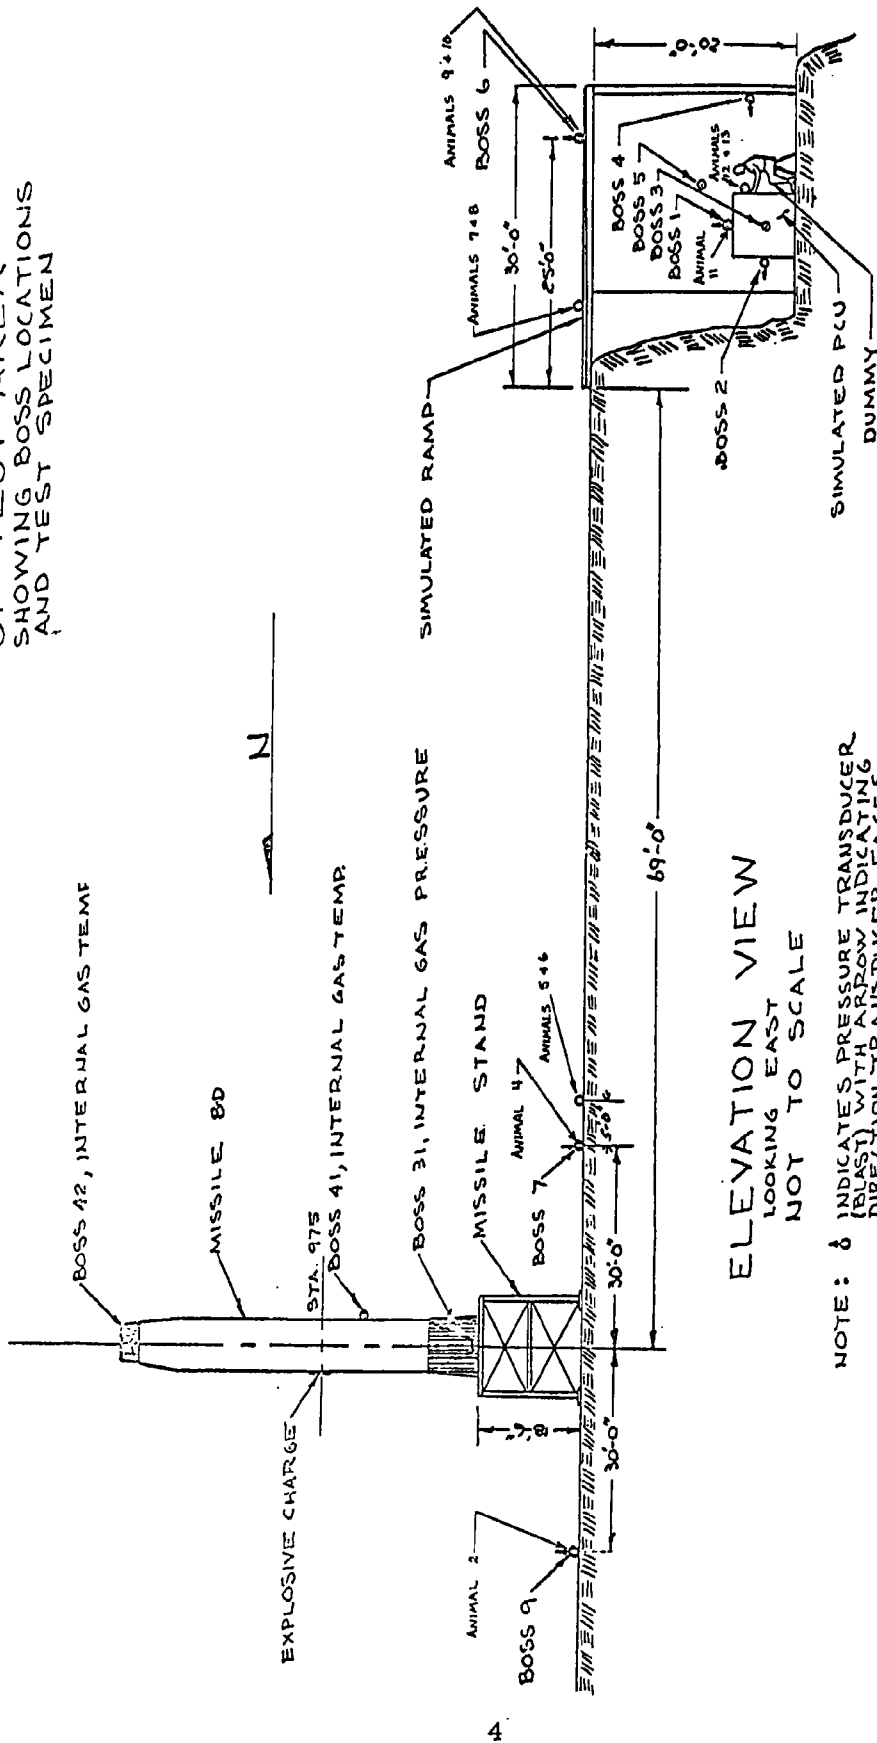
Figure 2

ELEVATION VIEW
OF TEST AREA
SHOWING BOSS LOCATIONS
AND TEST SPECIMEN

ELEVATION VIEW
LOOKING EAST
NOT TO SCALE

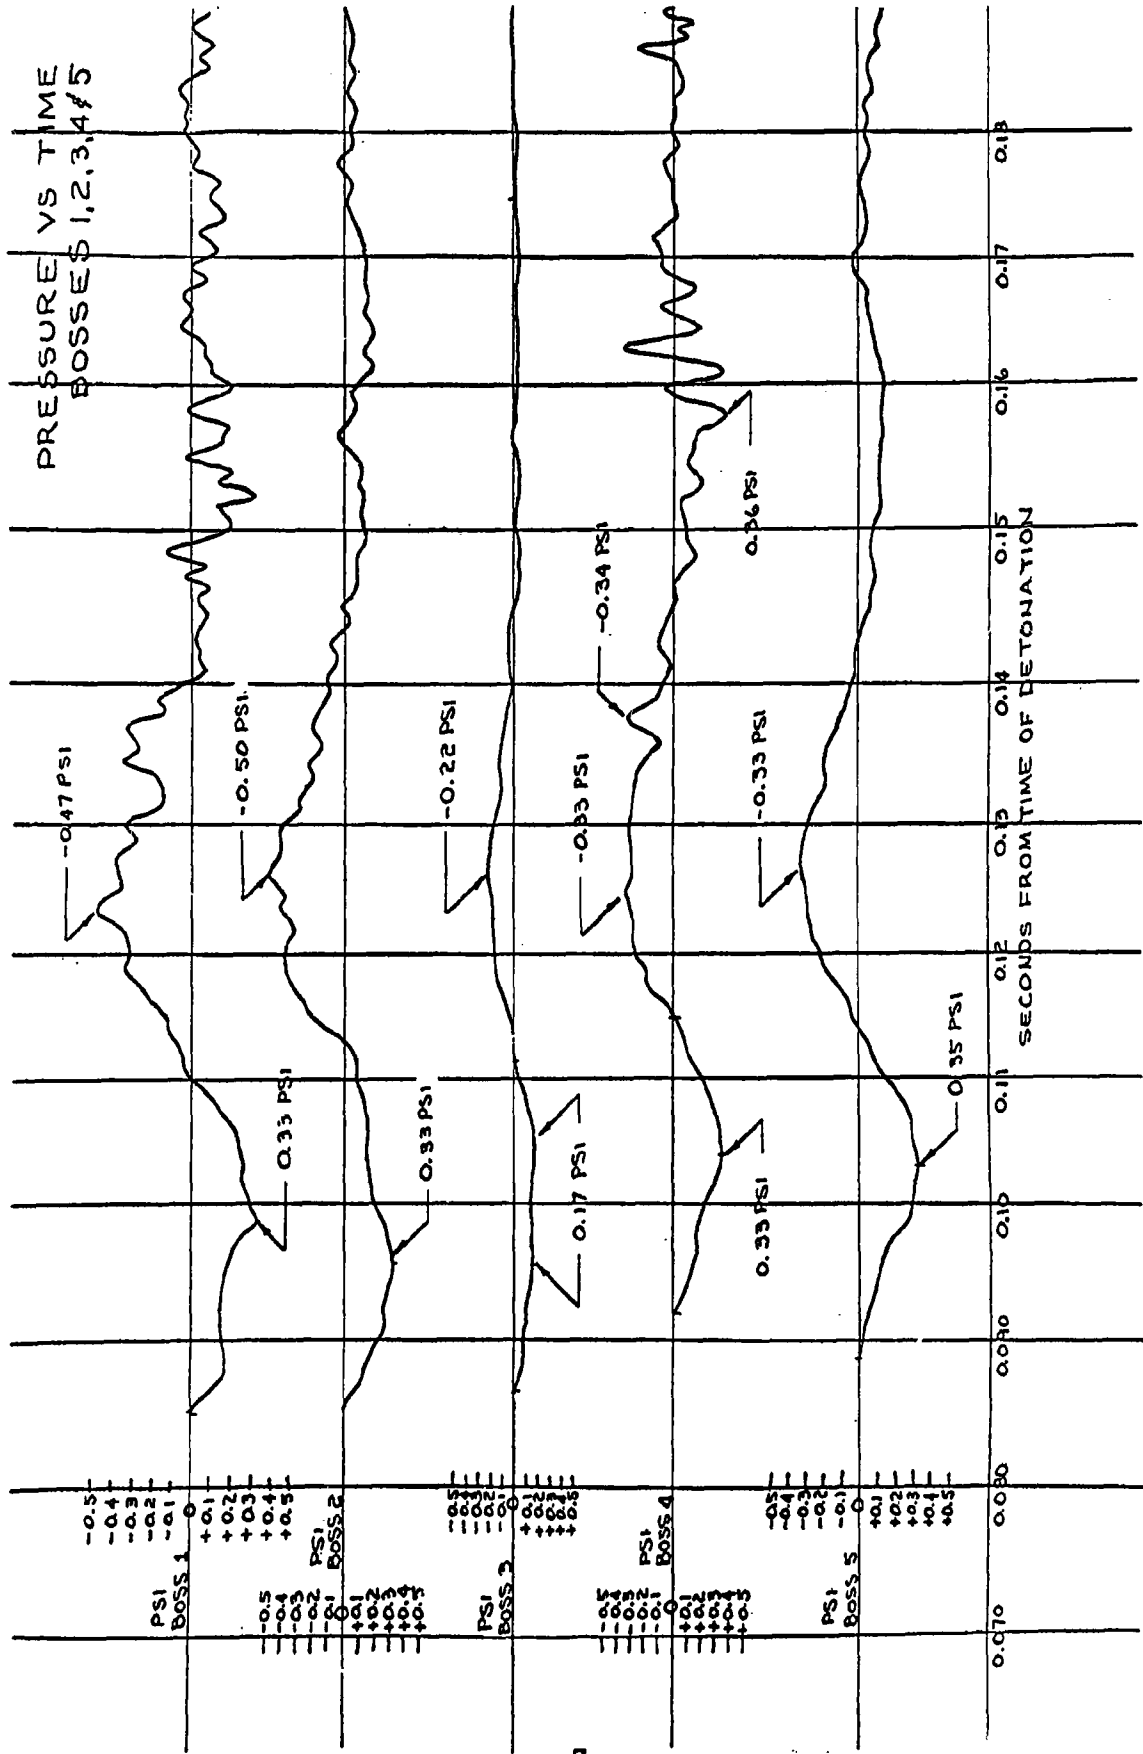
Figure 3

According to the records in Figure 3, the pressure-time pattern in the Pressure Control Unit room was merely a compression wave and not a shock wave. The pressures from the record of gauge 3 appeared low compared to the other four gauges in the Pressure Control Unit, which showed a P_{max} of 0.33 to 0.35 psi with rise times of from 10.2 to 14.3 msec, with minimum pressures during the negative phase of -0.33 to -0.50 psi.

That the pressure-pulse from the bursting missile was not intense enough to cause significant animal injury or lethality was substantiated by the pressure-time records which are illustrated in Figures 3 and 4. The significant pressure-time parameters were picked from these records and appear in Table 2.

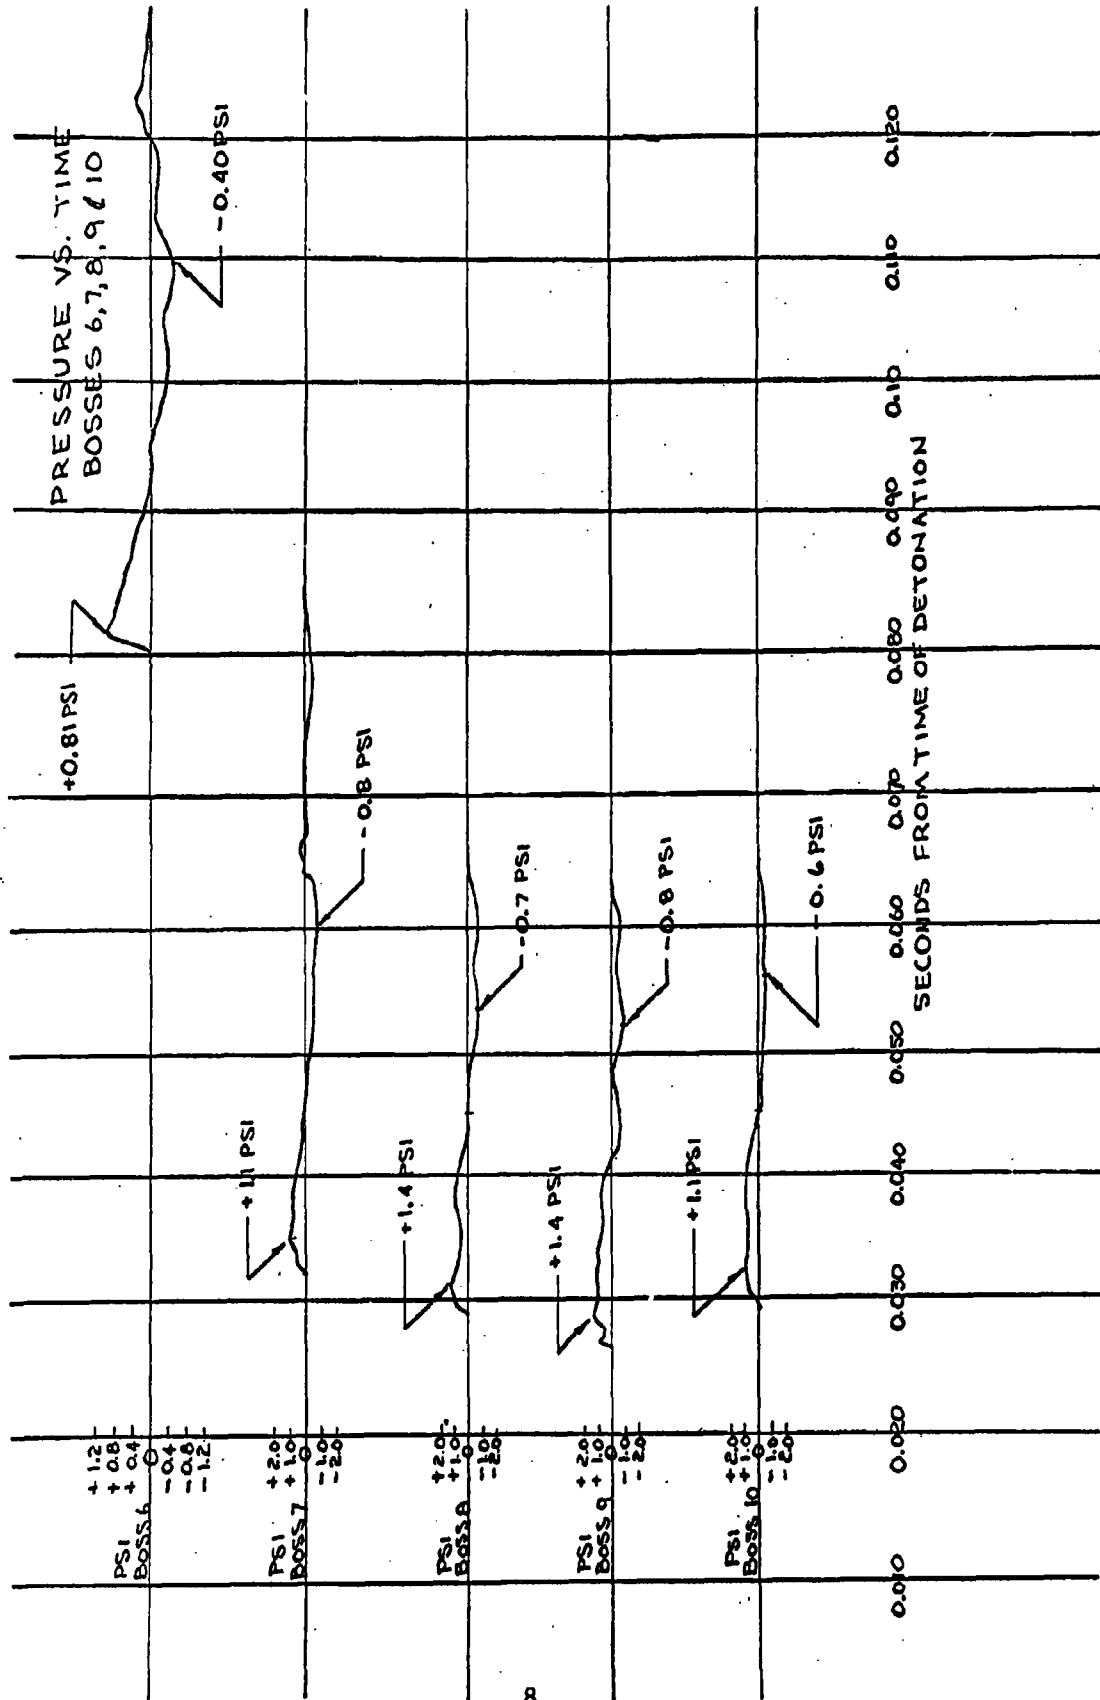
Figure 4

It is of interest to note from the four pressure-time records shown in Figure 4, taken with gauges at the 30-ft ranges, that the pressure disturbance arrived at the gauge to the north of the missile about 2.5 msec before it arrived at those located to the east and west, and about 4.5 msec before it reached the gauge placed 30 ft to the south. Apparently, the shock wave from the high-explosive detonation reached these gauges just before the main pulse from the rupturing missile. In addition, the rupture was initiated along the north side of the missile on which the explosive was attached. Gauge 31, located on the missile, showed that the pressure in the tank started to decay 8 msec after detonation and reached zero pressure in the next 9 msec.
