**PREFABRICATED AIRFIELD AND ROAD  
SURFACING MEMBRANE  
INVESTIGATION**

**ENGINEERING TESTS, JANUARY 1956 - DECEMBER 1959**

**TECHNICAL REPORT NO. 3-492**

**U. S. Army Engineer Waterways Experiment Station  
CORPS OF ENGINEERS  
Vicksburg, Mississippi**

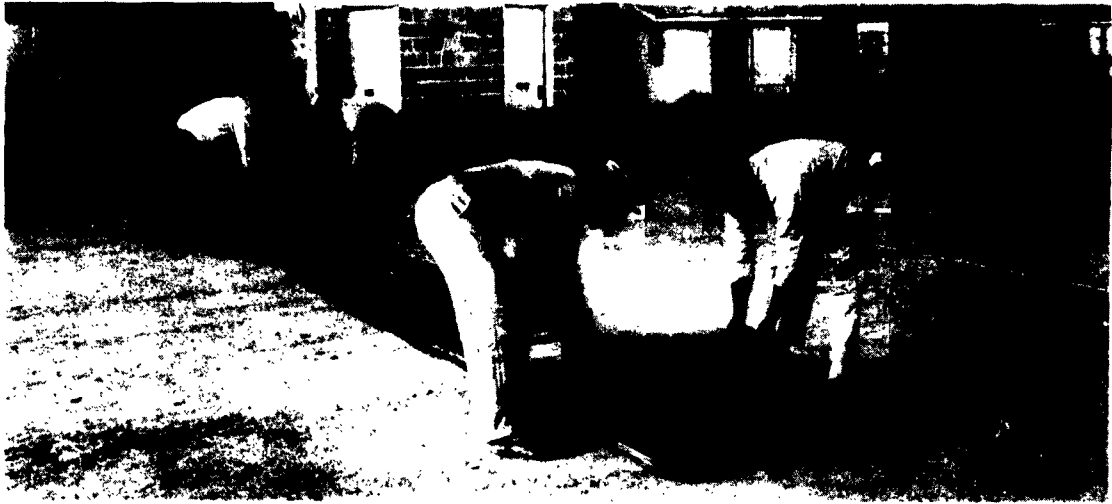
Fig. 11. Sewn membrane panel being unfolded across the test lane

27. Sewn membrane sections. Test sections 2, 4, and 6 were surfaced with sewn panels of the T1, T13, and T12 membranes, respectively. Each panel was 42 ft wide and 26 ft long and was constructed of membrane runs sewn together with a 1-1/4-in. single-lap, double-stitched joint. To surface these sections, the sewn membranes were unfolded first across the test lane and then along the lane as shown in figs. 11 and 12. To smooth the

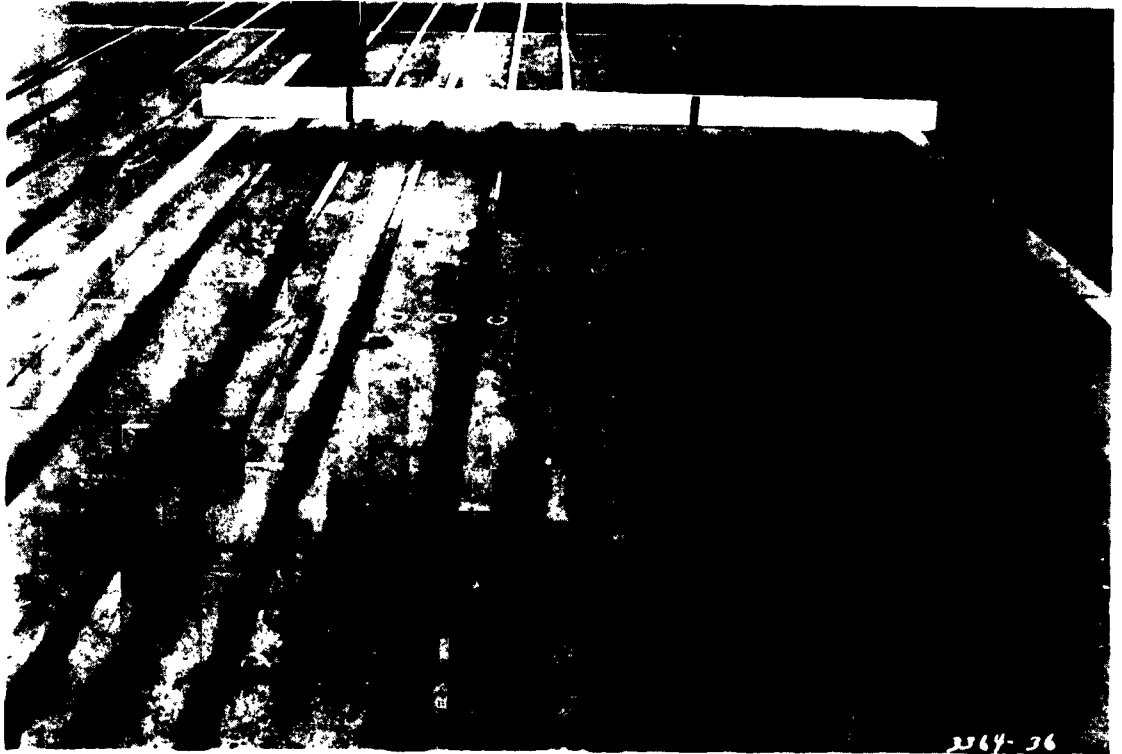
Photograph 11. Section 1, lane 1, prior to start of traffic tests

membrane, was used as the control or standard with which other sections surfaced with adhesive-bonded membranes were compared. Photograph 11 illustrates the smooth surface appearance of the section before traffic. As traffic was applied, it was observed that there was a tendency for the membrane to stretch and become slack; because of this, a slight wrinkle formed in the material in front of the load wheel as it passed over the section. However, traffic did not produce any appreciable detrimental effects on this membrane. Adhesive EC-866 used for sealing the joints was satisfactory except in a small area which became unsealed at 40 coverages (fig. 17); this was a result of failure to clean the membrane surfaces properly at the time adhesive was applied. The affected area was cleaned and resealed with adhesive EC-866 which provided adequate bond for the duration of the traffic tests. After 350 coverages, traffic was discontinued as there were no indications of membrane deterioration or subgrade failure (photograph 12). As shown in table 3, the CBR of the section varied from 42 at the start of traffic to a high of 60 after 174 coverages; the CBR at the end of the test

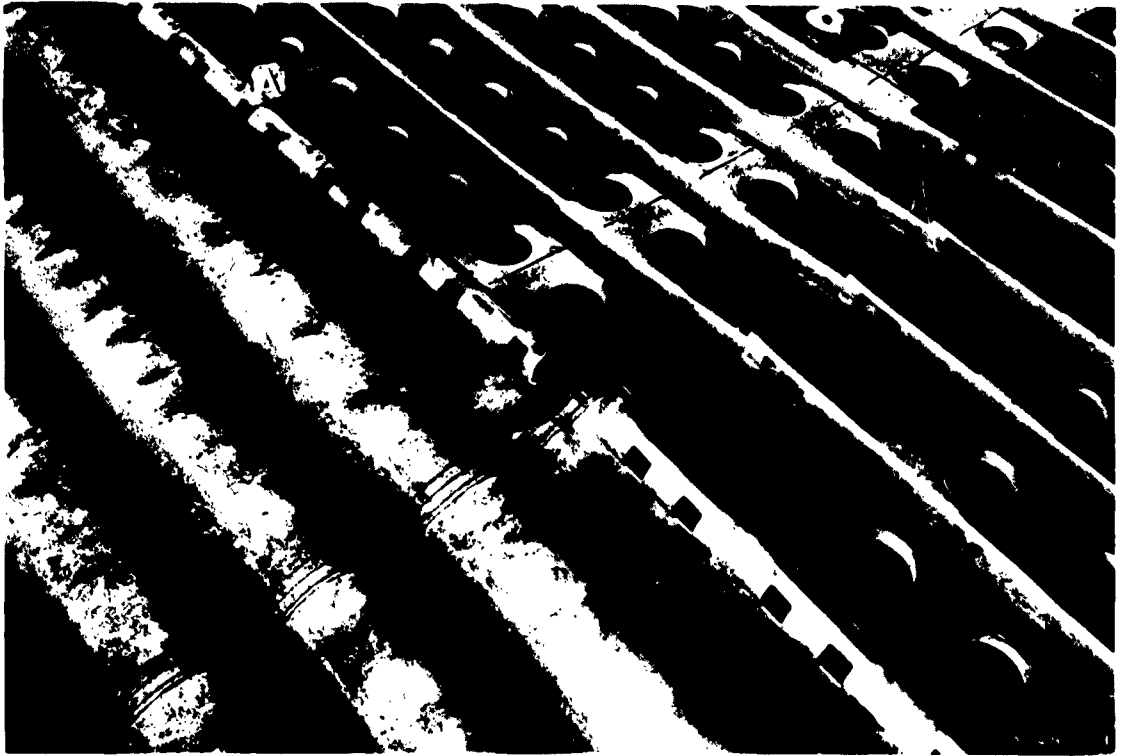
Photograph 27. Failure of T1 membrane caused by rolled edge of mat after 700 coverages on section A, lane 2

at the end of the test lane for safety purposes.) After the mat panels were removed from the section, numerous small cuts were found in the membrane; these had been caused by the rolled edge of the mat near the panel end joints (photograph 27). Sewn and adhesive membrane joints remained in excellent condition, although the thread of the sewn joints had been severely scuffed and abraded by the flexing of the landing mat. After 700 coverages, the mat in the traffic lane was approximately 70 percent seated.
