QUARTERLY REPORT FOR THE PERIOD

PRODUCTION ENGINEERING MEASURE

2N914 AND 2N995

IMPROVE PRODUCTION TECHNIQUES  
TO INCREASE THE RELIABILITY OF  
SILICON PLANAR EPITAXIAL TRAN-  
SISTORS 2N914 AND 2N995

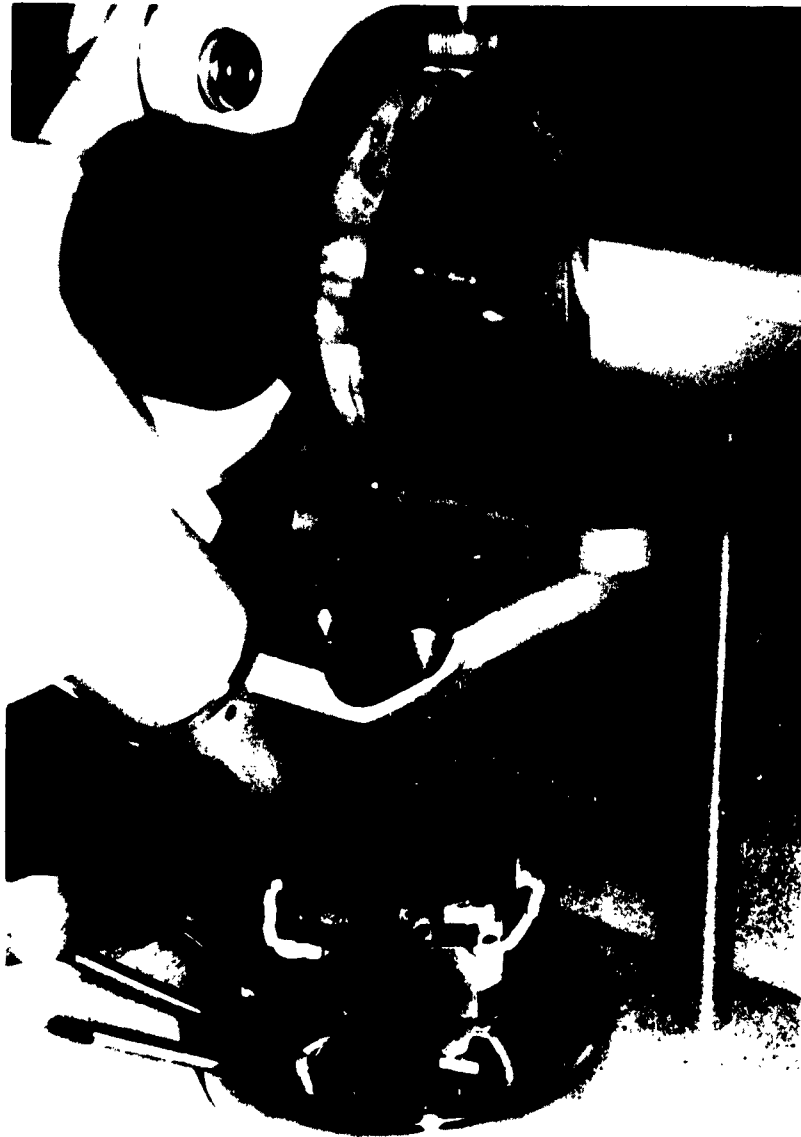
TASK 1B - EXHIBIT 3

LEVER CLUTCH WIRE FEED MECHANISM

C. Wire Feed Mechanism:- Incorporation of a small felt cleaning pad to clean the wire prior to entering the capillary will be evaluated.

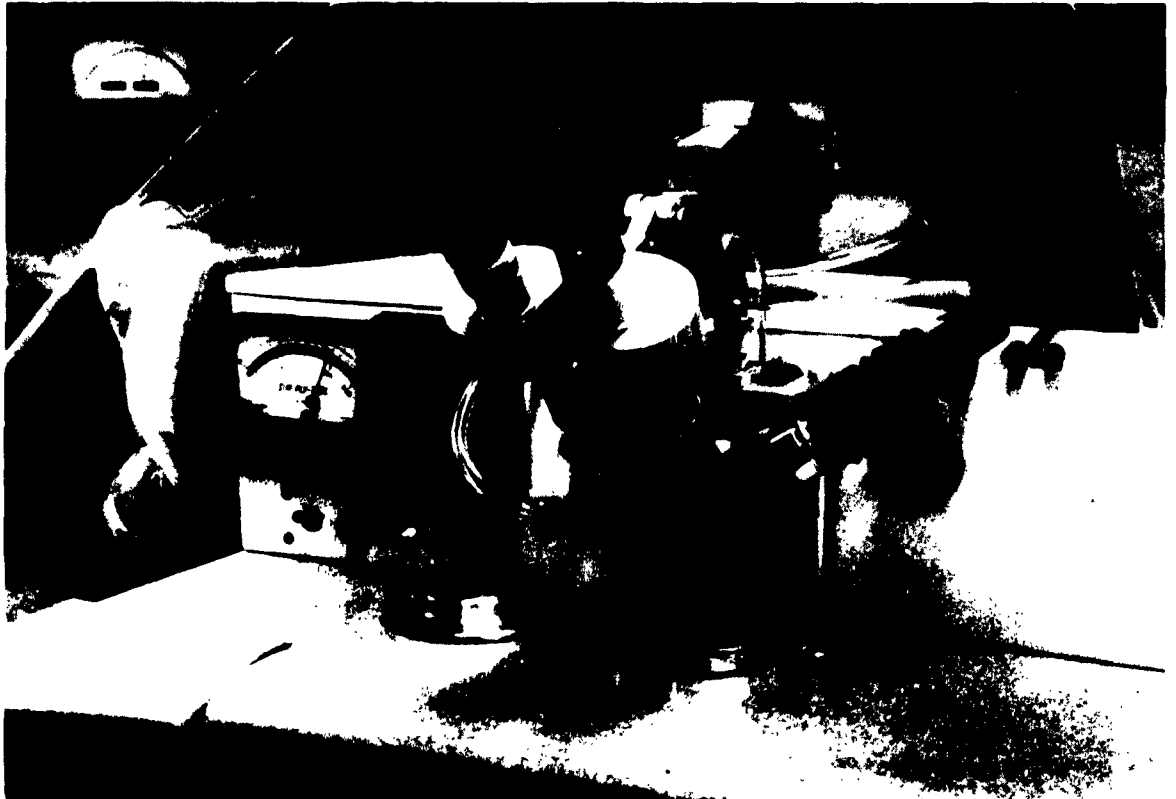
TASK 1B - EXHIBIT 4

MECHANIZED BALL BONDER

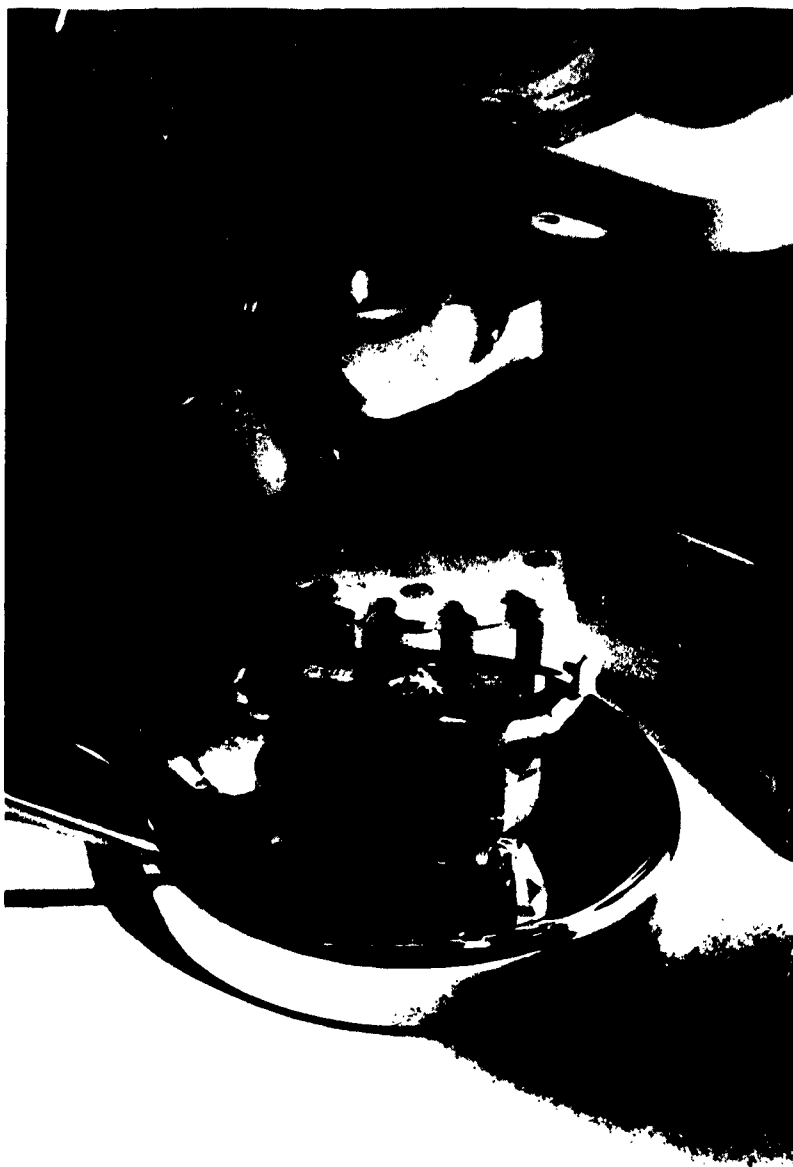
TASK 1B - EXHIBIT 5

HEATER NEST

D. Mechanized Ball Bonder:- Heater improvements will be investigated to further improve the thermal characteristics of the heater block.
