U. S. NAVAL PROVING GROUND  
DAHLGREN, VIRGINIA

REPORT NO. 7-45

EXAMINATION OF ITALIAN PROJECTILES

To make a complete physical, chemical and metallurgical examination of the following Italian projectiles.

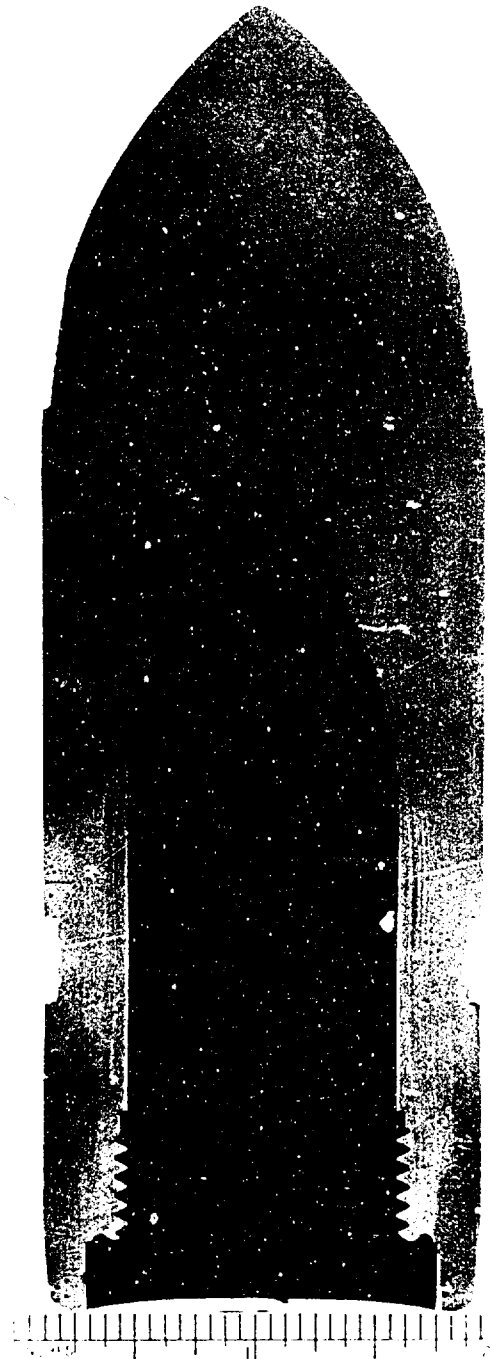
# HARDNESS DISTRIBUTION AND MACROSECTION OF ITALIAN 47mm AP PROJECTILE

Hardness Values: Vickers Pyramid (50 Kg.)  
Etch: Ammonium Persulphate

The projectile body was split longitudinally with an abrasive cut-off wheel and a hardness survey made of the entire cross-section. Figure 3 shows the hardness distribution and macro-etch section of the body. A maximum hardness of approximately 630 VPN (56Rc) has been obtained on the nose of the projectile. The hardness drops off slowly from the nose to a point about a quarter of an inch above the band score where it drops off rapidly to approximately 260 VPN (25Rc) which hardness is maintained throughout the base. The flow lines shown in the macro-etch section indicate that the projectile was forged and machined.

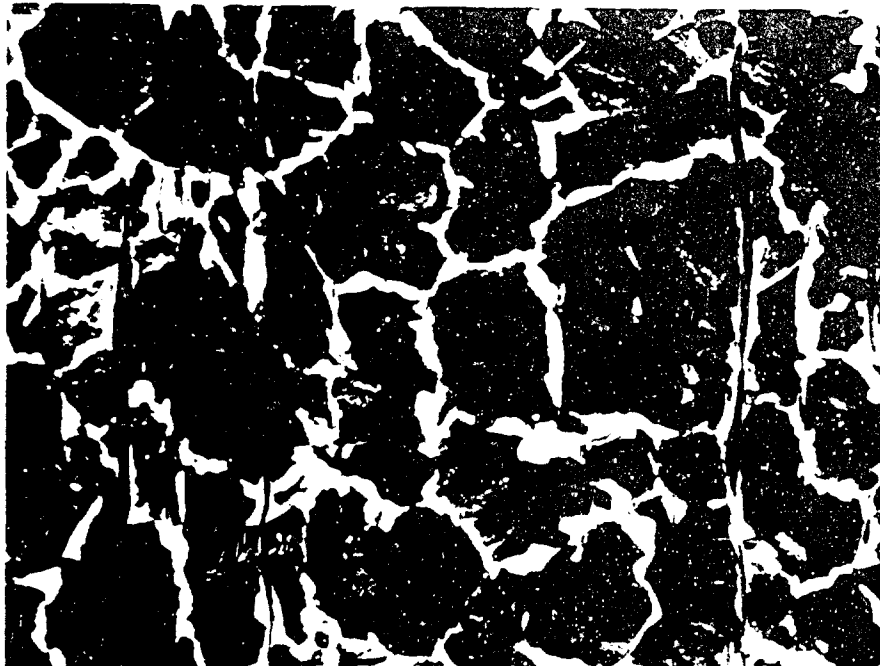
Figure 4

MICROSTRUCTURE OF THE BODY OF  
ITALIAN 47mm HE PROJECTILE

Fine Pearlite and Ferrite

Hardness - 92 Rb      Magnification 250X

The projectile body was split longitudinally and deep etched to reveal the flow lines. Figure 3 shows the etched section and indicates that the projectile was machined from bar stock. A uniform hardness of approximately 92 Rb was obtained along the surface of the body. The microstructure of the projectile body is shown in Figure 4. It consists of fine pearlite and ferrite and has a relatively large number of non-metallic inclusions.

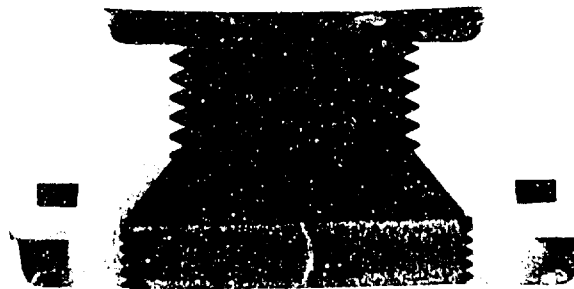
Bottom view and deep etched section of base plug of  
Italian 120mm Common projectile CEE No. 3437.  
15 May 1945
