NRL Report 5542

**TRACKING FLARE INSERTION LOSS TESTS
AT 9.2 AND 24 kMc**

October 19, 1960

U. S. NAVAL RESEARCH LABORATORY
Washington, D.C.

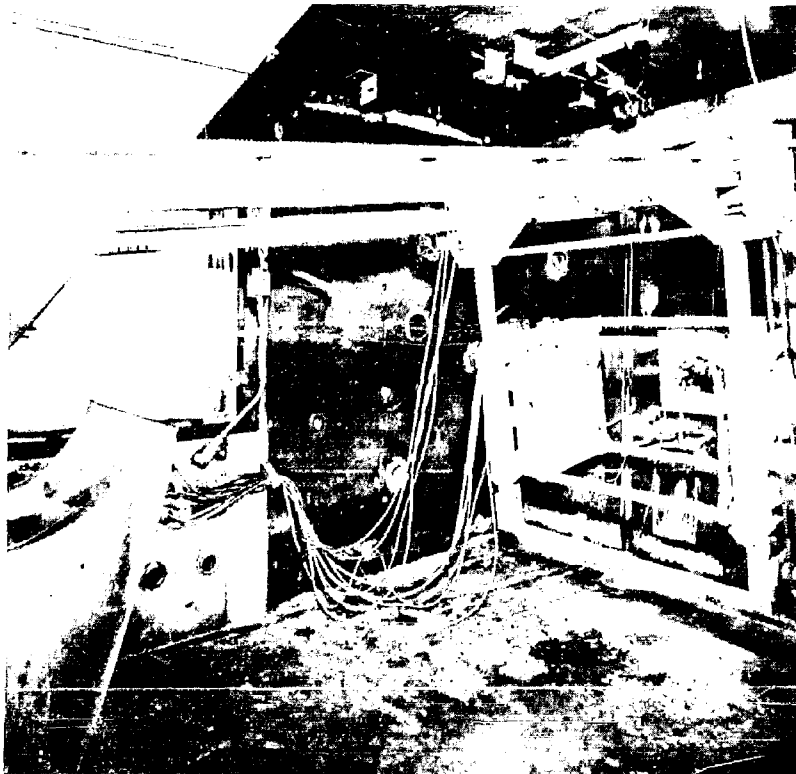
Fig. 2 - Probing assembly inside altitude chamber

Figure 2 shows the probing system inside the altitude chamber. It consists of a movable focusing lens-horn assembly which can traverse either along or perpendicular to the exhaust axis. (A small rocket motor is shown where the tracking flares were positioned for these tests.) The chamber has interior dimensions 7 ft by 10 ft by 7 ft high. Figure 3 shows the insertion loss measuring system. Loss measurements were taken at 9.2 kMc (in the X band) and 24 kMc (in the K band). Figure 4 shows an expended flare. Its overall length is 10 inches. The flare is ignited by an electrical firing squib. During the 60-second flare burning period the probing system can make either three horizontal traverses along the exhaust axis or three vertical traverses at a given position along the exhaust axis. Insertion loss is determined by a substitution method. The focusing property of the lens-horn at K band is such that 90% of the energy from the klystron passes through a 3/4-inch circle at the focal point. At X band the circle is 2-1/2 inches. The movable rack is positioned so that the exhaust axis passes through the focal point.
