ROYAL AIRCRAFT ESTABLISHMENT  
(BEDFORD)

TECHNICAL NOTE No: AERO. 2755

**A FLIGHT ASSESSMENT OF THE  
VIEW FROM THE T.S.R.2 BY  
SIMULATION IN A HUNTER 6**

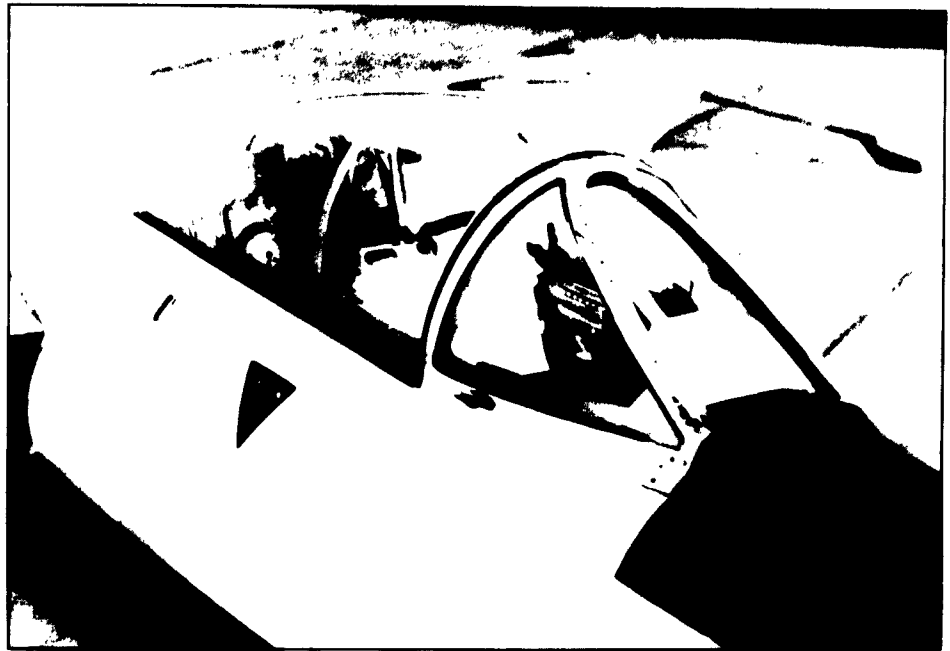
FIG.11. GENERAL VIEW OF HUNTER COCKPIT IN CONFIGURATION 5

Simulation of T.S.R.2 configuration A. The Hunter is shown in the photograph Fig.9b from which the field of view Fig.10b has been derived, and in the general view Fig.11.
