ROYAL AIRCRAFT ESTABLISHMENT  
(FARNBOROUGH)

TECHNICAL NOTE No: MECH. ENG. 333

CONTINUOUS-ROD WARHEAD  
LETHALITY TRIALS AGAINST  
B.29 AIRCRAFT FUSELAGES

(3/16, 1/4 and 5/16 INCH SQUARE-SECTION RODS)

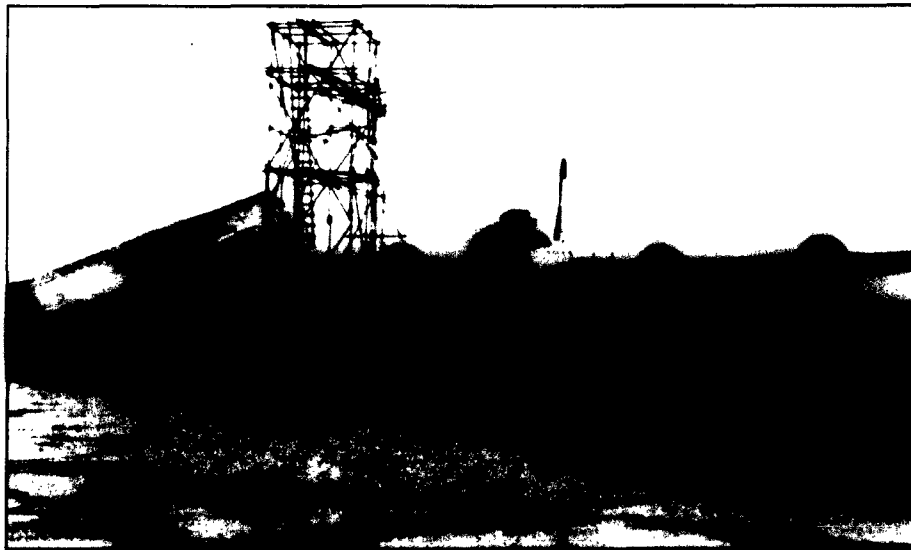
FIG.10. TYPICAL LAYOUT SHOWING PRIMARY  
AND SECONDARY TARGETS (FIRING 4)

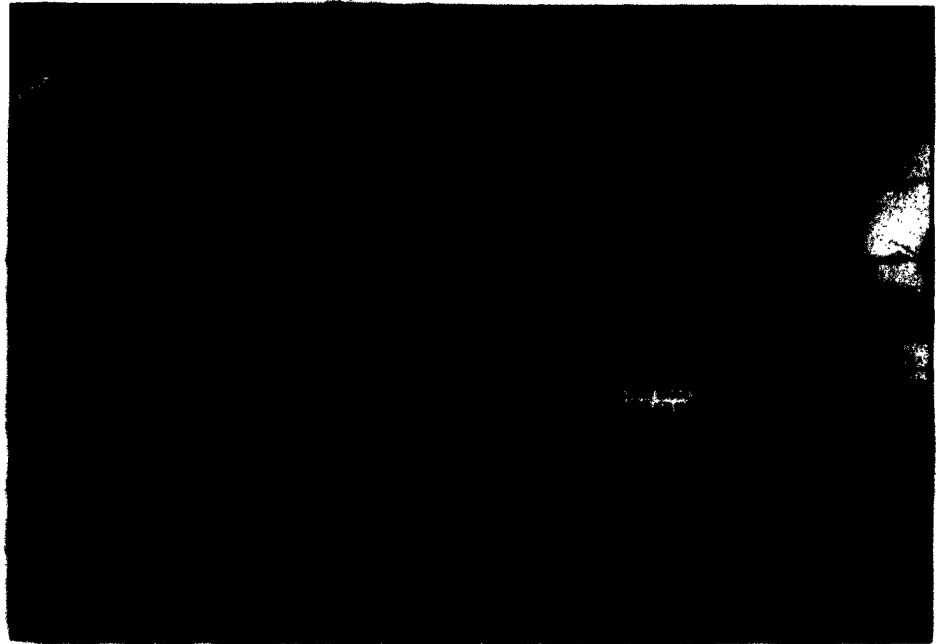
FIG.14c. FIRING 4. SECONDARY TARGET. ROD DAMAGE TO ATTACK  
SIDE EXTERIOR ( $\frac{1}{8}$  Inch ROD. STN.566, 60' OFF DEAD ASTERN)

9.2.2 The results of Firings Nos.3 and 4 against the secondary targets showed that the effect of changing the direction of attack from  $45^\circ$  above abeam to  $60^\circ$  off astern was to slightly decrease the amount of skin and stringer material severed, but this was offset by the severance of several frames. Exit damage was reduced to negligible proportions. The 5/16 in. rod was also shown to be capable of damaging longeron members adjacent to the skin to a greater extent than the 1/4 in. rod.
