NWL Report No. 1832

INVESTIGATION OF STOWAGE HAZARDS  
IN AIR LAUNCHED MISSILE MAGAZINES:  
THE COMPATIBILITY OF PREPACKAGED  
LIQUID- AND SOLID- PROPELLANT BULLPUP  
MISSILES IN A COMMON SHIPBOARD MAGAZINE (U)

Weapons Development and Evaluation Laboratory

Date: 16 NOVEMBER 1962

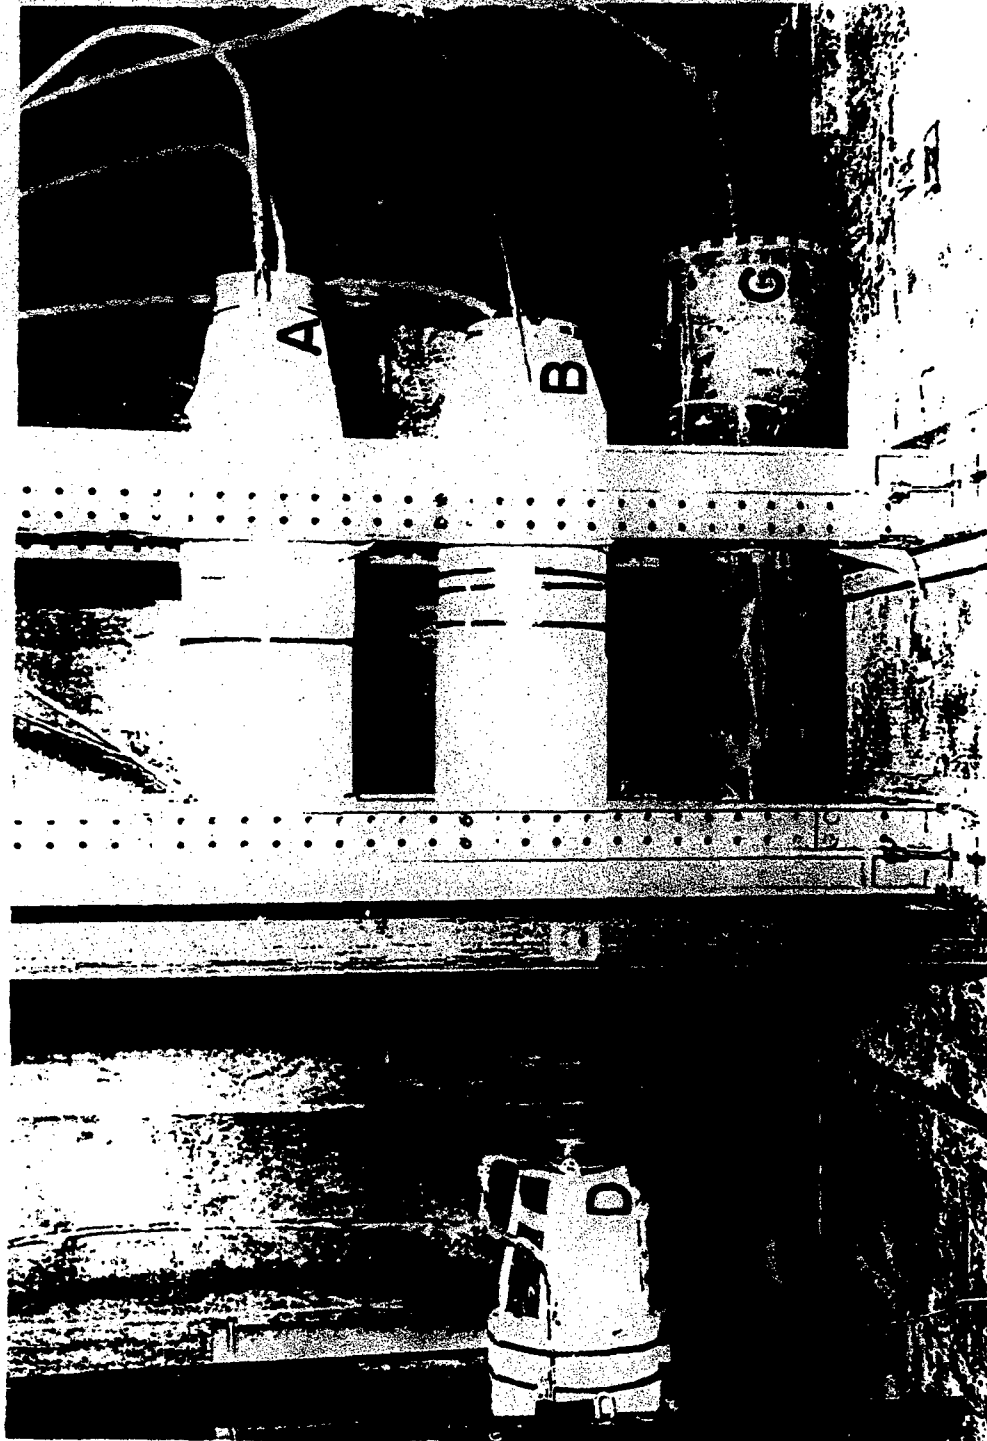
DD-5703-5-62

Test A-2-a. View of active and passive units before test. (A) Passive solid-propellant motor, (C) passive liquid-propellant engine, (G) wax-filled simulated warhead, (D) active solid-propellant motor, and (E) bullhead.

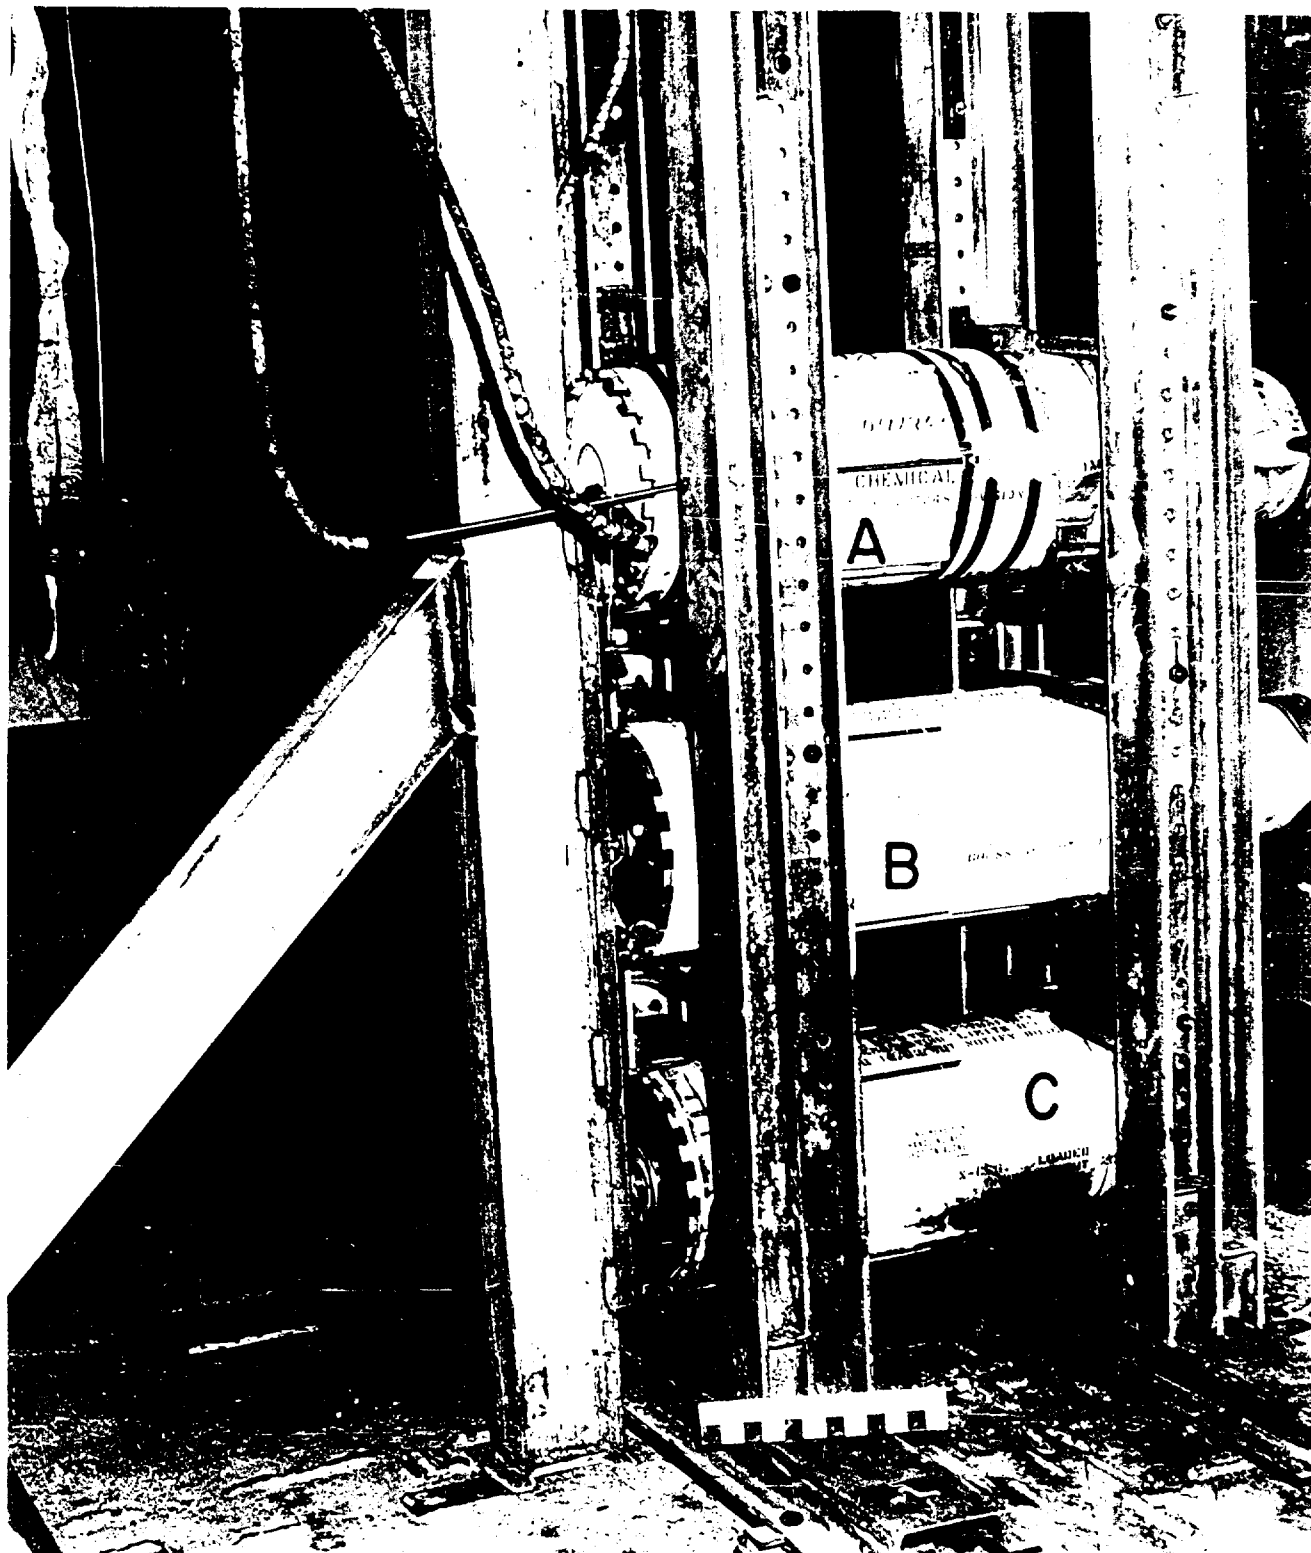
Figure 11.

Test D-2-a (Mod). View of arrangement before test. (A) Passive liquid-propellant engine, (B) active solid-propellant motor, and (C) passive solid-propellant motor containing a 4-inch grain segment in the after end.

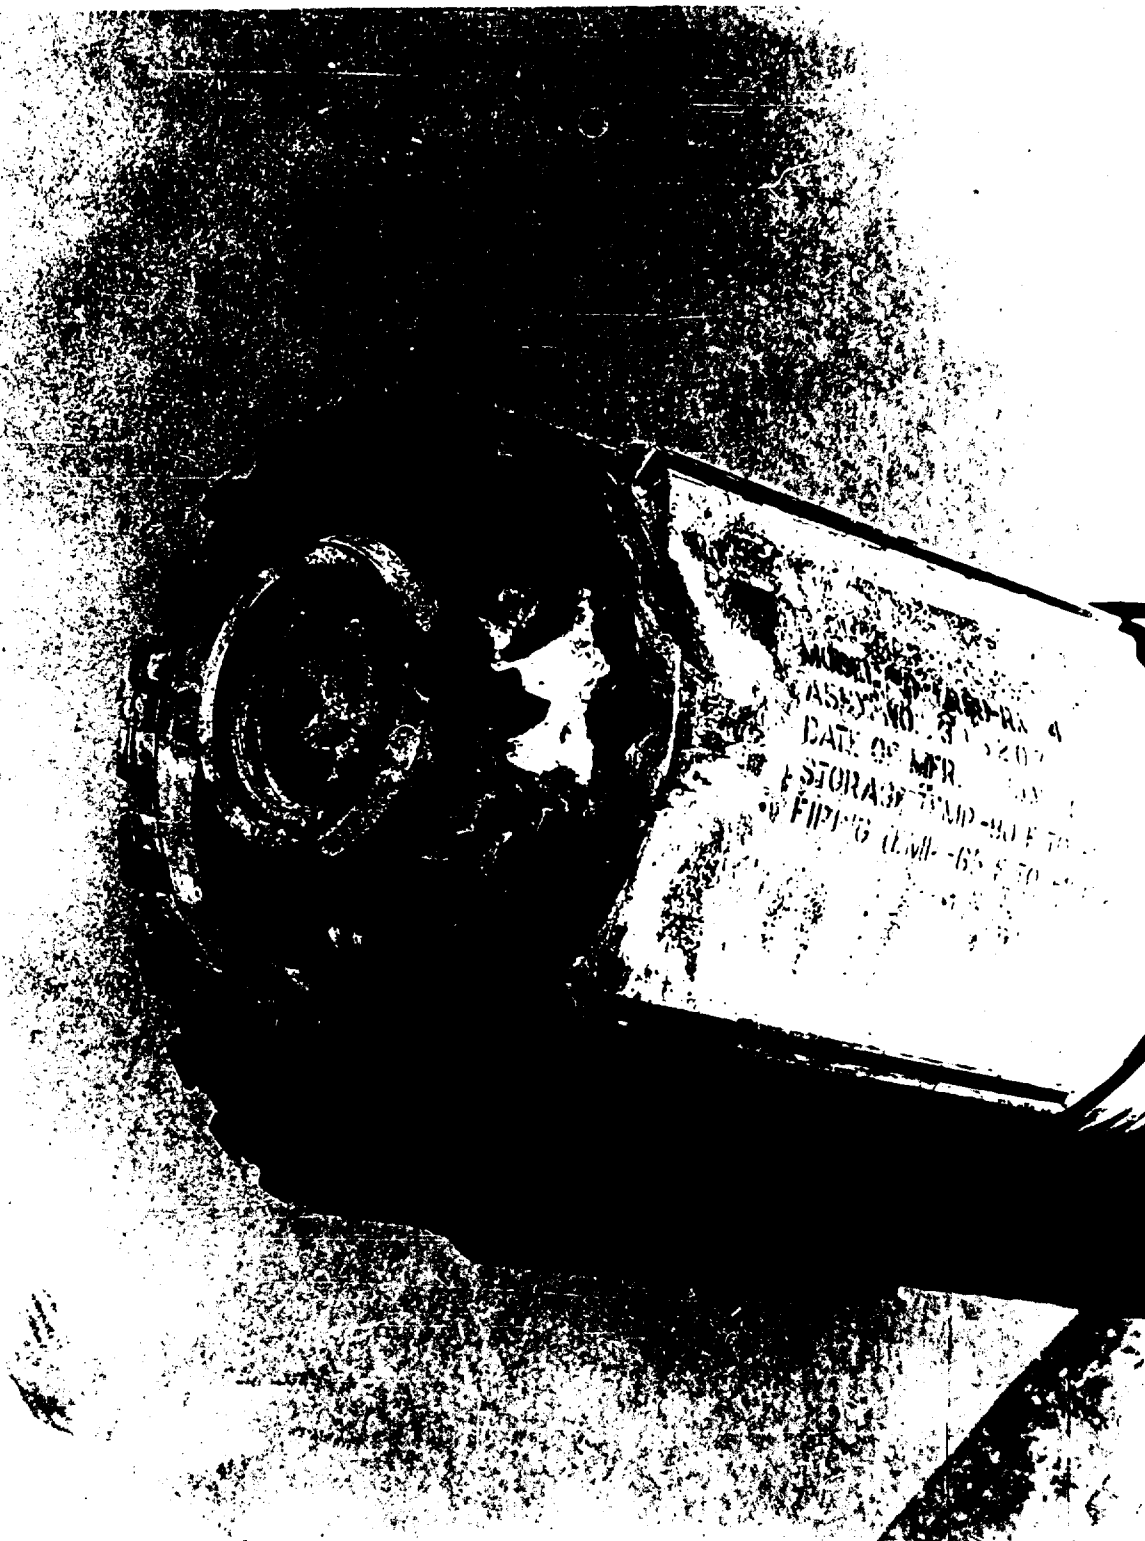
Figure 18

Test A-1-b. View of the initiator opening of the active liquid-propellant engine after test. Note how the opening was enlarged by the gas venting from this opening as well as the nozzle.

Motion pictures of the magazine showed sufficient displacement of the overhead to allow the modular stowage stanchions to be lifted out of the deck tracks and to permit the blast from the burning engine to cause the passive units to be blown, with the stanchions and the bulkhead, away from the active unit. These units were only slightly damaged and did not ignite. The results of this test are presented in Appendix D, Figures 16, 17 and 18 and Table 2.

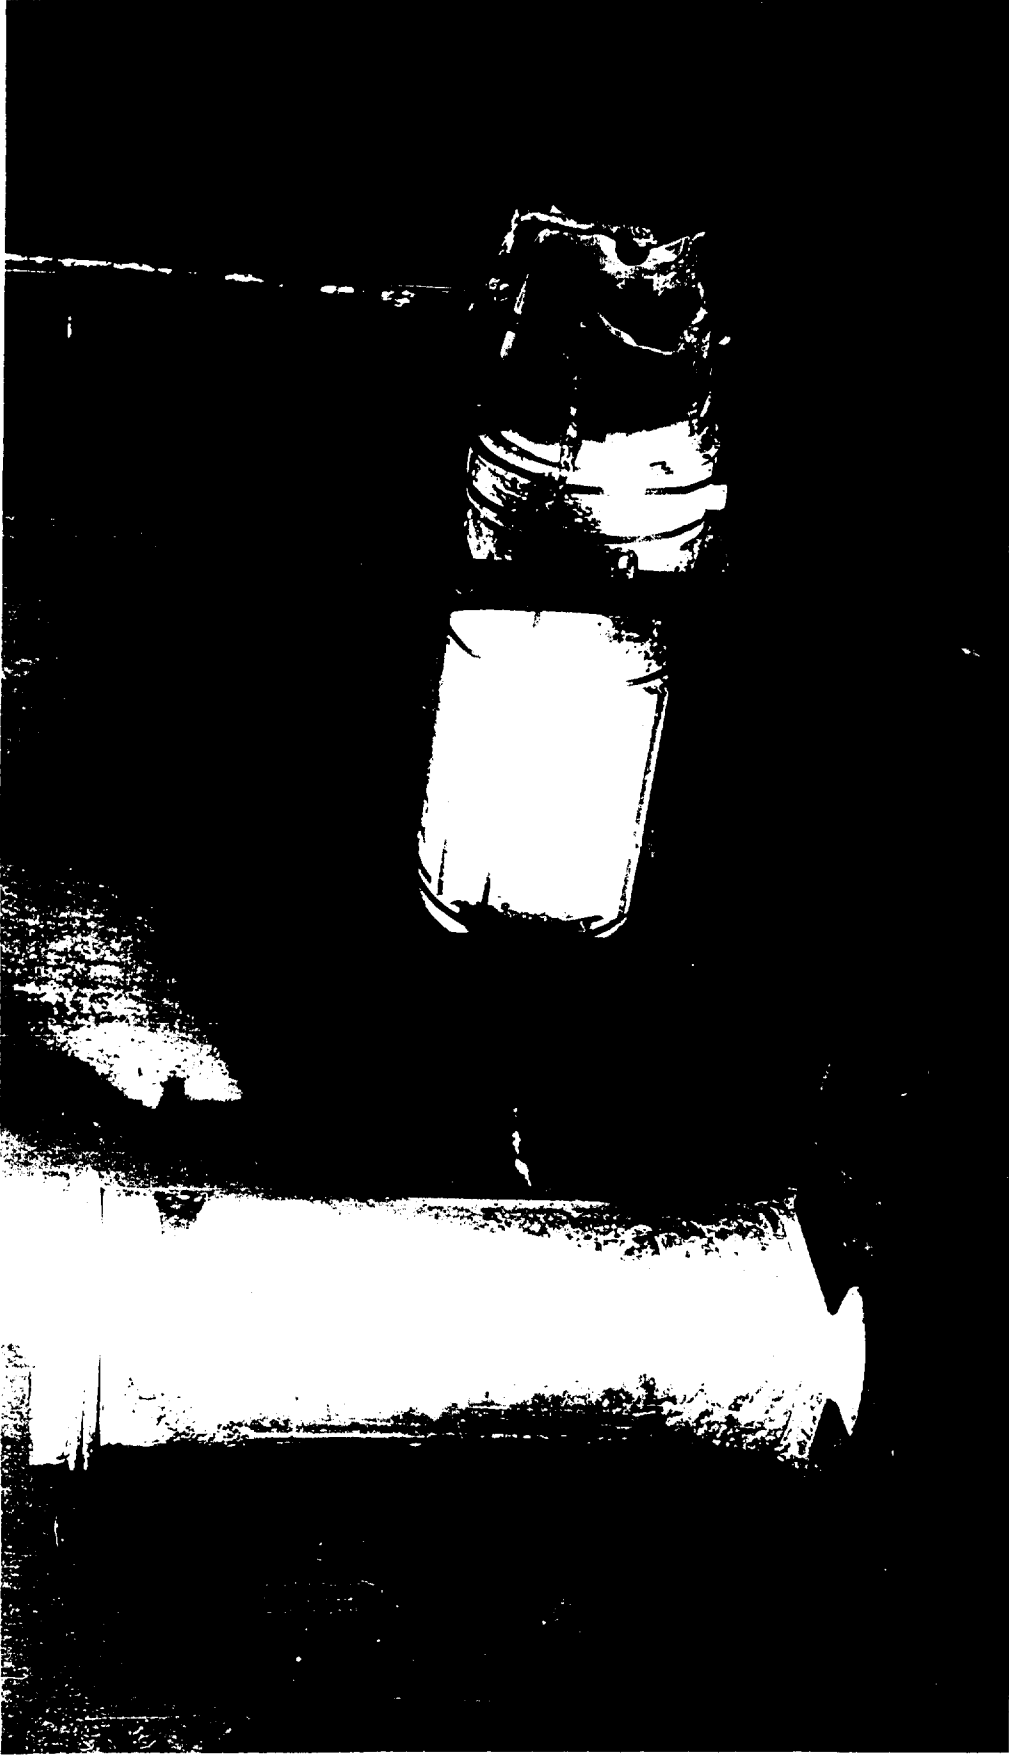
Test A-2-a. View of active solid-propellant motor after test. The spill cans had been righted before this picture was taken.

The active motor did not ignite and other than the paint being slightly charred, was not damaged. The passive units did not ignite and neither the active unit nor the passive units approached cook-off temperature. Magazine pressure was not sufficient to dislodge the vent cover. The results of this test are presented in Appendix D, Figure 20 and Table 2.

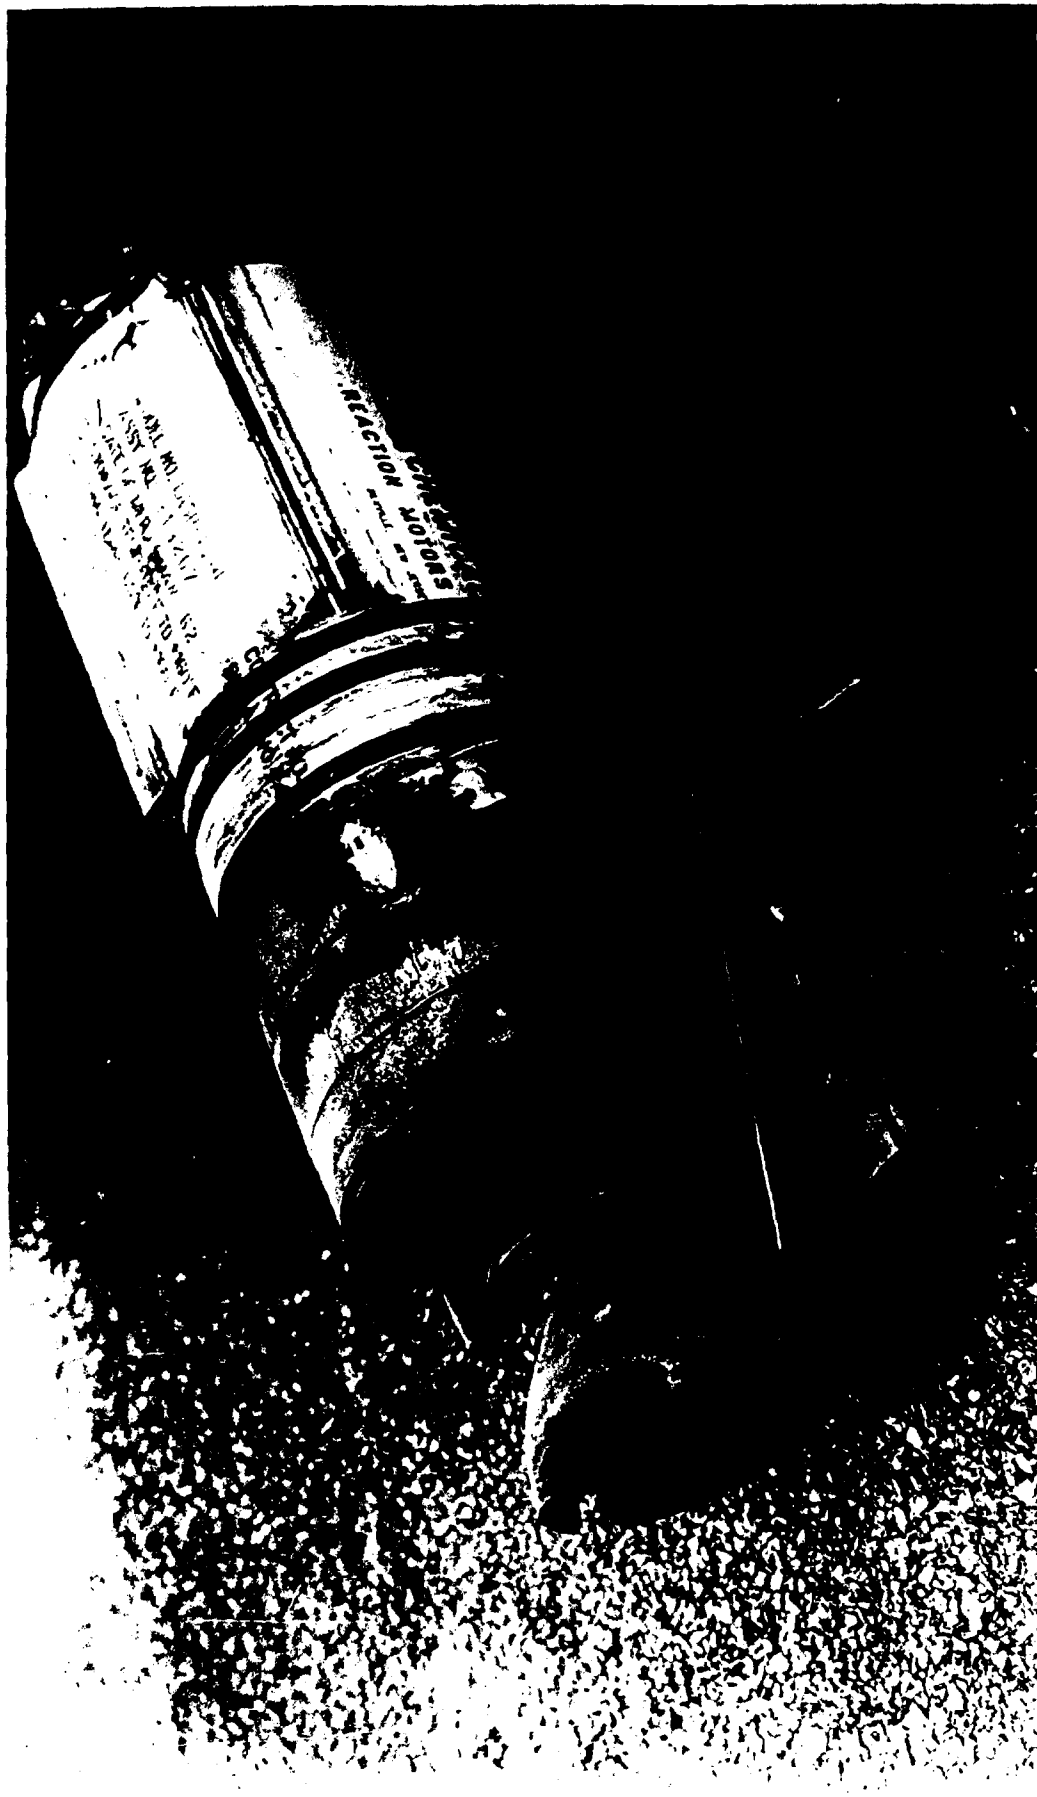
Figure 26

Test B-2-a (MOD). View of the passive liquid-propellant engine (stowed above the active unit) after test.

The nozzle shroud of the passive liquid-propellant engine was burned completely off, the nozzle shroud of the lower solid-propellant passive unit was burned almost entirely off, and the nonpropulsive attachment (NPA) closure band was dislodged; however, the two passive units did not approach ignition or cook-off temperature. Only one nylon tie-down strap was used in this test and it burned through. The results of this test are presented in Appendix D, Figures 25, 26 and 27, and Table 2.

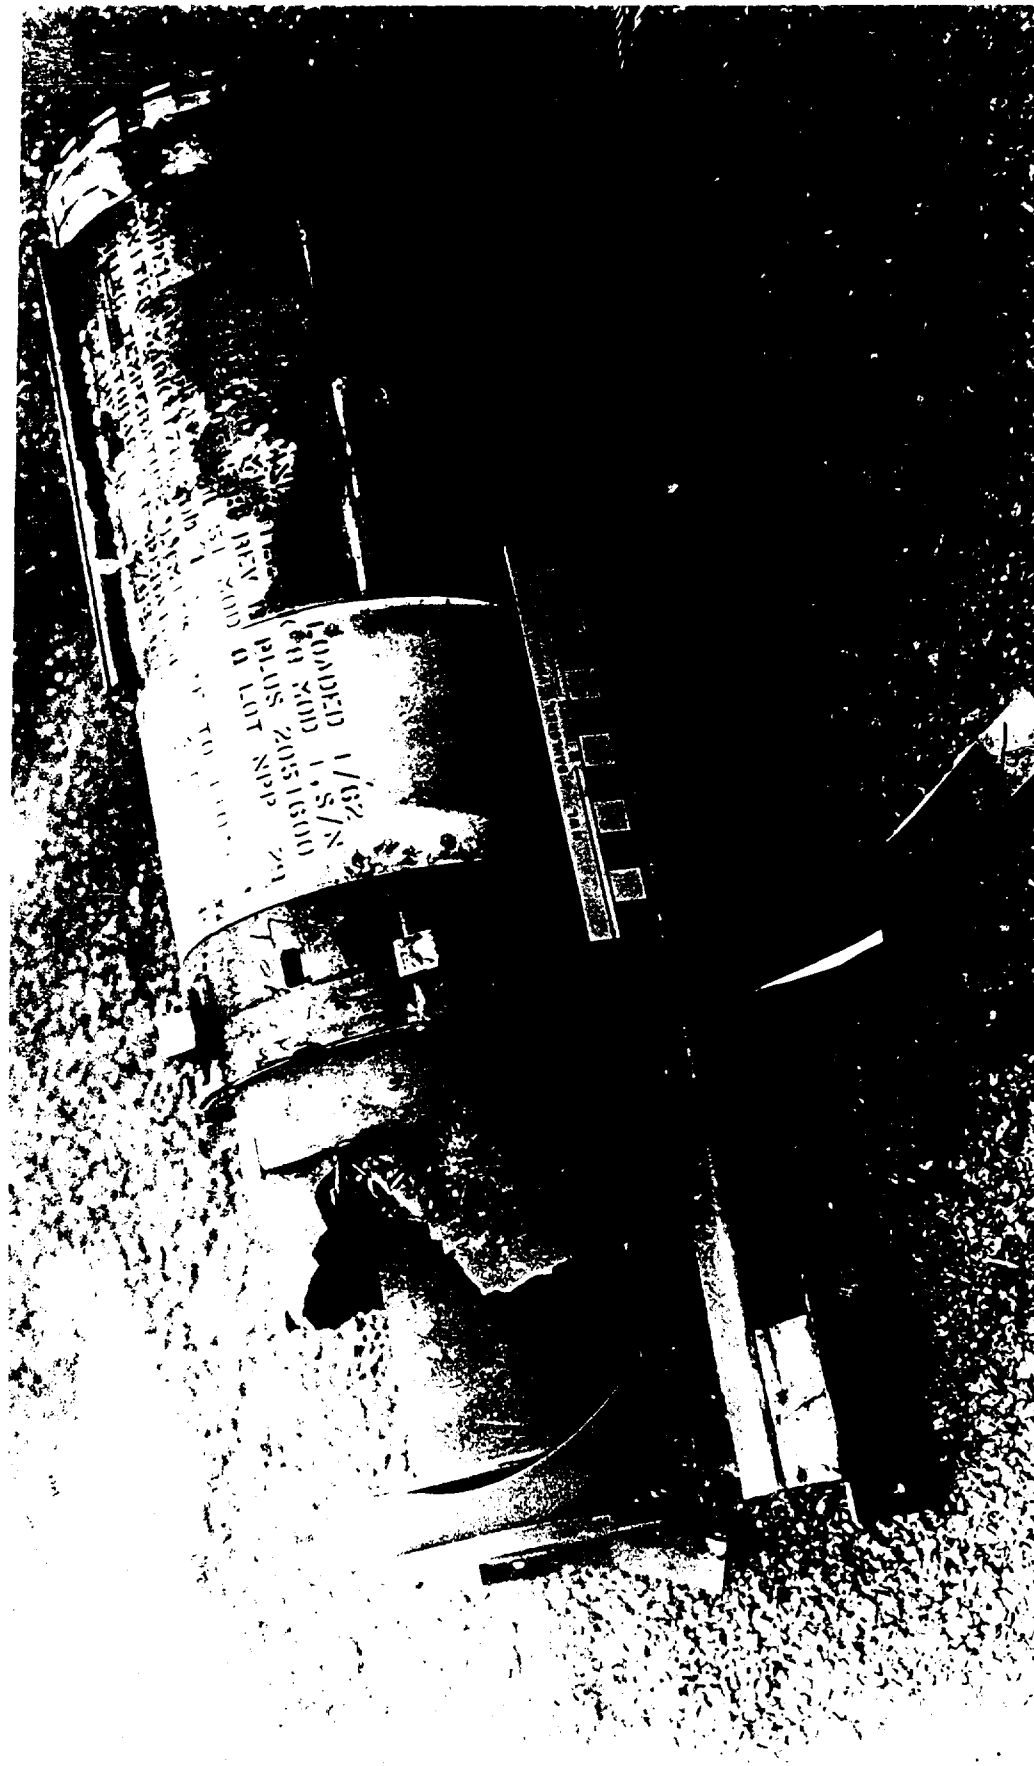
FHD-C9882-6-62

Test B-2-a (MOD). View of the passive solid-propellant motor (stowed below the active unit) after test.
