# NOUGAT

## SHOT HARD HAT

PROJECT OFFICERS REPORT—PROJECT 3.2

ELECTRONIC MEASUREMENTS IN ROCK AND  
TUNNEL LINER STRUCTURES (U)

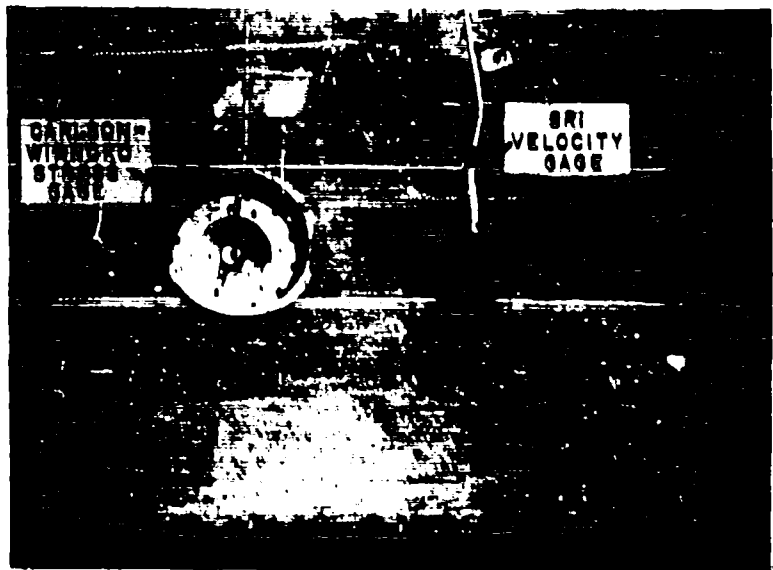
Figure 3.2 Foam pressure gage and velocity gage on  
Liner B3c. (DASA 032 (NOU-072-08) NTS-62)

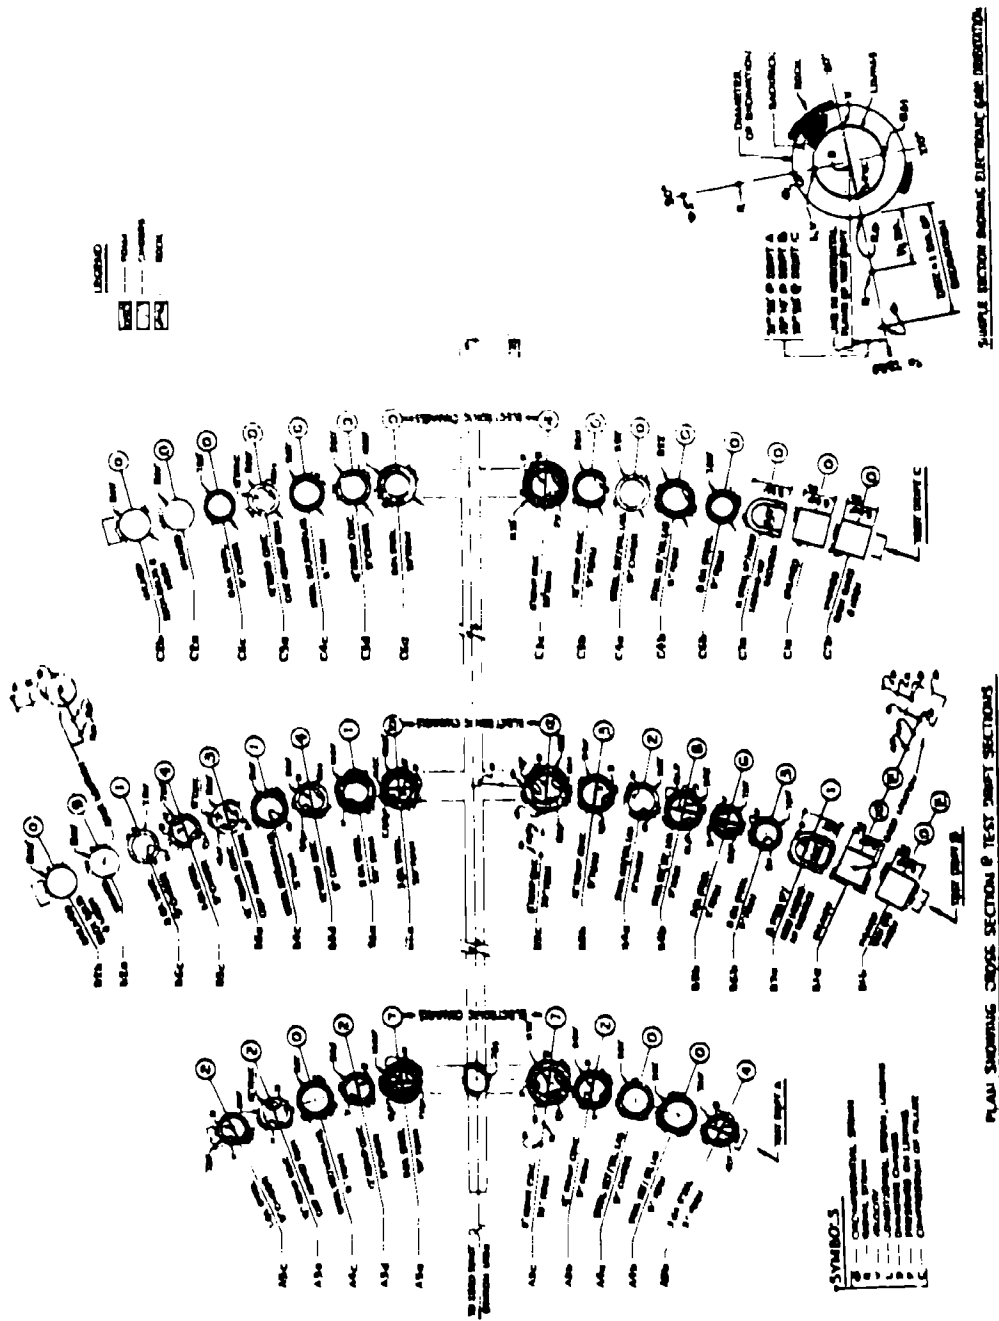
Figure 3.5 Structural response program instrumentation.

The overall program of Project 3.1 involved utilization of 43 test sections having a variety of liners, or no liner at all, originally to be located at three ranges (500, 350, and 250 ft) from the zero point (Reference 1). These three ranges were selected to give maximum probability of producing meaningful damage without complete destruction to the sections at one or more ranges. Under Project 3.2, a total of 108 electronic measurement channels were planned (Table 3.1 and Figure 3.5).

3.1.6 Summary. A summary of gage types and locations is presented in Table 3.1. The identification used for the liners is that used on Project 3.1. Figure 3.5 is a plan view of the test drift sections indicating the liner material and filler and the instrumentation orientation.

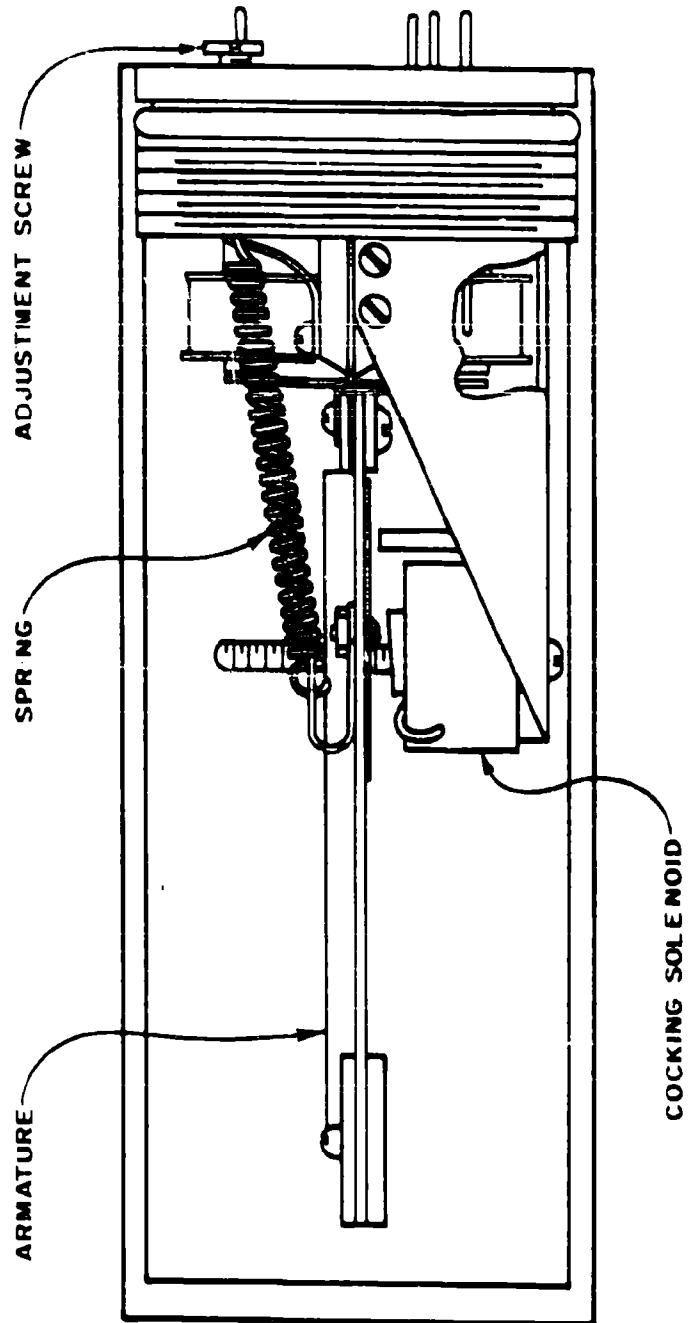
Figure 3.7 Sketch of SRI Mark II velocity gage.

3.3.2 Velocity Gages. When the SRI Mark II velocity gage is used in any other position than horizontal, the armature is brought to balance by a spring as shown in Figure 3.7. The effective pull of the spring is proportional to  $g \sin \alpha$ , where  $\alpha$  is the angle of departure of the mounting axis from the horizontal. For calibration, the gage is cocked by the solenoid, then turned in the reverse vertical position so that the spring is down. The solenoid is then released, and the record is taken of the output of the gage as the armature moves through zero. The force acting on the armature as it passes through zero is proportional to  $1 g$  plus the force of the spring. The calibration, then, is such that the distance  $y$  which the spot moves in  $t$  seconds corresponds to a velocity of  $gt(1 + \sin \alpha)$ , so that the velocity per unit deflection is

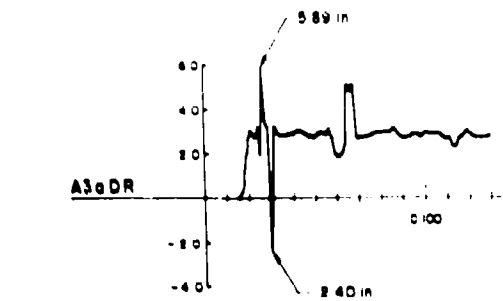
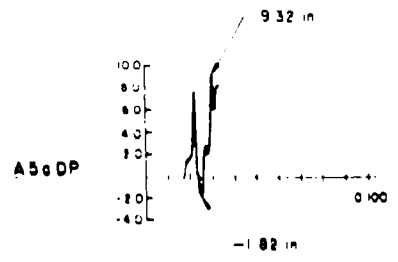
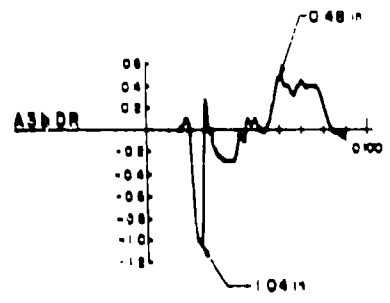
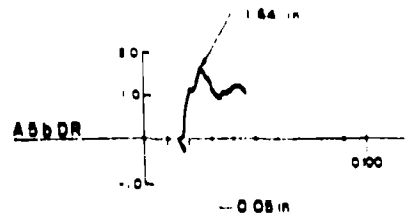
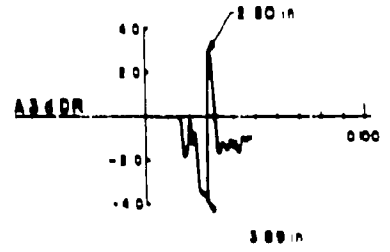
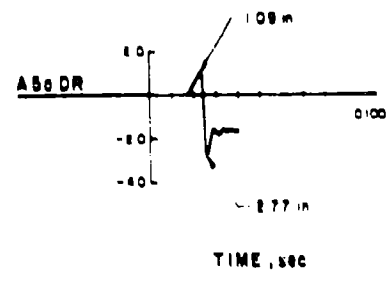
Figure 5.2 Measured relative displacements.

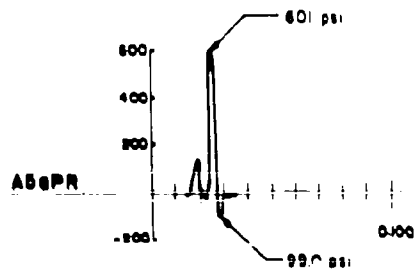
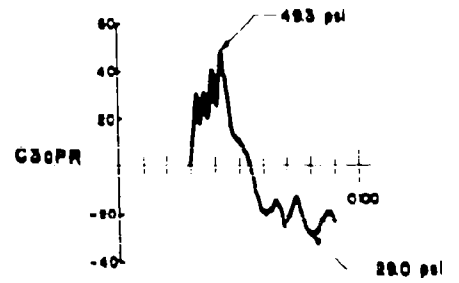
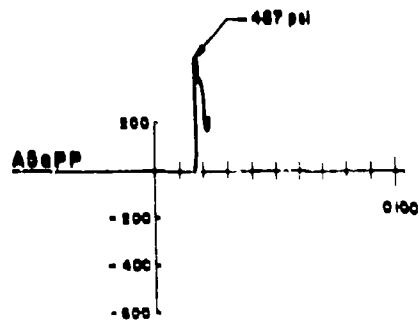
Figure 5.3 Pressure in foam.

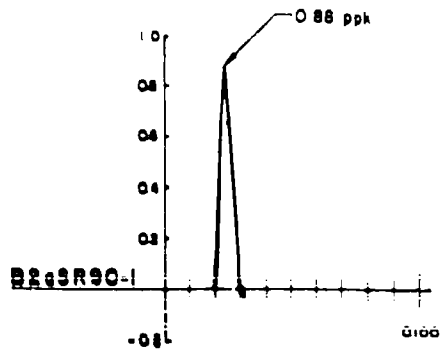
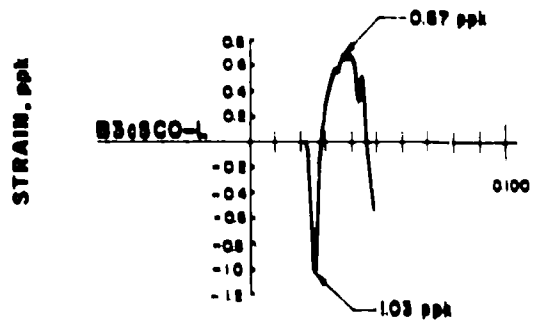
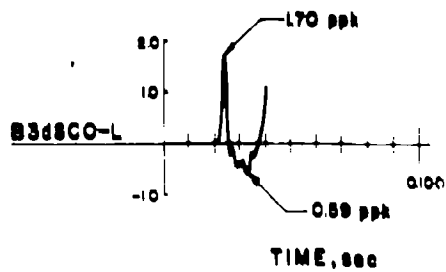
Figure 5.4 Strain in liners.

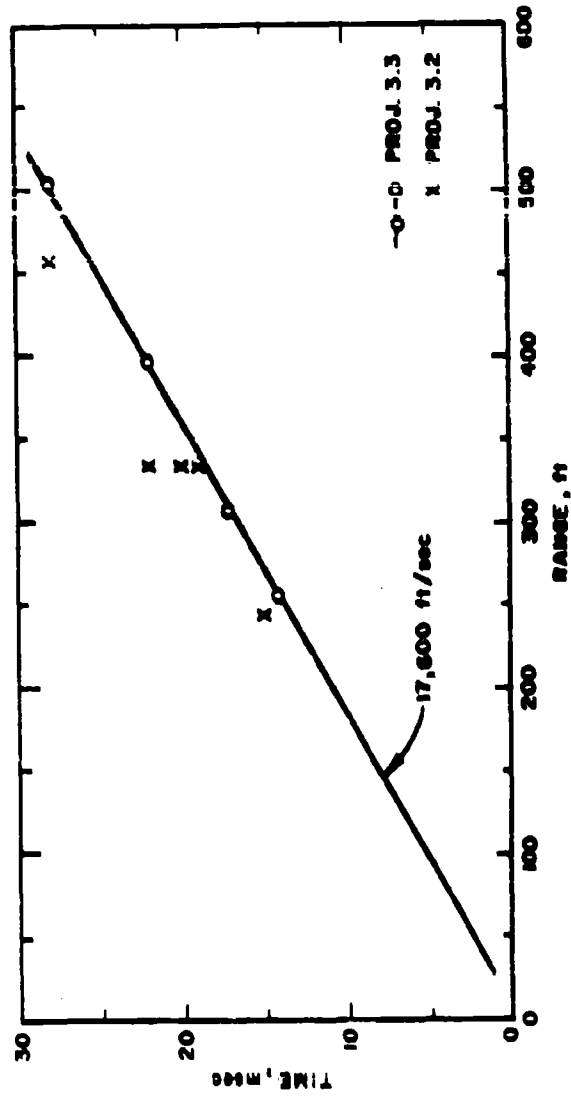
Figure 6.1 Arrival times, Projects 3.2 and 3.3.

Figure 6.1 shows comparison of the arrival times observed on this project with those observed in the free-field measurements of Project 3.3 as quoted in Reference 6. The free-field measurements show propagation velocity in the ranges of interest from about 17,600 ft/sec. All of the definite arrival times shown on Table 5.1 are later than those shown on this curve by times ranging from 0.5 millisecond to 3.5 milliseconds. This is to be expected, since there should be a considerable delay of the shockwave passing through the foam backing of the liners. The general trend confirms the velocity determined from Project 3.3 data.
