| | Page |
|---|---|
| 1.2 Experiments with Armor under Conditions of Atomic Bomb Attack . . . . . | 3 |

### CHAPTER 7 CONCLUSIONS AND RECOMMENDATIONS

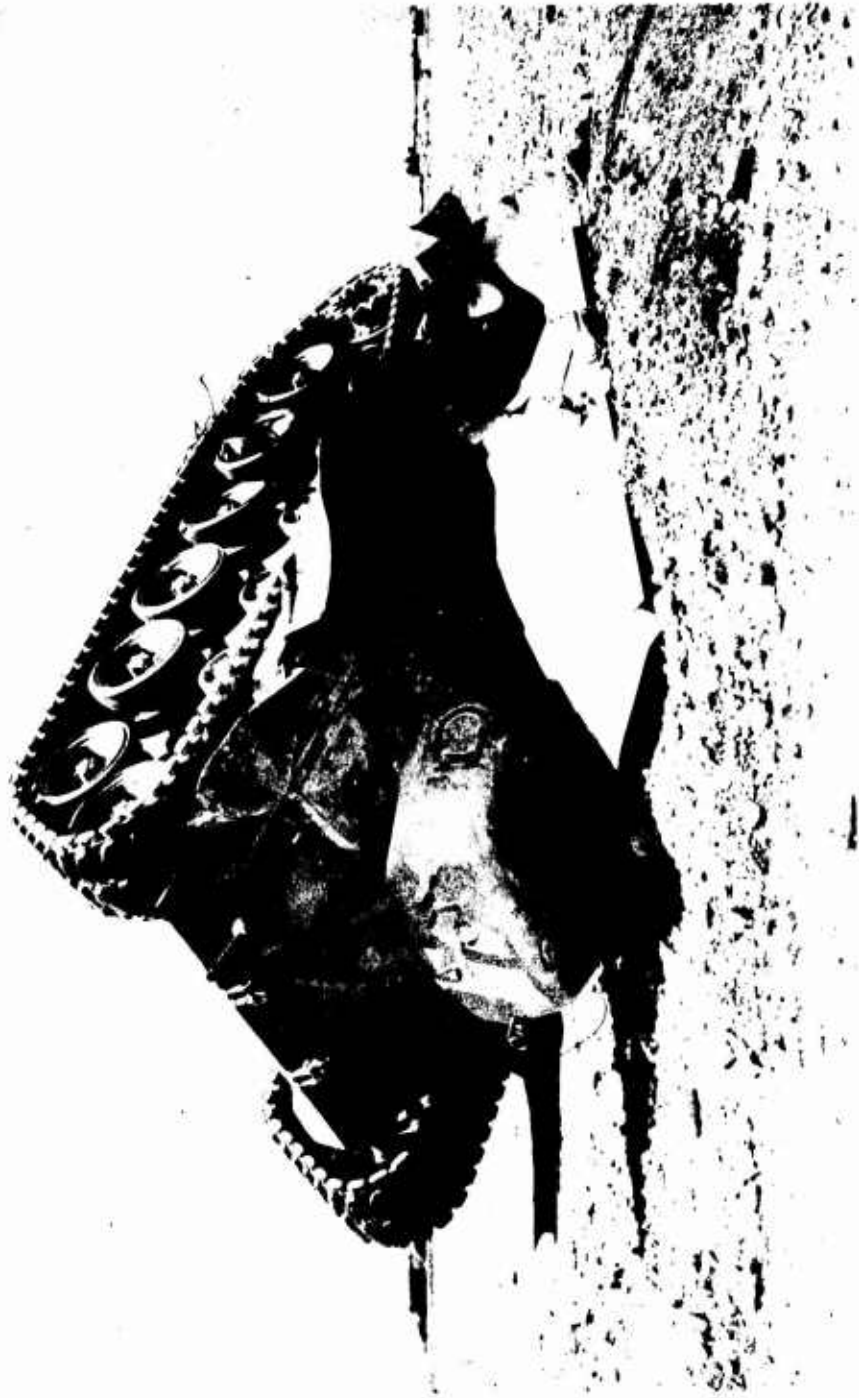
Fig. 5.16 Side-on Tank after Exposure to Blast, 750 Yd

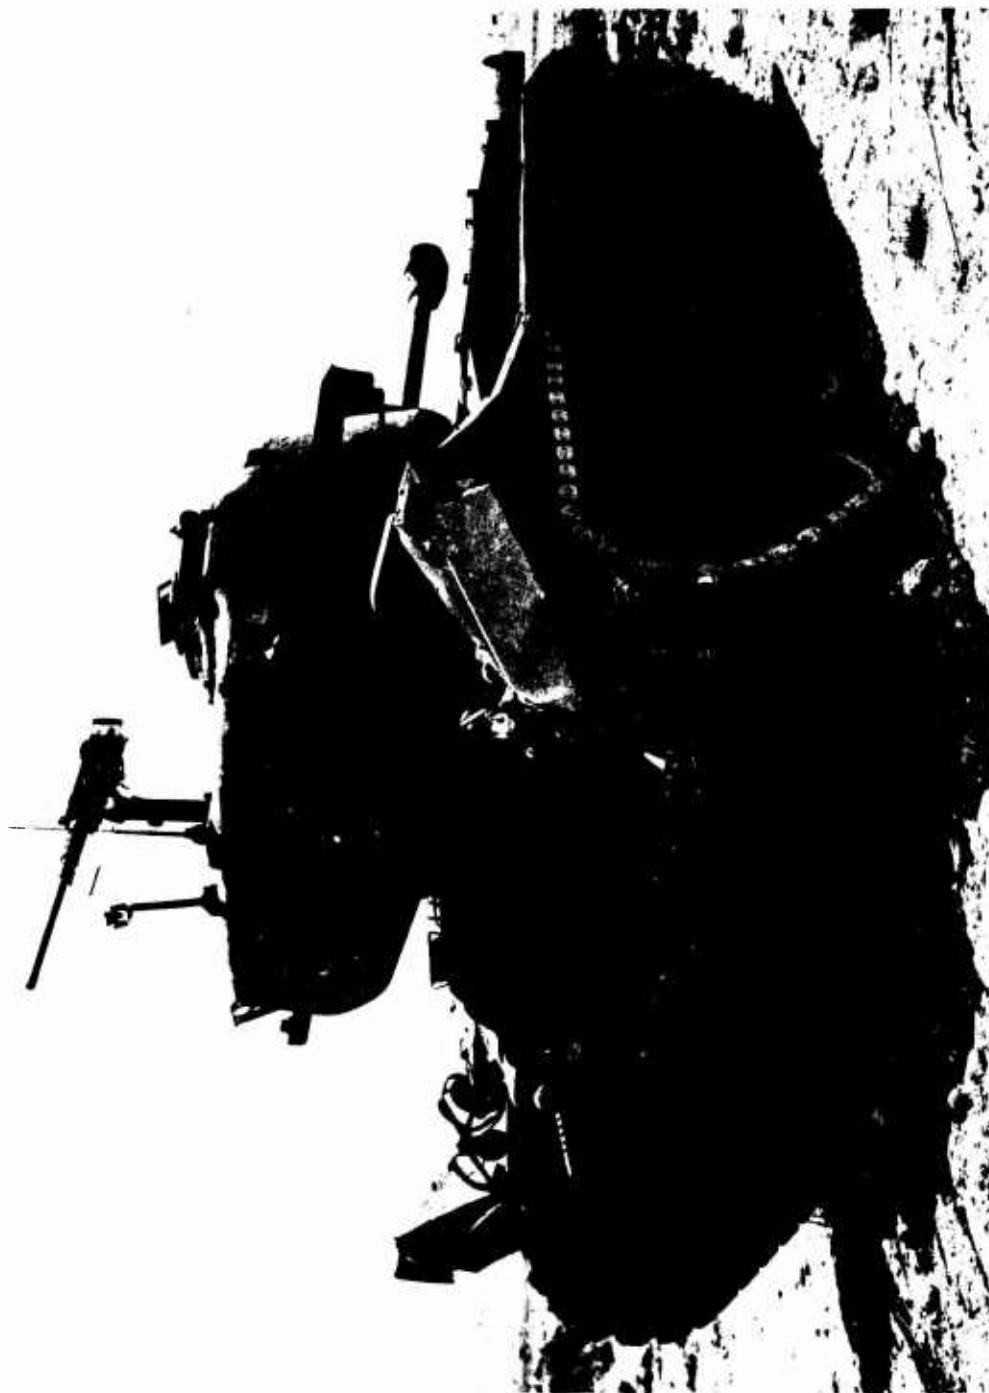
Fig. 5.20 Head-on Tank after Exposure to Blast, 1000 Yd

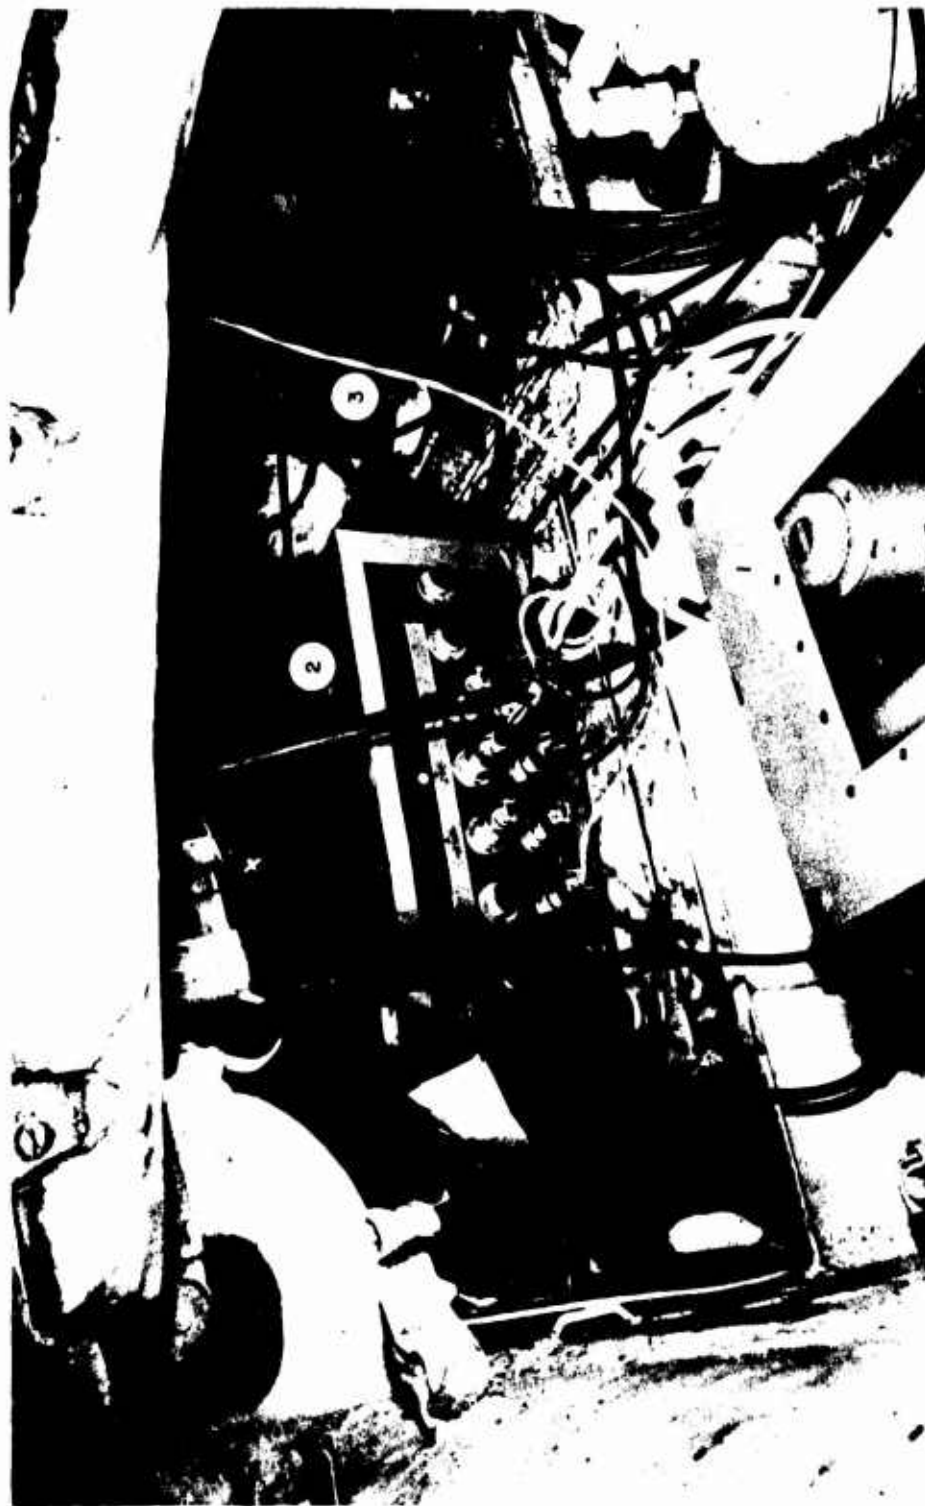
Fig. A.16 Typical Installation of Equipment. 1, 24-channel tape recorder. 2, Control unit. 3, Radiation monitor. (As seen looking into vehicle through assistant driver's hatch at position 6321.)

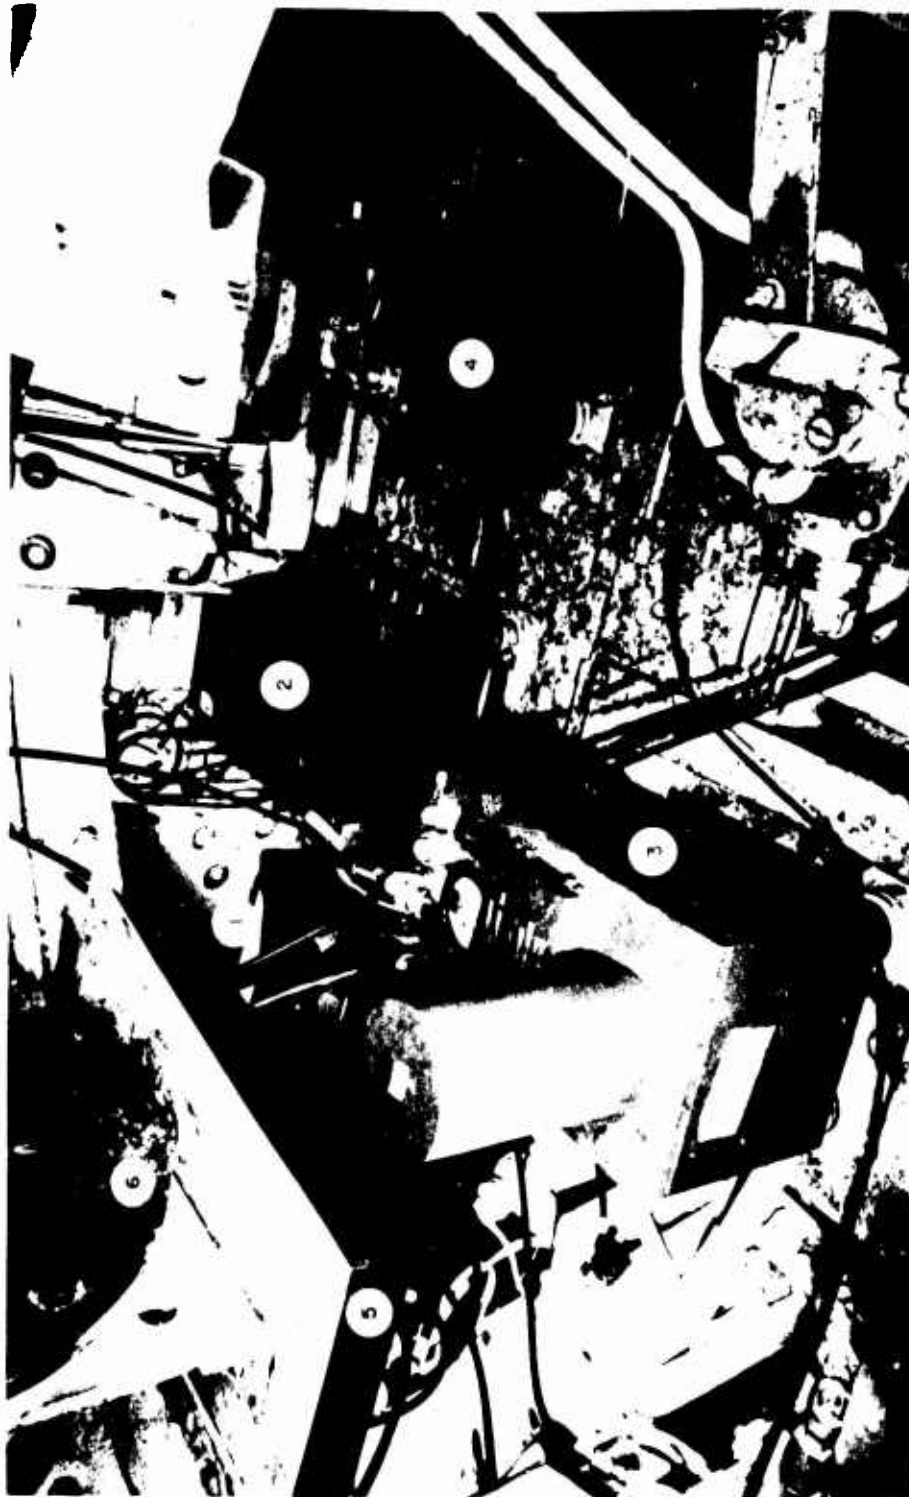
Fig. A.19 Typical Installation of Equipment. 1, 24-channel tape recorder. 2, Control unit. 3, Radiation monitor. 4, Radiation monitor. 5, 7-channel resistance gauge balancing unit. 6, Foil-rupture gauge. (As seen from commander's seat at position 6321.)

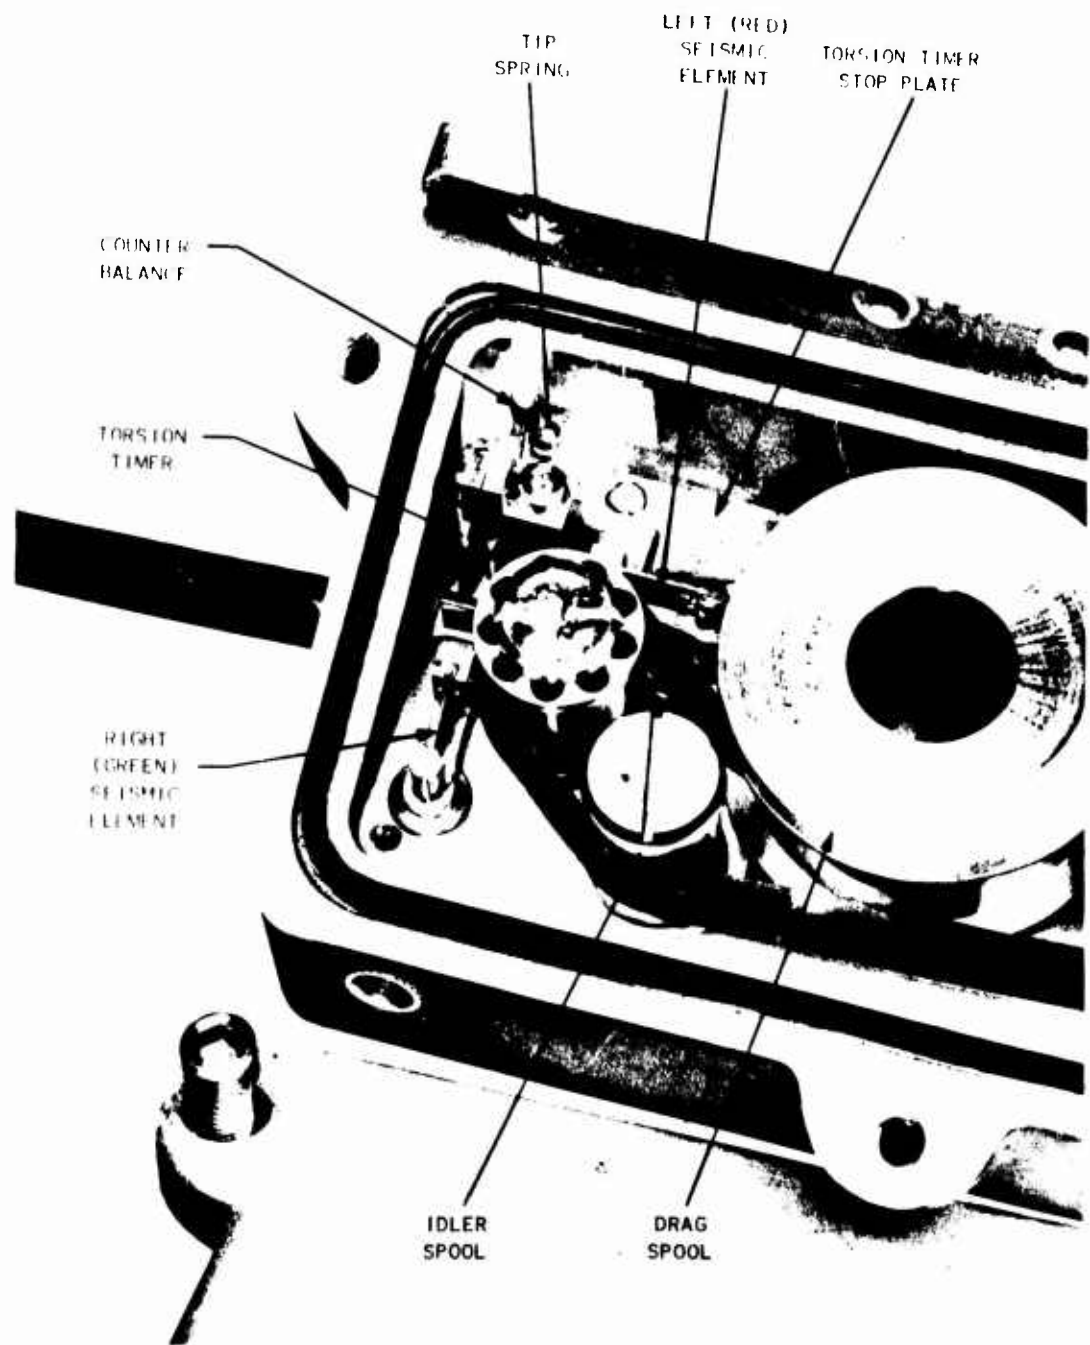
Fig. A.47 Accelerometer, Self-recording Type, with Main Cover Removed Showing Tape in Place Ready for Recording

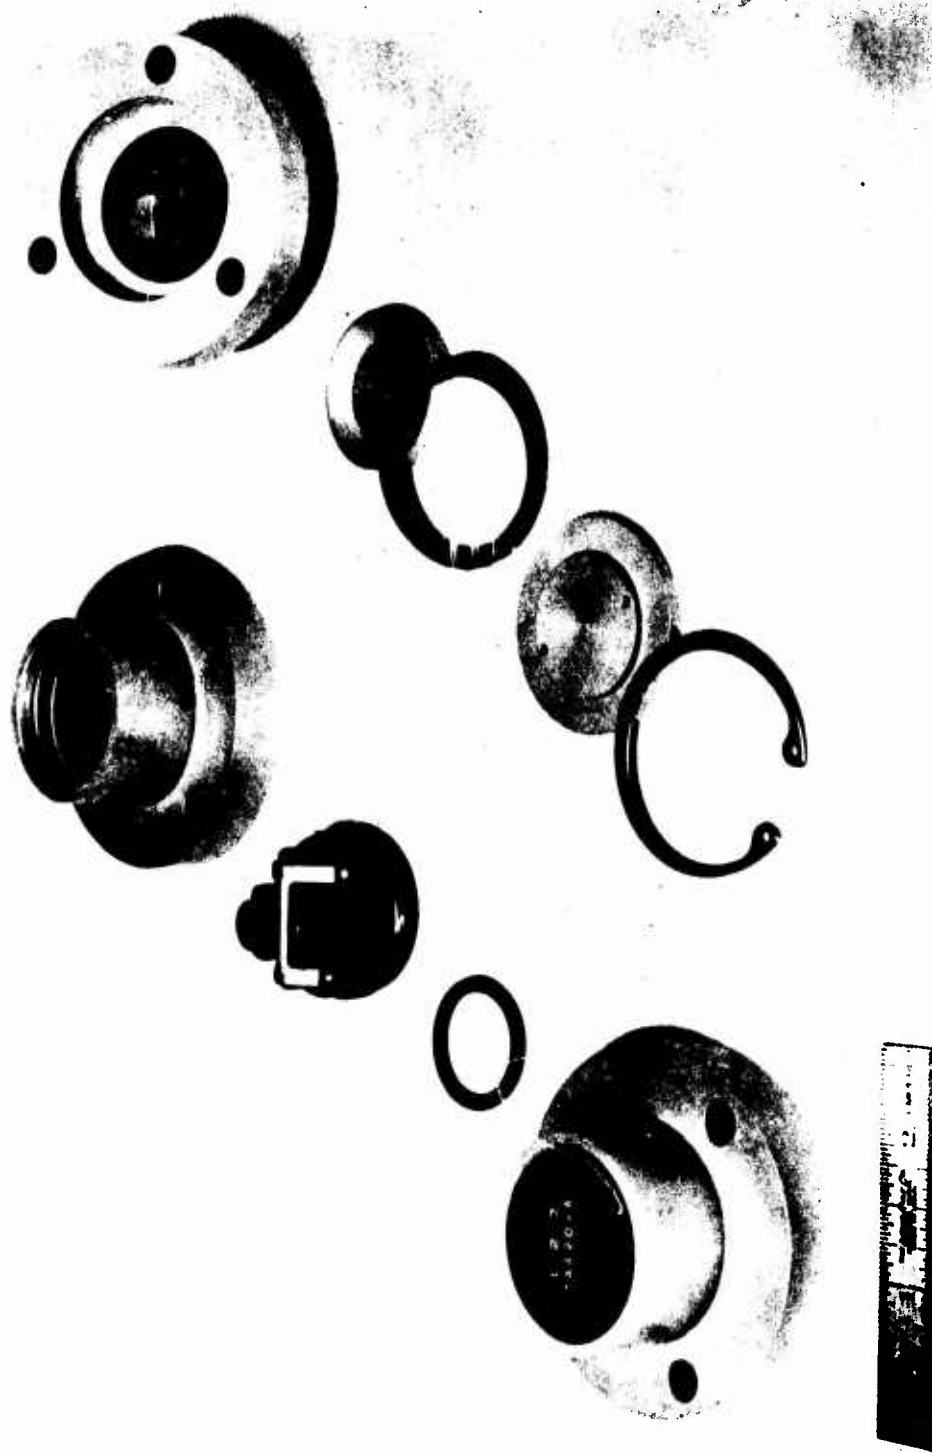
Fig. A.50 Accelerometer, Impedance Type, One Completely Assembled, a Second with Gauge Element Assembly Removed, and a Third with Oil Diaphragm Assembly Removed

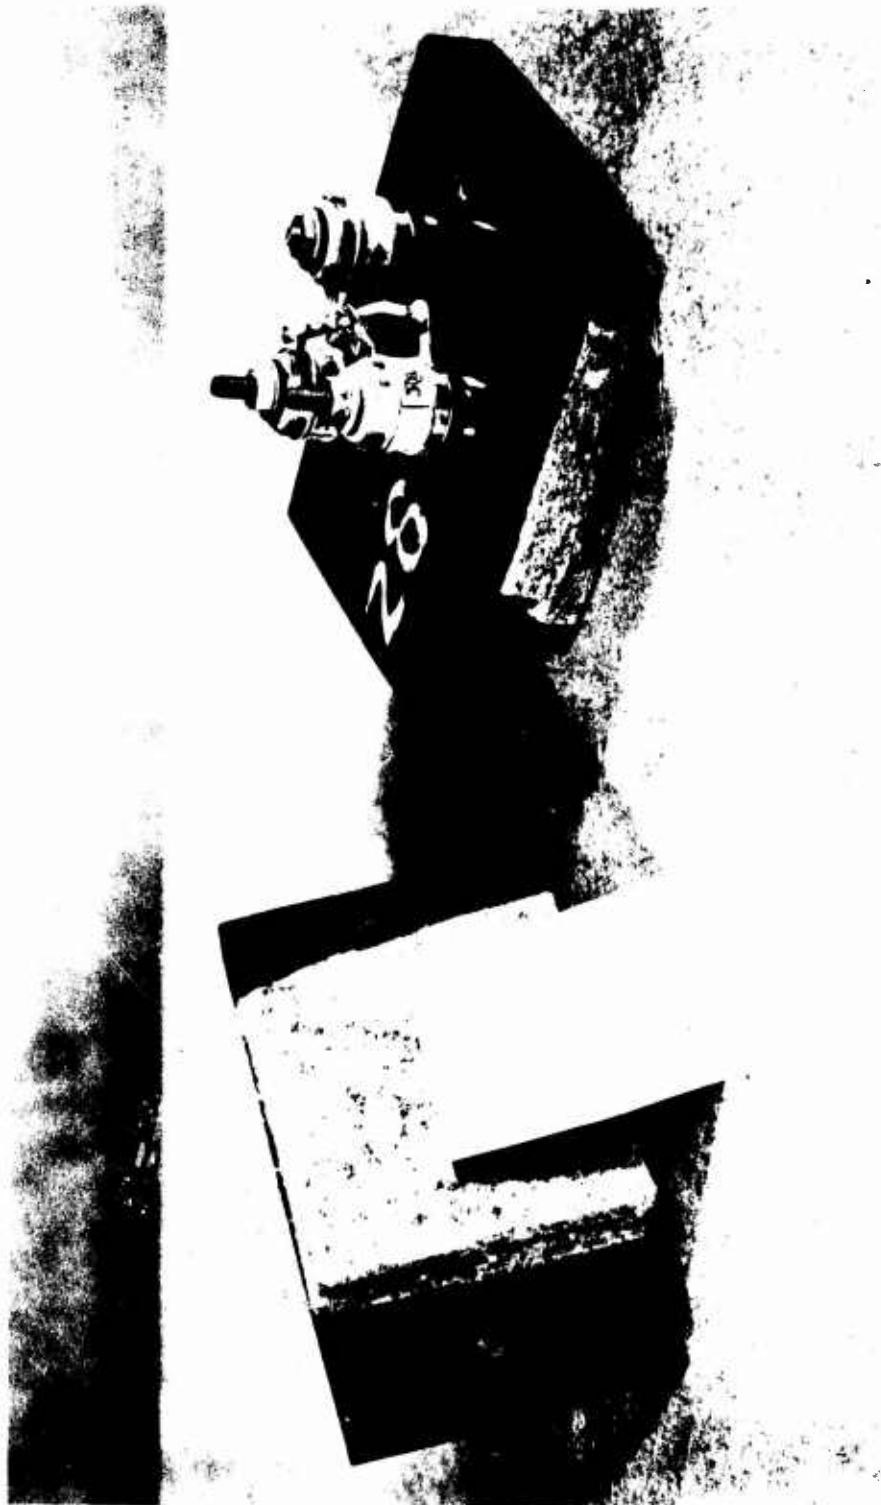
Fig. A.61 Resistance-wire Wall-temperature Gauges (Two), One Showing Active Element Lying against Felt Backing, the Other Showing Fixed Resistance Bridge Elements Attached to Back

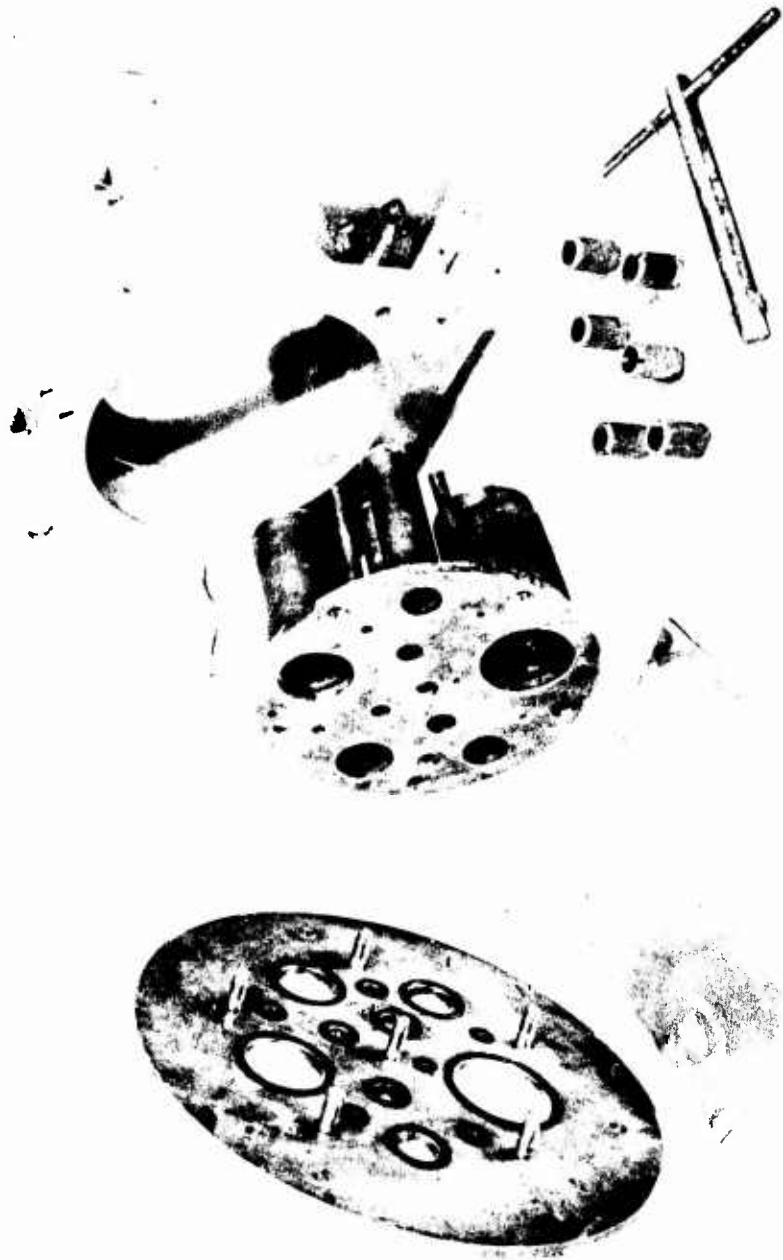
Fig. A.63 Modified Foil-rupture Gauge Ready for Assembling with 0.001-in. Aluminum Foil

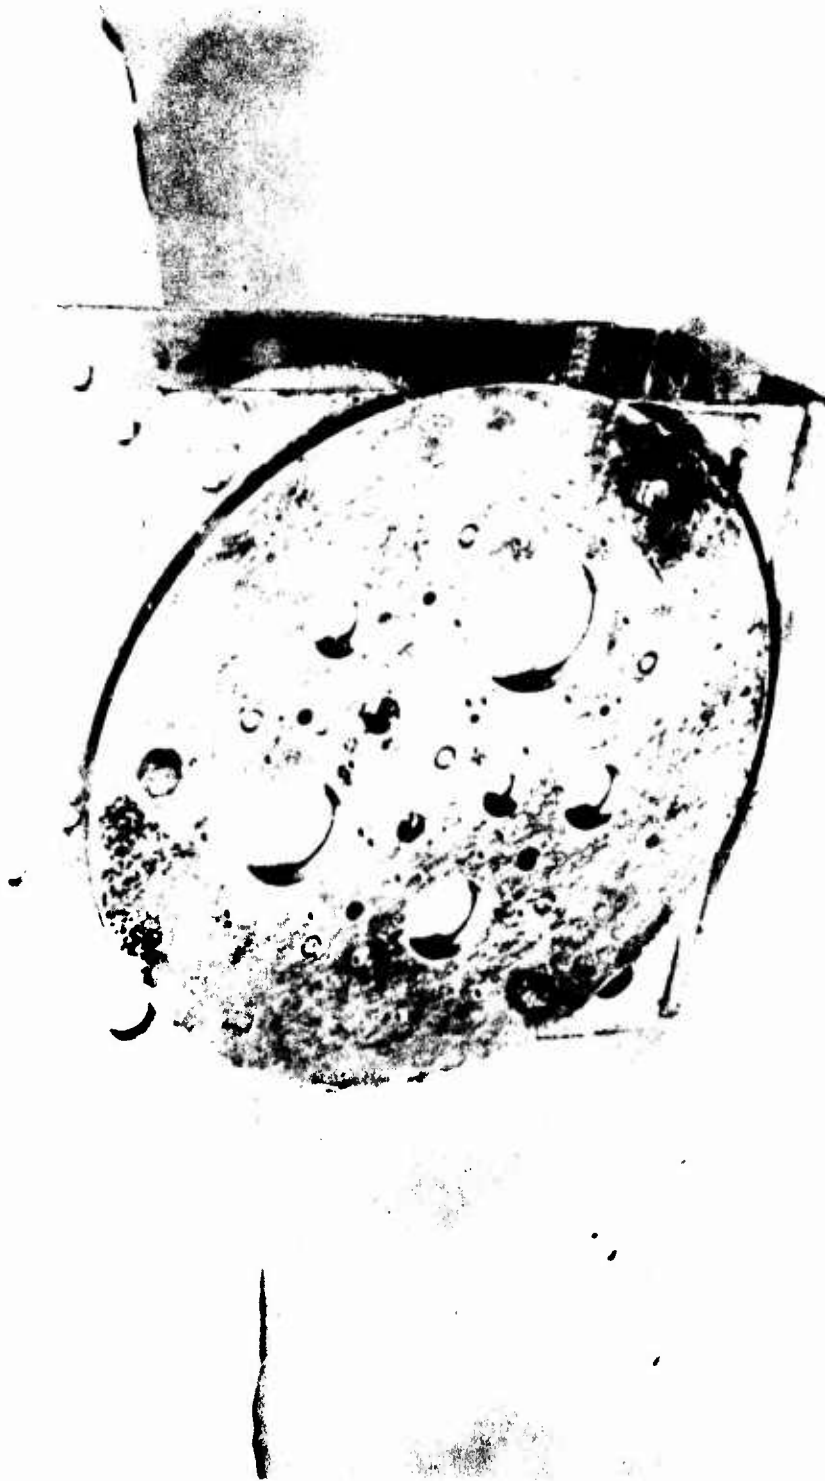
Fig. A.64 Modified Foil-rupture Gauge Assembled and Loaded with 0.001-in. Aluminum Foil
