BUREAU OF SHIPS GROUP  
TECHNICAL INSPECTION/REPORT

U.S.S. BRISCOE (APA65)

# TEST ABLE

# OPERATION CROSSROADS

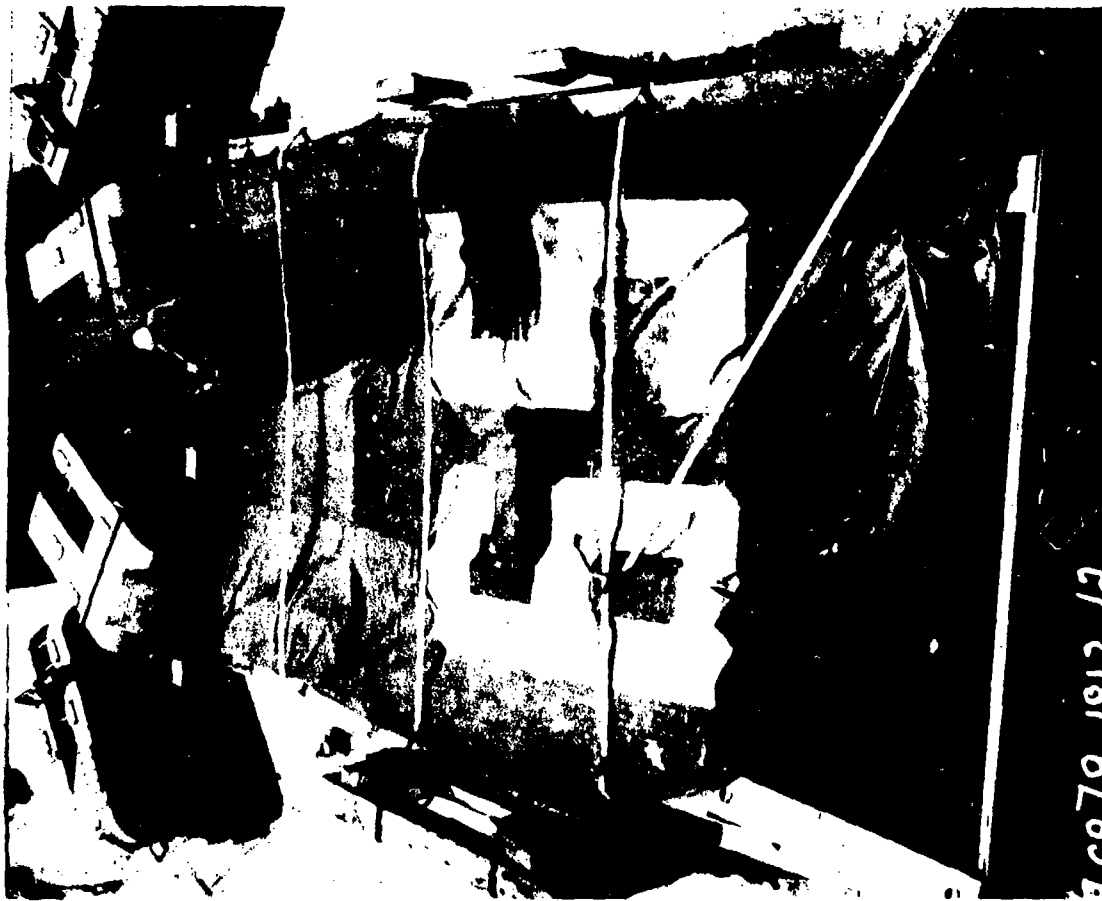
AA-CR-79-1812-12. No. 1 hatch at upper deck - Looking forward.

Hatches - Number one hatch boards, O1 deck, were thrown to the main deck. Number two hatch tarpaulin, O1 deck, burned away, the hatch boards O1 deck were dished 3' to 4' and thrown to the lower decks. The pontoons, main deck, were displaced and thrown to the second platform.
