(U) Subscale (100 lb) and fullscale (5000 lb) rocket thrust chambers of an advanced nonregeneratively cooled concept were designed, fabricated, and tested for durability at 500 psi chamber pressure, using  $N_2O_4/0.5$   $N_2O_4-0.5$  UDMH propellants. The concept employs a silicon carbide-coated graphite thrust-chamber liner prestressed in compression by a refractory metal outer shell. The subscale units were successfully tested for continuous and intermittent firing durations exceeding 600 seconds. In the subscale tests, the inner SiC coatings were cracked through the nozzle region, but did not oxidize or erode. In both fullscale rocket thrust chamber tests, the SiC coating fractured catastrophically during the initial 5-second test, leaving the graphite substrate unprotected. Test results and failure analyses indicate that a practical size/configuration limit was exceeded for this structural design concept in progressing from the 1.75-inch diameter chambers to the 6.0-inch diameter chambers. Since the silicon carbide is highly efficient from the environmental resistance aspect, new design concepts should be developed to circumvent the critical size limitation.

(U) The Phase II

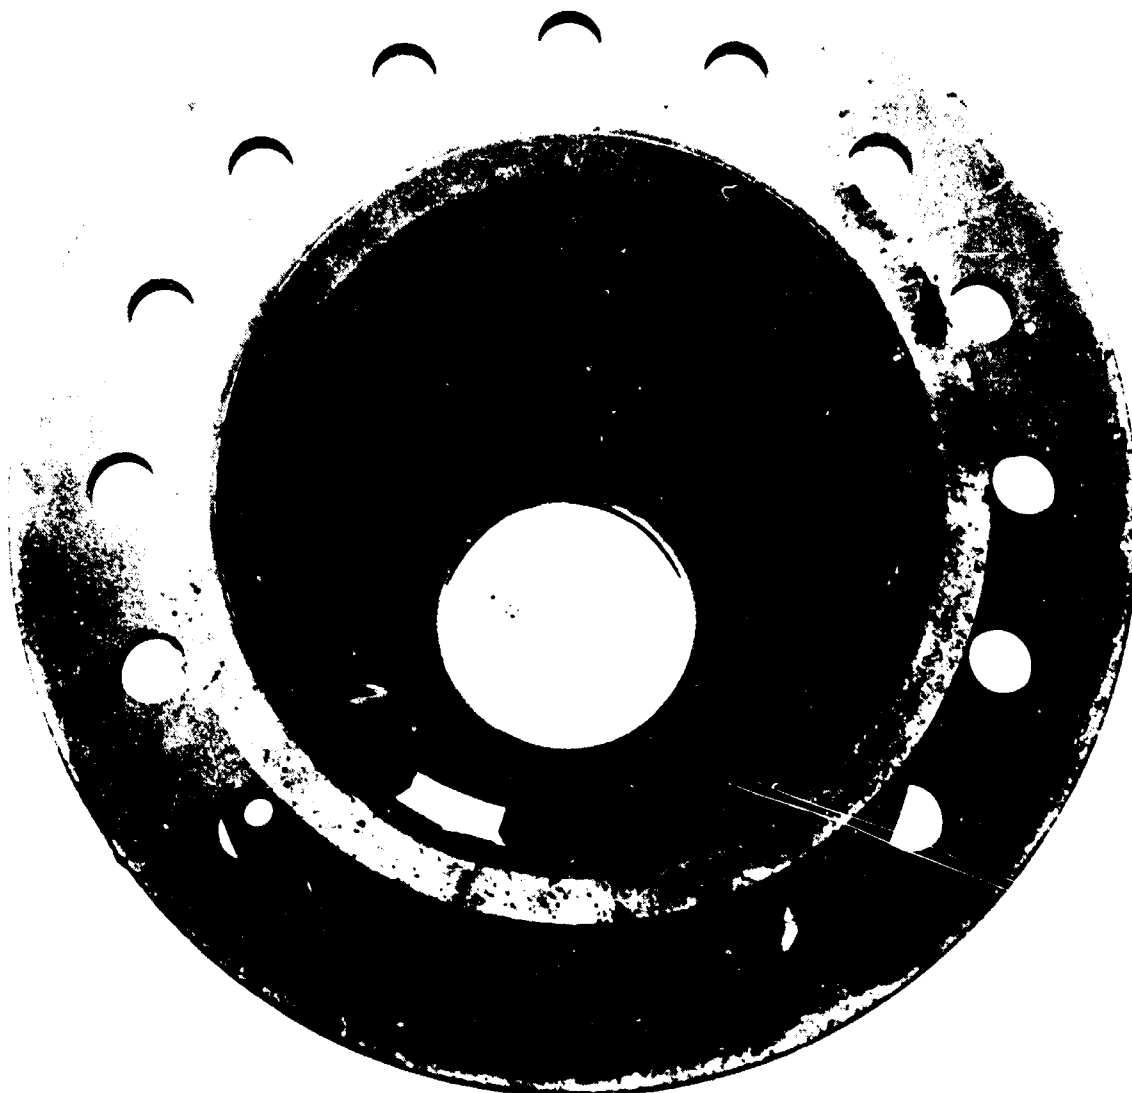
Figure 18

FIRST ASSEMBLY - SiC COATING FLAKED  
5000 POUND THRUST CHAMBER

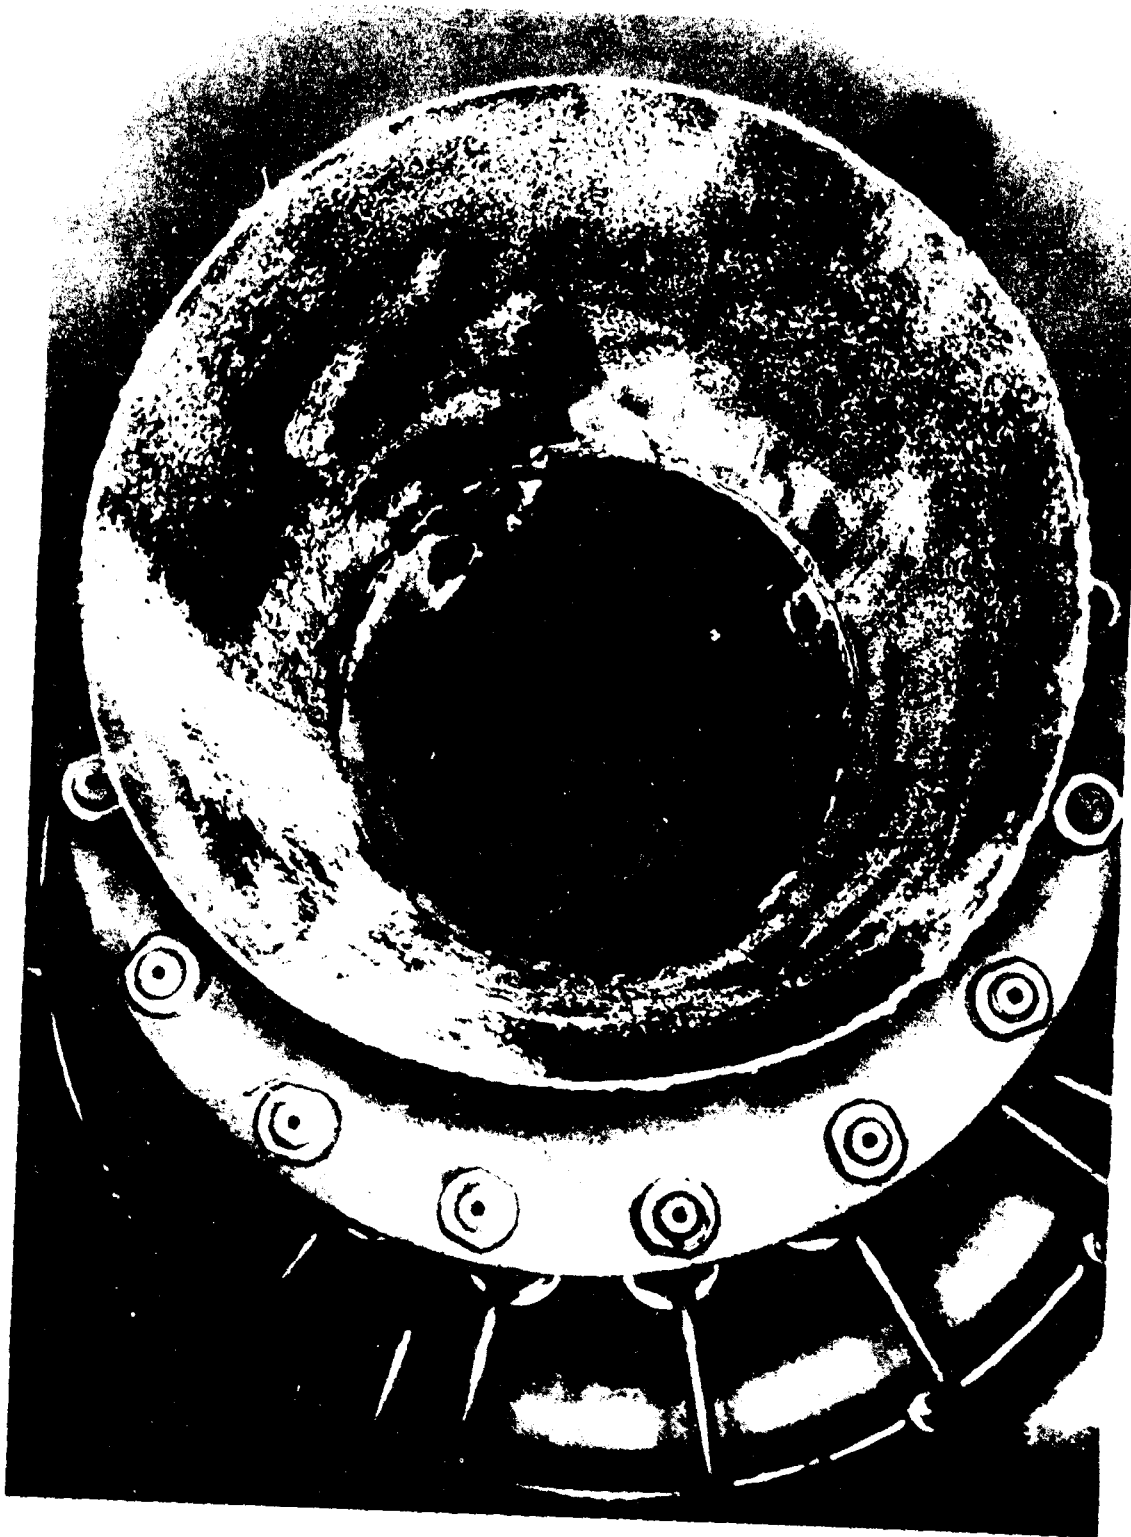
Figure 23  
EXIT CONE DAMAGE - ASSEMBLY NO. 1 AFTER 5 SECOND TEST AT AFRPL

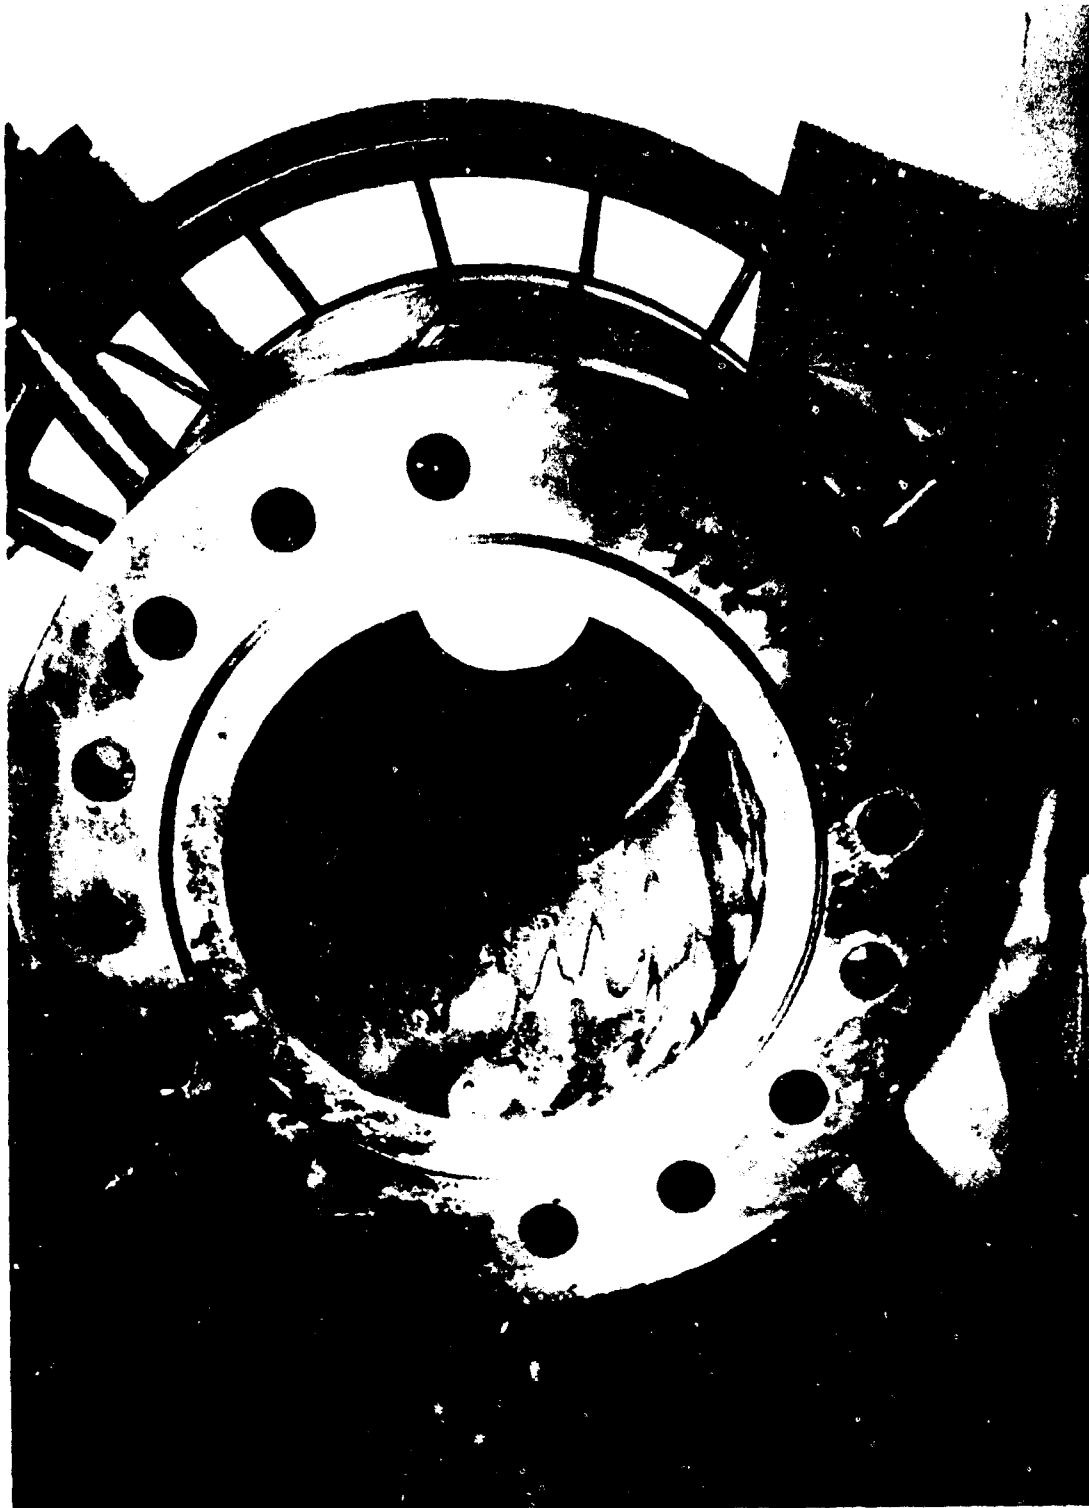
Figure 26

CHAMBER AREA - ASSEMBLY NO. 1 AFTER 5 SECOND TEST AT AFRPL
