TAC-TR-62-58

OPERATIONAL TEST AND EVALUATION

MB-2A BOMB BANDS

Operational Test and Evaluation  
MB-2A Bomb Bands

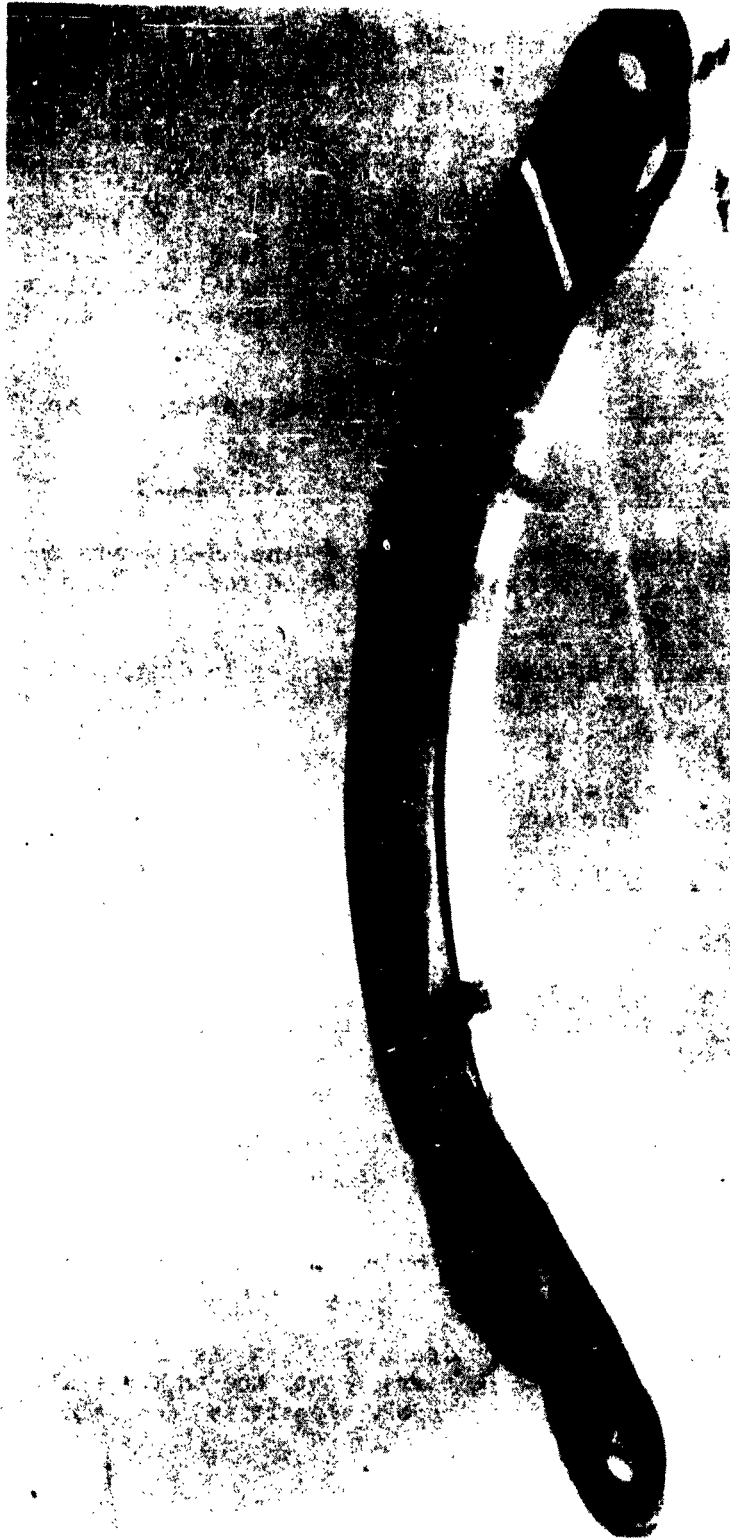
Figure 1

2. DESCRIPTION OF TEST ITEM. The MB-2A bomb band is a metal strip with washers on each end (see Figure 1). The metal band fits around the MB-2A bomb and is attached to the B-37K-1 bomb rack (see Figure 2). The band releases at the same time as the bomb.

(1) That the width of the washers used in the original bands be changed from 1/16" to 3/32".

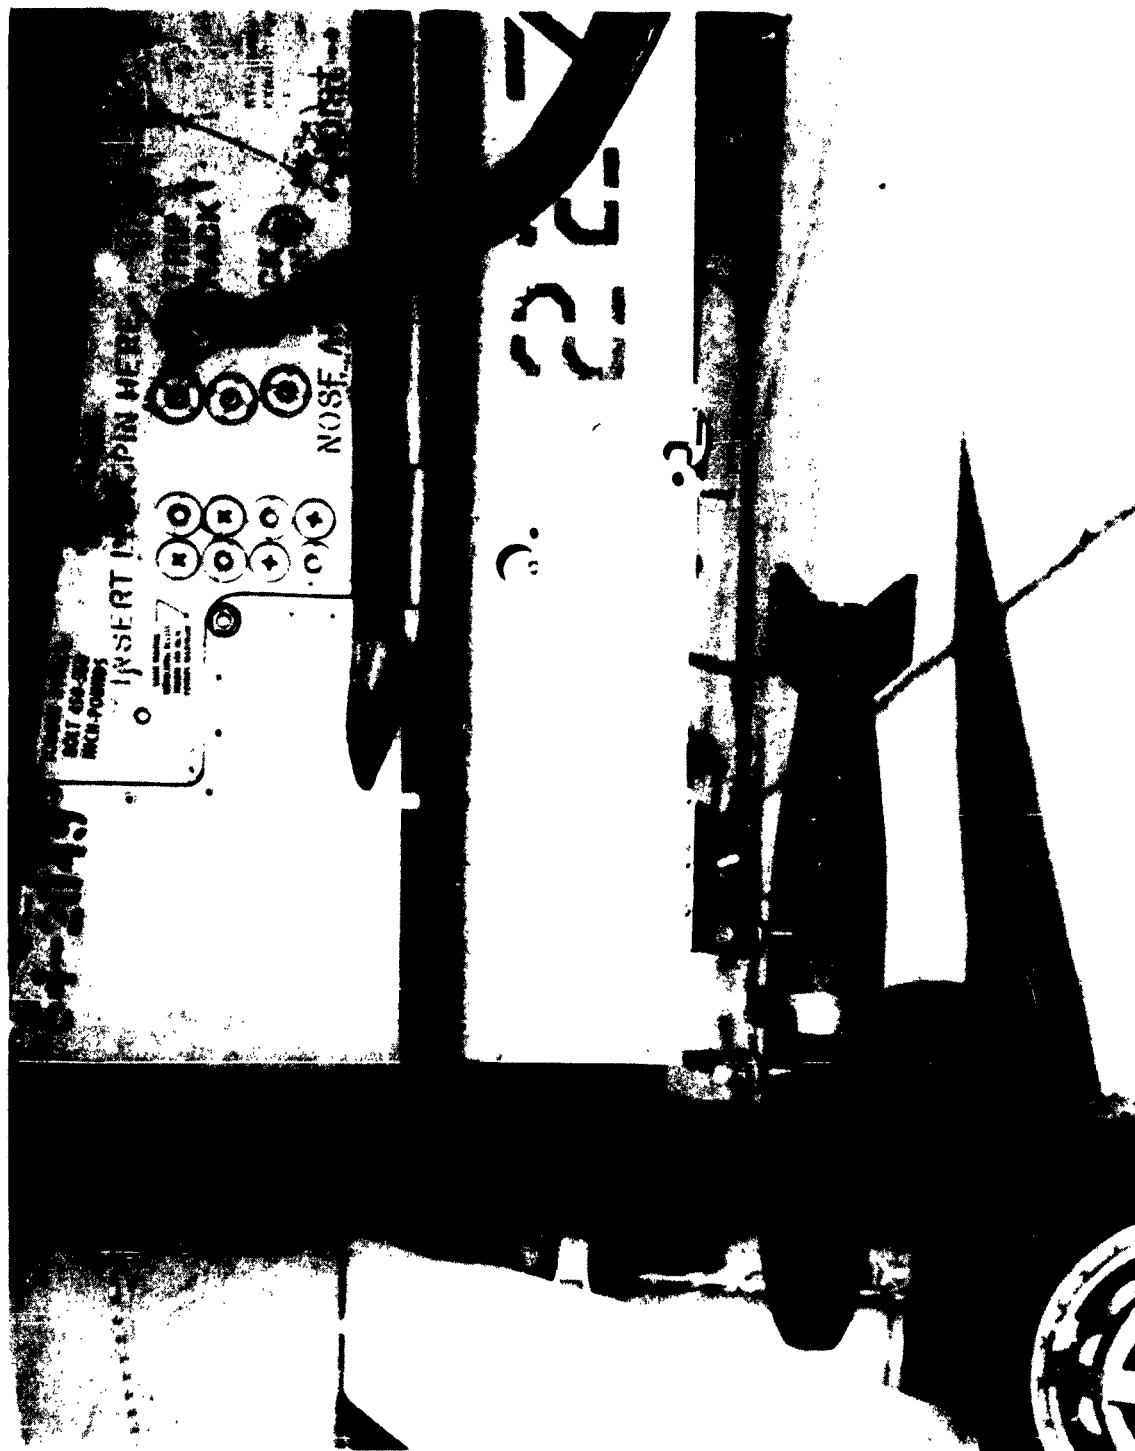
APPENDIX C

Side View Loaded

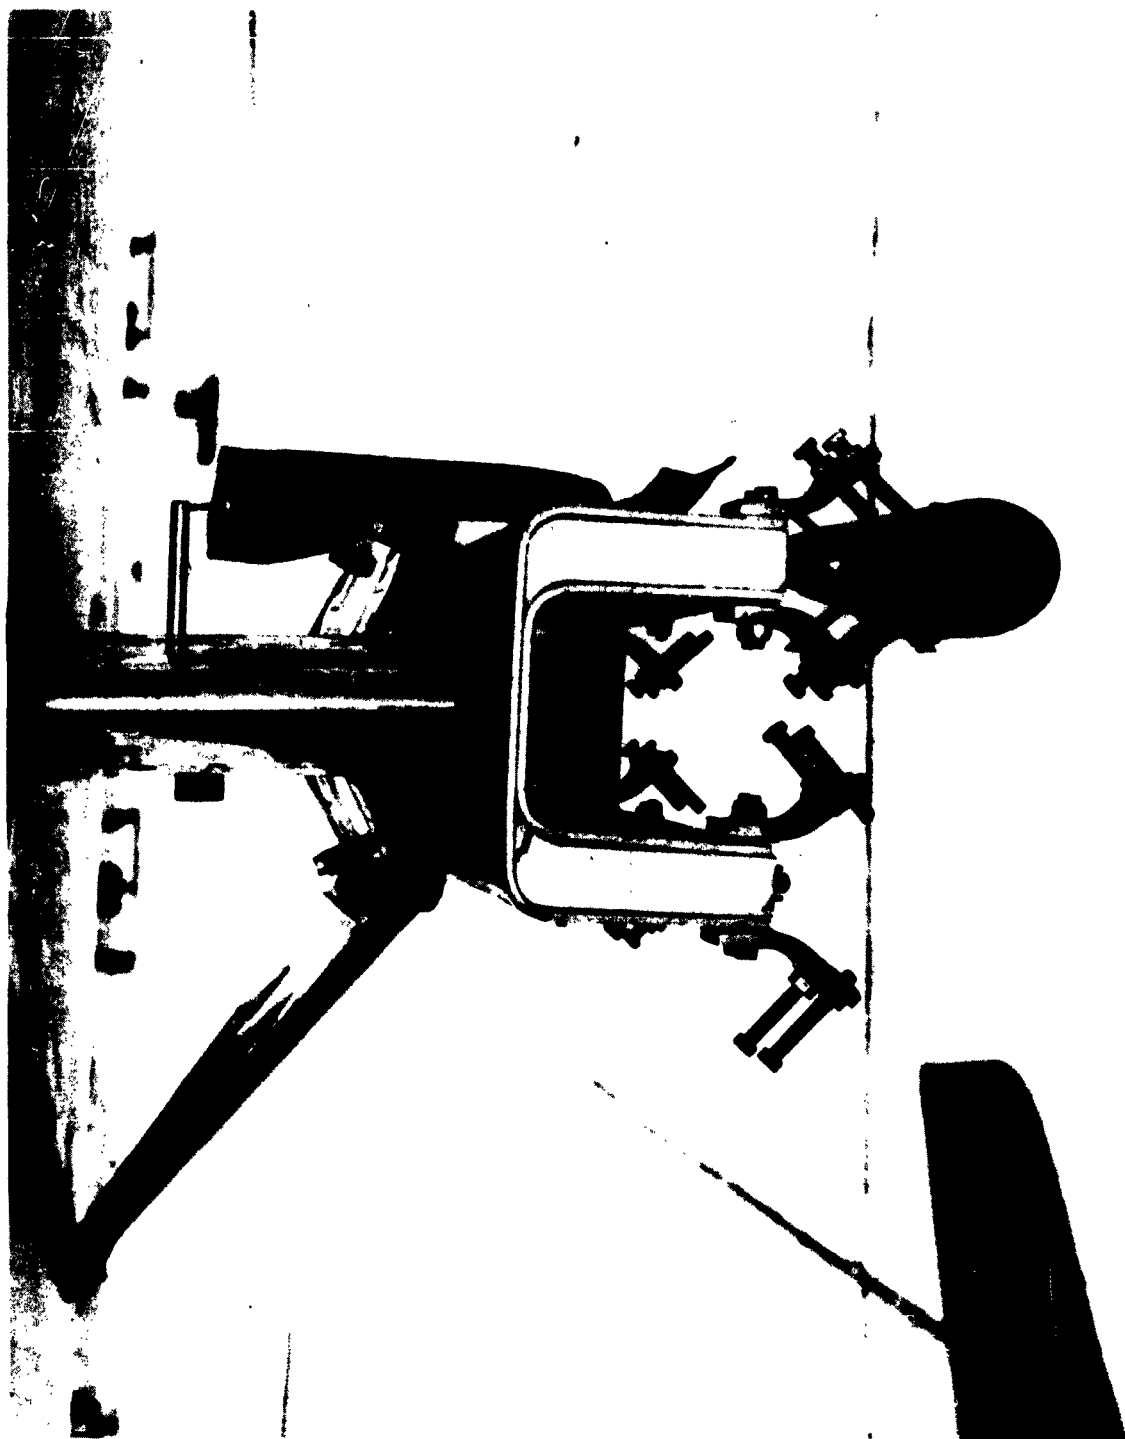
APPENDIX D

Front View Loaded
