# SOIL STABILIZATION

## INVESTIGATIONS OF QUICKLIME AS A STABILIZING MATERIAL

TECHNICAL REPORT NO. 3-455

U. S. Army Engineer Waterways Experiment Station  
CORPS OF ENGINEERS  
Vicksburg, Mississippi

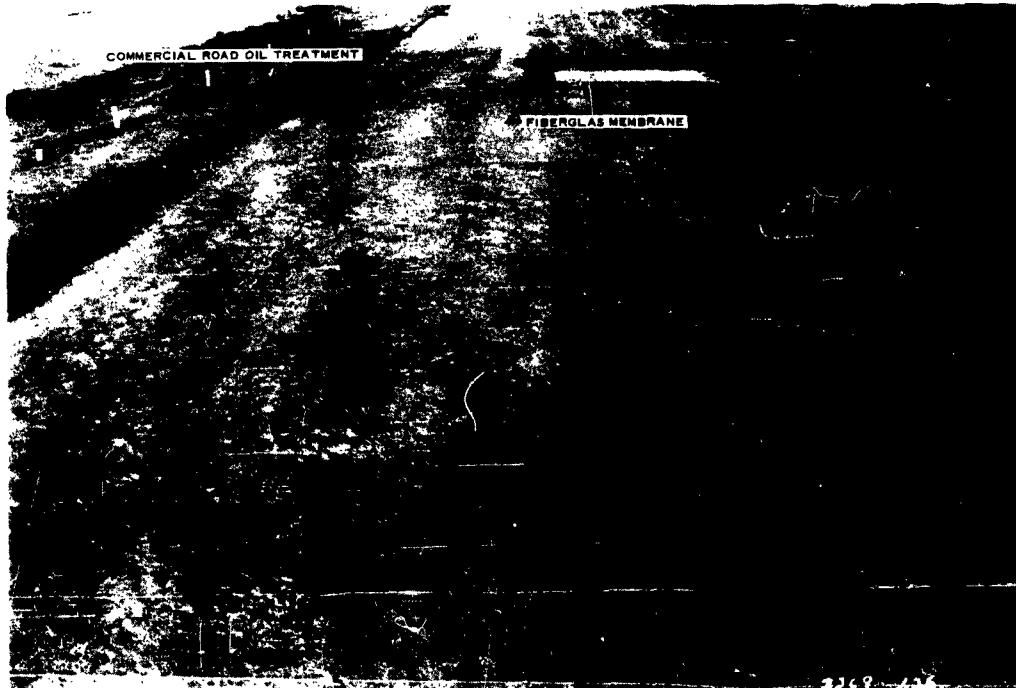
Fig. 14. Overall view of test section (facing north) prior to traffic testing

an overall view (looking north) of the completed test section just prior to beginning traffic tests, showing the areas treated with the road oil and the plastic membrane.
