**DEVELOPMENT OF DESIGN CRITERIA  
FOR A  
DRY FILM LUBRICATED BEARING SYSTEM**

TECHNICAL DOCUMENTARY REPORT NO. ASD-TDR-62-1057

Project No. 8128, Task No. 812801

(Prepared under Contract No. AF 33(616)-7395  
by The Boeing Company, Seattle, Washington.  
Authors: M. E. Campbell and J. W. Van Wyk)

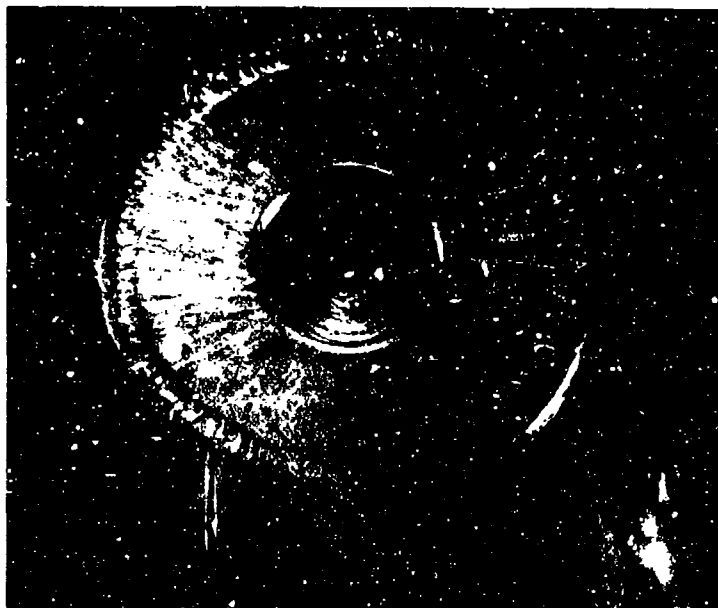
**FIGURE 12 ROLLER END WEAR MAGNIFIED**

The examination of the roller ends and race thrust faces revealed a bright polished surface. The raceways and rollers appearance indicated that

about half the width of the race was carrying the load. The load zones were worn rough and pitted. It is considered that the deposition or reaction products from the 0.5% TiMo cage contributed to the wear and deterioration of the raceways and rollers. These products were apparently thrown out of the bearing on the thrust faces. In the raceway, however, the products were retained and were abrasive in nature.
