TECHNICAL REPORT NO. WAL TR 310.24/5-4

METALLURGICAL ASPECTS OF FRACTURE AT HIGH STRENGTH LEVEL

Final Technical Report

Massachusetts Institute of Technology

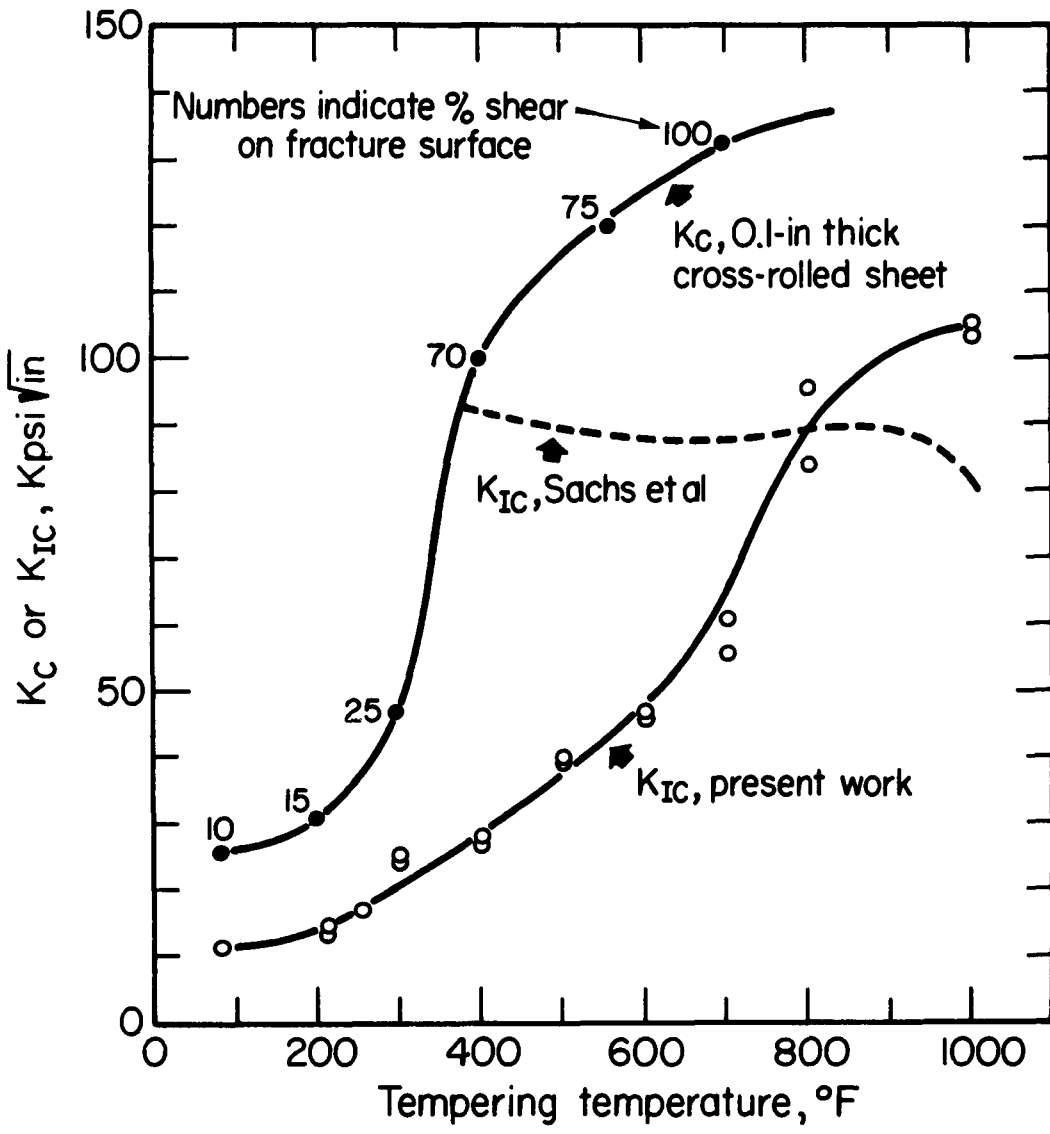
Figure 2 - Fracture toughness of AISI 4340 steel. K_{IC} values for dull (0.001-in radius) notches calculated from the results of Sachs, et al, as presented in Ref. 15. K_c data from Ref. 16.

As shown in Table I and Fig. 2, K_{IC} increased steadily with tempering temperature with no indication of a "500°F embrittlement". Also included in Fig. 2 are K_{IC} values calculated from data on circumferentially-notched specimens with notch-root radii of 0.001-in(15) and K_C values from edge-notched 0.1-in thick sheet(16). The importance of using fatigue-crack sharpened notches is apparent; compared to a notch of 0.001-in radius, a fatigue-cracked notch acted to reduce K_{IC} by a factor of 3 for material tempered at 400°F. Comparison of the sheet (plane stress) and plane-strain fracture toughness illustrates two important distinctions between K_C and K_{IC} in AISI 4340 steel. First, K_C is much larger at all tempering temperatures. Also, even though shear constituted less than 15% of the fracture surface in sheet specimens tempered below 200°F, K_C was still more than twice K_{IC} . Clearly, the implication is that much more energy is absorbed in shear than in the flat-fracture mode.

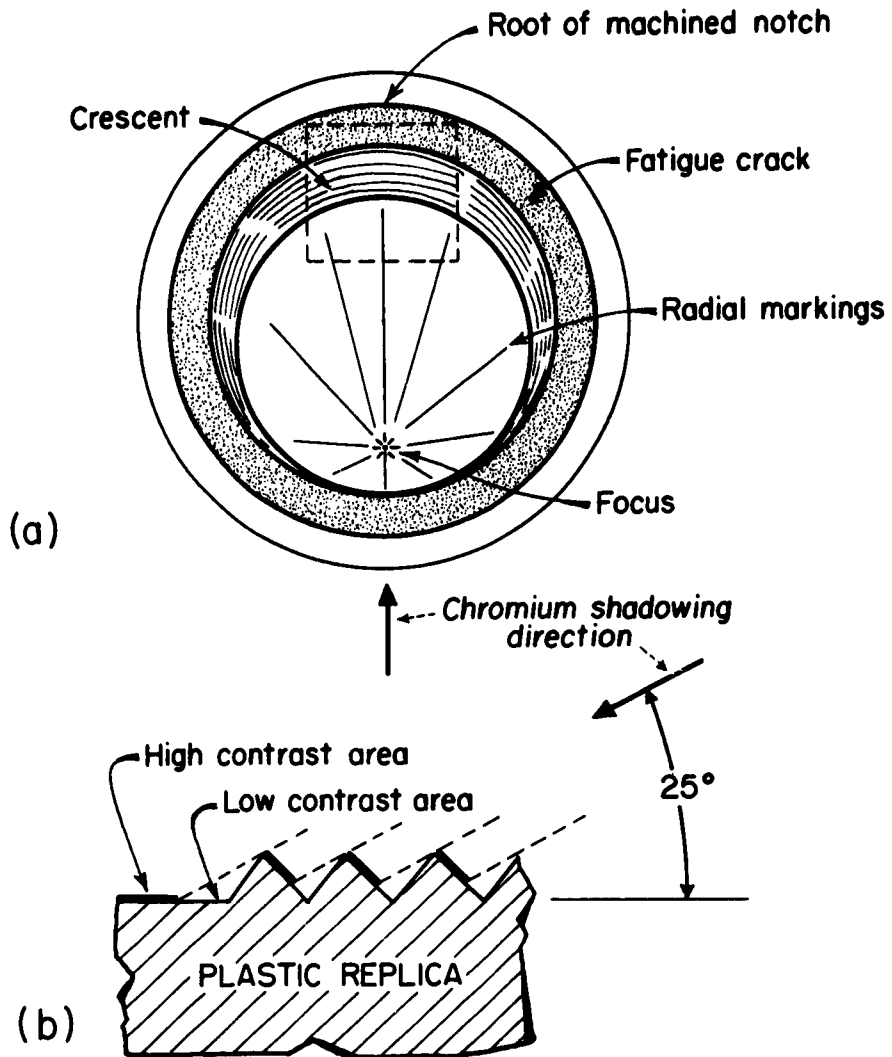
Figure 4 - Schematic of surface details and chromium-shadowing procedure: (a) general view of the cellulose-acetate replica (area corresponding to the dashed square shown in Fig. 5a); (b) manner of shadowing to develop ridge character of the crescent.

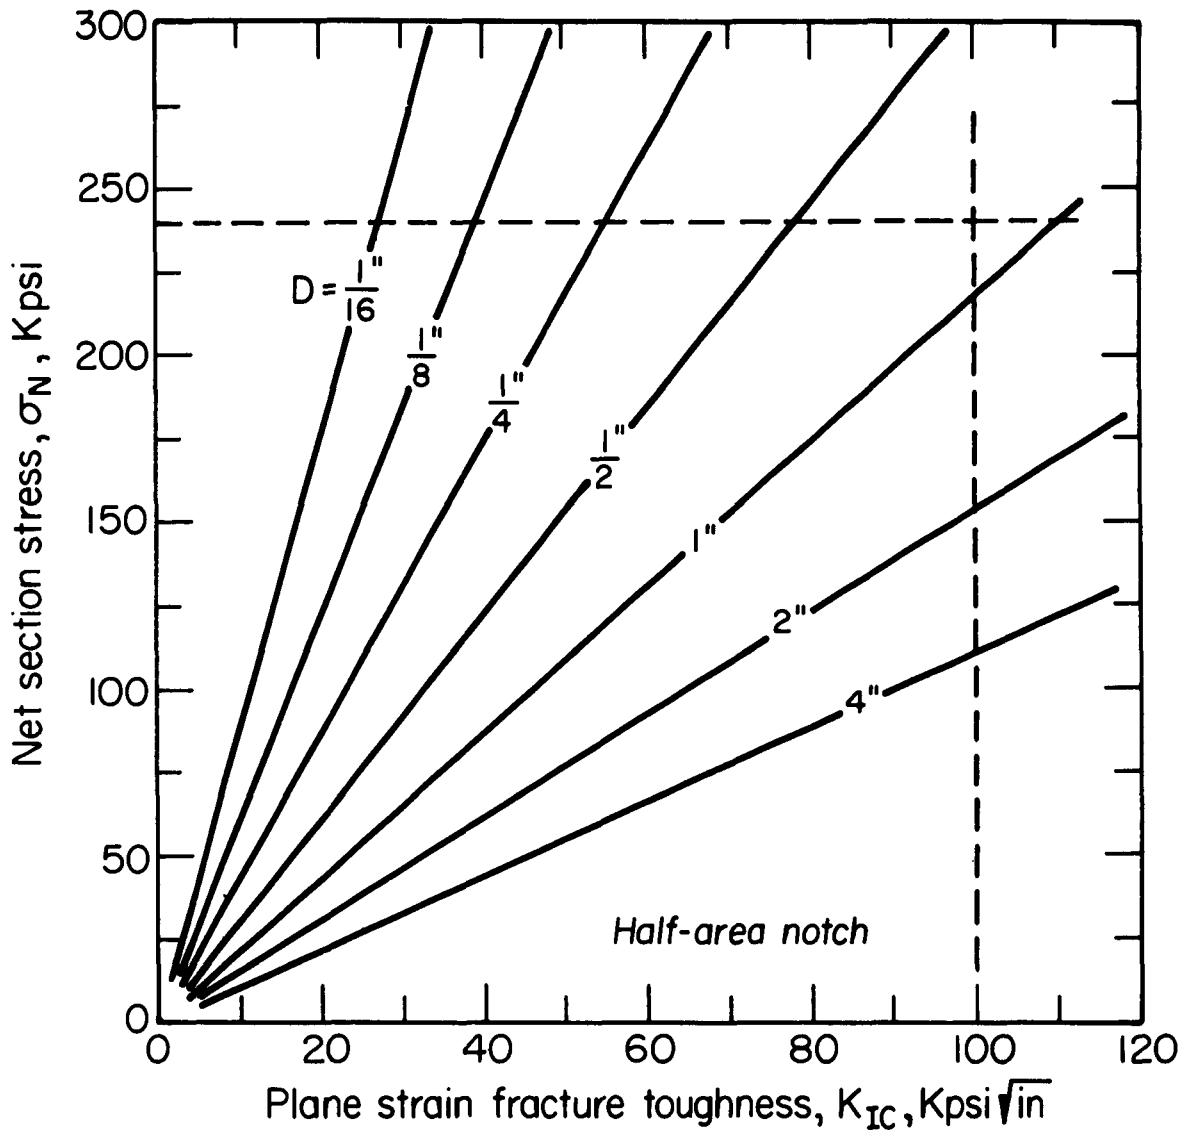
Figure A-1 - Nomograph for determining the appropriate size of circumferentially notched tensile specimens. Major diameter (D, inches) indicated on each curve.

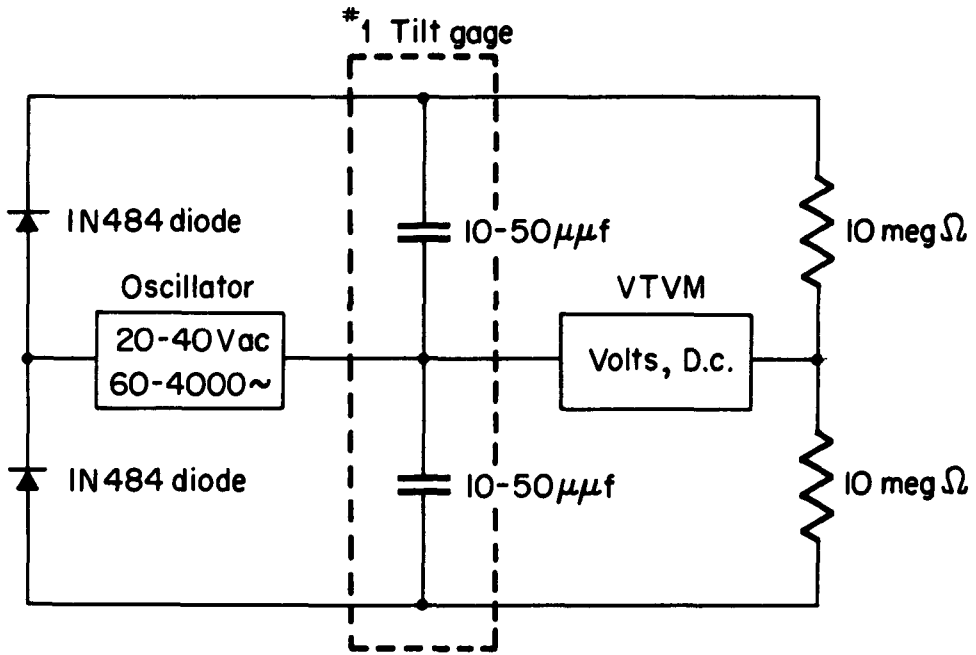
Figure A-4 - Bridge circuit used with the differential capacitor gages shown in Fig. A-3. Oscillator frequency adjusted to give maximum output for a fixed unbalance. No. 2 tilt gage switched into measuring circuit after No. 1 gage is balanced.

gage (Fig. A-4) consisted of a simple bridge, an oscillator, and a voltmeter. The sensitivity of the capacitor bridge is determined primarily by the closeness of the plates (or absolute capacitance), which in turn depends on machining accuracy. After the gages were made, the sensitivity was maximized by adjusting the oscillator frequency for maximum output for a fixed unbalance. For the gages used in the present work it was estimated that a tilt of about 0.02° could be detected.

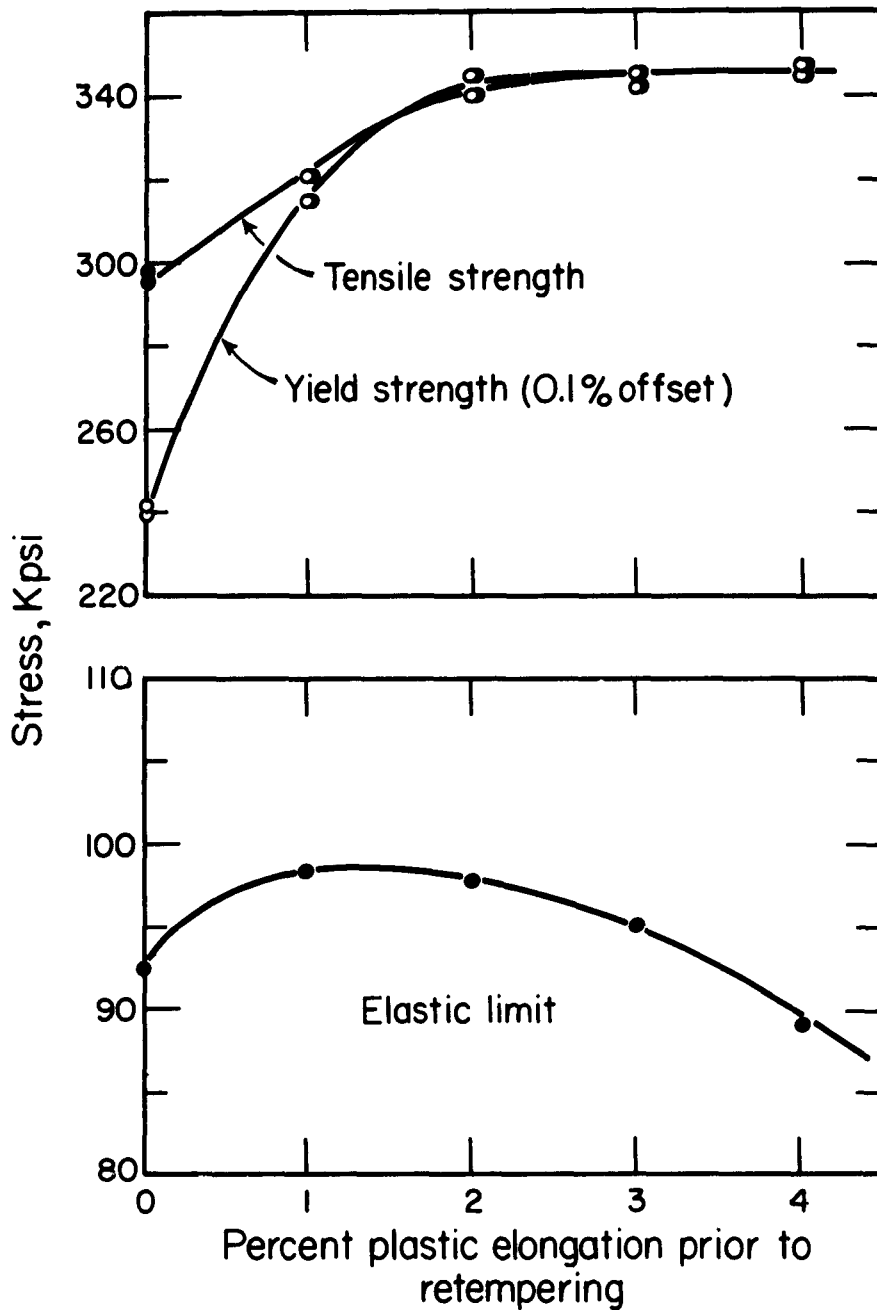
Figure B-1 - Strength of Strain-aged AISI 4340 steel. The elastic limit is the stress at a residual plastic strain of 10^{-6} .

Load or stress-elongation curves of the strained and aged steel were characterized by a load maximum at yielding, a drop in load to a relatively constant level, and finally, a gradual decrease in load until fracture. A tensile strength was defined in the usual way with the maximum-load value. For prestrain of 1% or more, the 0.1% offset yield strength and tensile strength were the same. The elastic limit proved to be essentially independent of prestrain. Results are summarized in Fig. B-1.

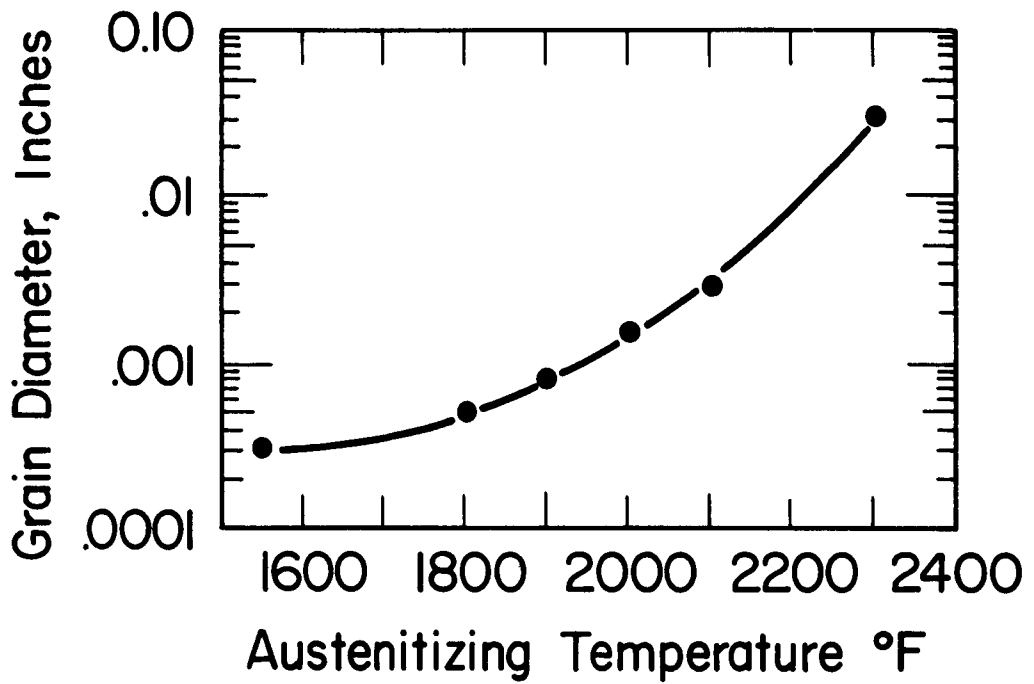
Figure C-2 - Prior austenite grain size as a function of austenitizing temperature.
