R-5166

**FINAL REPORT, KEL-F LINER  
FOR THE ATLAS MARK 4  
SUSTAINER TURBOPUMP**

**ROCKETDYNE**

Presented are the results of a program to  
develop, evaluate, and qualify a Kel-F  
liner for the oxidizer inlet passage of  
the Mark 4 sustainer turbopump, and to  
measure turbopump shaft deflection during  
operation.

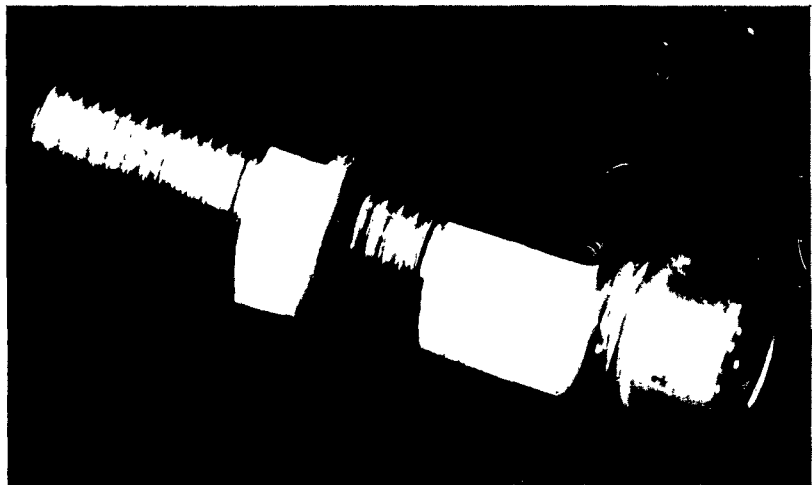
Figure 9 . Shaft Deflection Position Transducer
