EVALUATION OF THE KC-135 AND  
U-2 BAILOUT SURVIVAL KIT

TECHNICAL NOTE TN 63-4

ARCTIC AEROMEDICAL LABORATORY

Project 8238-01

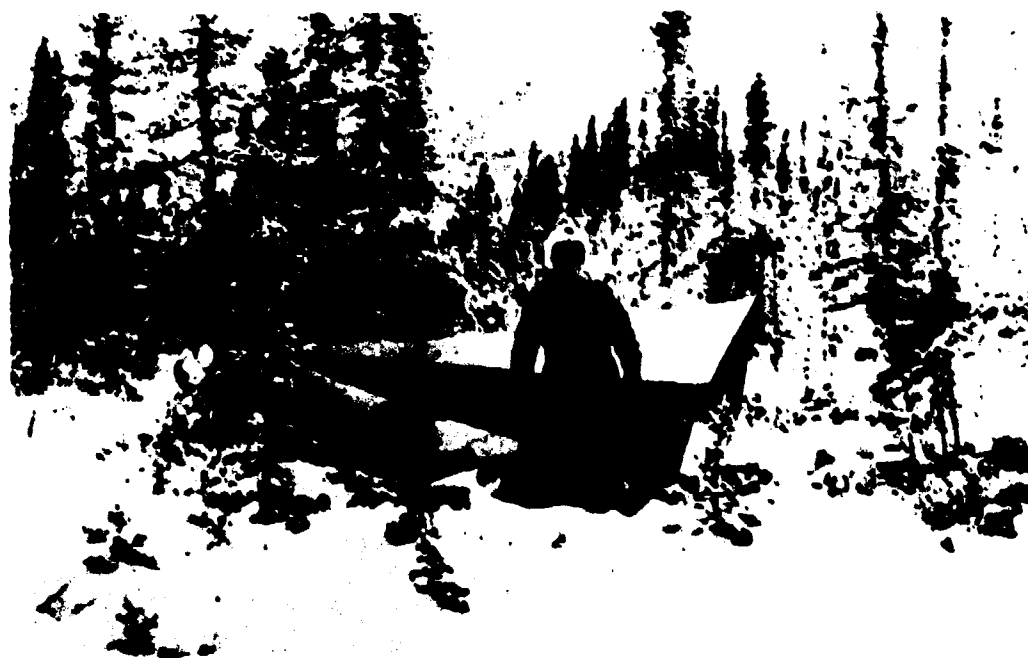
**FIGURE 1**

**Subject in CSU-4/P clothing assembly and his shelter**

Each man utilized the parachute cloth to construct a type of "A" frame lean-to shelter of single thickness of nylon parachute cloth (Figures 1 and 2). Some subjects used the cloth to form a covering or door at the front of the shelter. Bough beds were made from black spruce. Some subjects removed the snow and placed the boughs on the frozen ground while others placed the boughs on top of the packed snow.

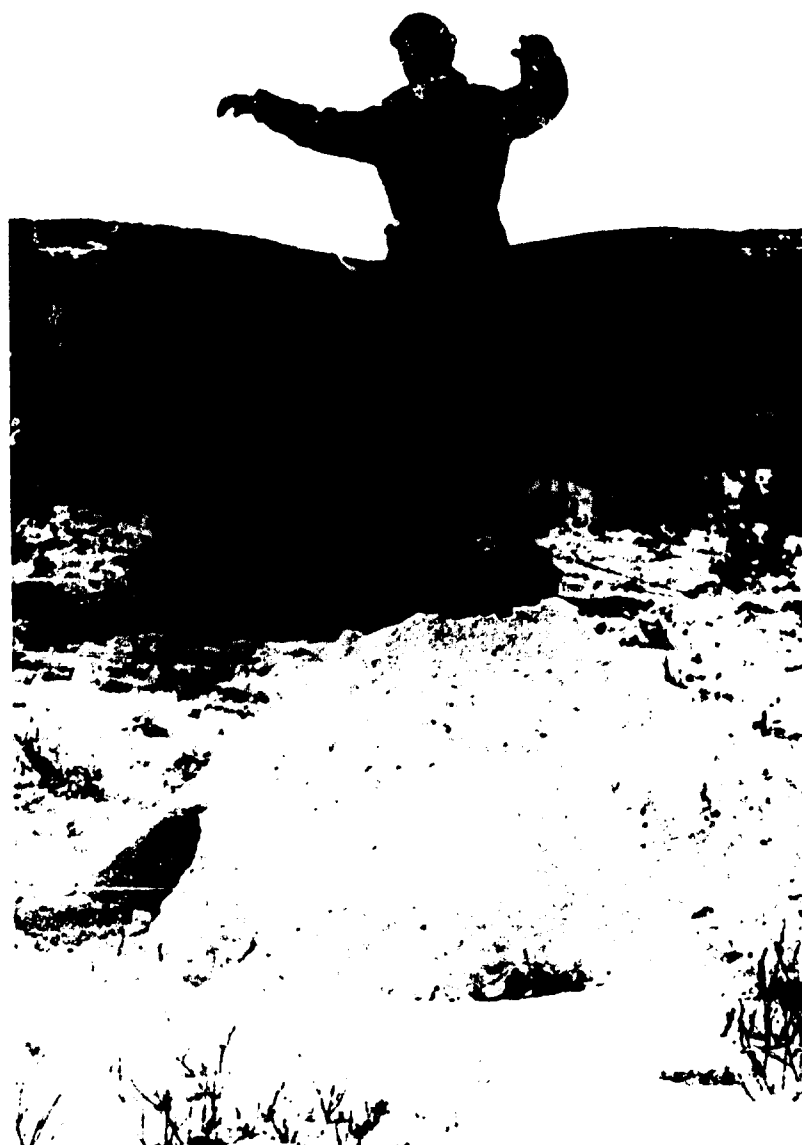
FIGURE 3

Snow hut with subject jumping on the top to show its strength

The remainder of the field trip was devoted to constructing various shelters as it was quite obvious that the shelter was of primary importance in this situation. The subjects experimented with emergency shelters constructed from natural materials available in this particular area. Two shelters were constructed from snow, one by making a pile of loose powdered snow 4 1/2 feet high and 8 feet in diameter (Figure 3). After 30 minutes the snow had become firm enough to be hollowed out inside. This type of shelter has proven, in past experiments, to be superior to any other type for protection in extreme cold. Temperatures inside were recorded at +22.0° F while the outside ambient temperature was -22.0° F.

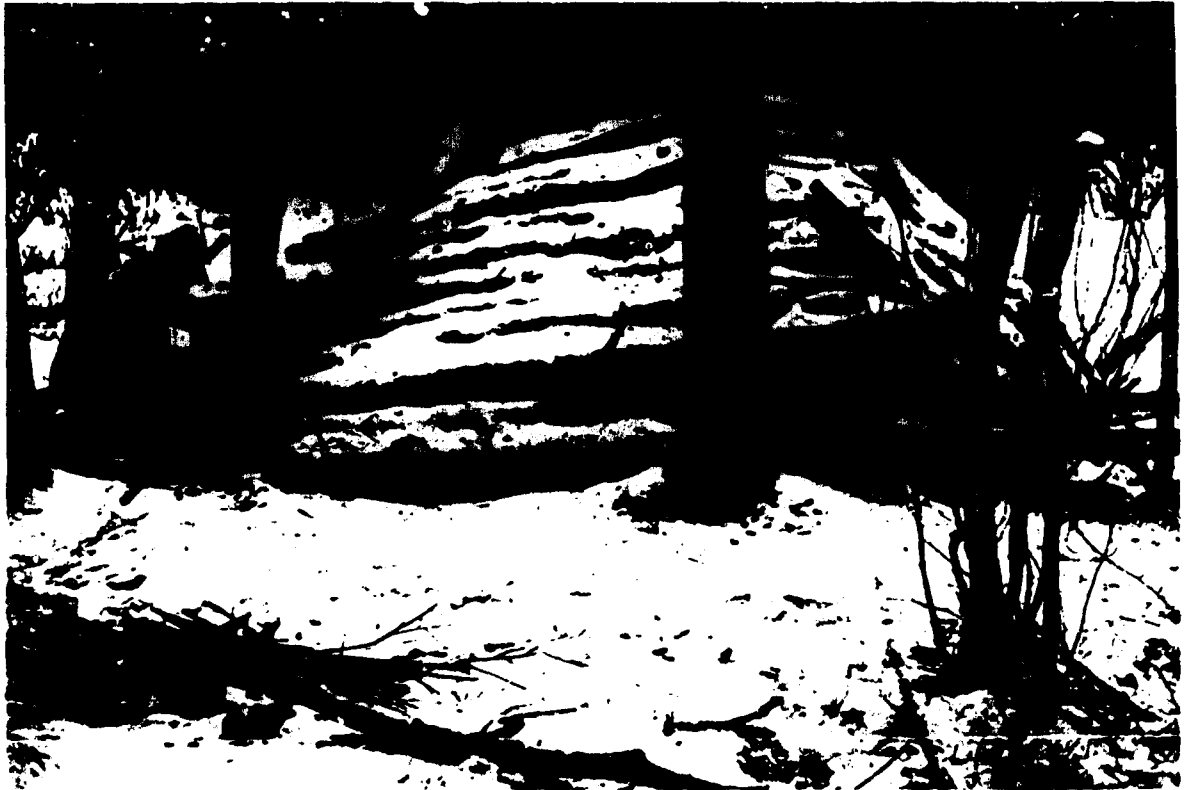
FIGURE 4

Shelter constructed of grass and logs

However, snow is not always available during late fall and early winter months. With this in mind, it was decided to experiment with other shelters to determine if another type could be constructed under field conditions that would be comparable to the snow shelter. Two subjects selected a site along the banks of Bear Creek and built a shelter from approximately 95% dead poles and logs, 3% snow and 2% dead grass. It was constructed by standing 5-foot lengths of poles against a dead tree that had broken approximately 3 1/2 feet above the ground but was still attached to the stump portion of the tree. A layer of poles was put in place, with grass along the cracks between the poles and another layer of poles placed over the grass. Several layers of poles and grass were used with some snow being placed over the grass. The finished shelter had walls from two to three feet thick and a small doorway located at the lower end. The shelter was constructed without the aid of a knife or other tools. All snow was removed from the ground inside the shelter, a layer of bark from dead standing black poplar trees was placed on the ground, and dead grass placed over the bark for added insulation (Figure 4).

Two subjects slept in this shelter in the MC-1 sleeping bags. Outside air temperature was -38.2° F at the time of retiring, while inside temperature was -22.0° F at 1945 hours before the door was closed for the night. By 2100 hours the inside temperature was recorded at -7.6° F. During the night the outside temperature rose to +15° F. Both subjects slept comfortably. The following day the doorway was improved and additional dead grass was placed inside the shelter. The temperature warmed to +23° F during the day. Both subjects retired at 2200 hours, one with the MC-1 sleeping bag, the other without a sleeping bag. The subject without the bag slept clothed in his arctic flying clothing with dead grass completely covering him. He felt cool but was able to get approximately eight hours sleep. This type of shelter appears to have excellent insulation qualities and could be used in lieu of the snow shelter in a timbered area prior to an adequate snow fall.
