ARMY CONCEPT TEAM IN VIETNAM  
APO 143, San Francisco, California

ENGINEER CONTROL AND  
ADVISORY DETACHMENTS

Final Test Report

15 October 1963

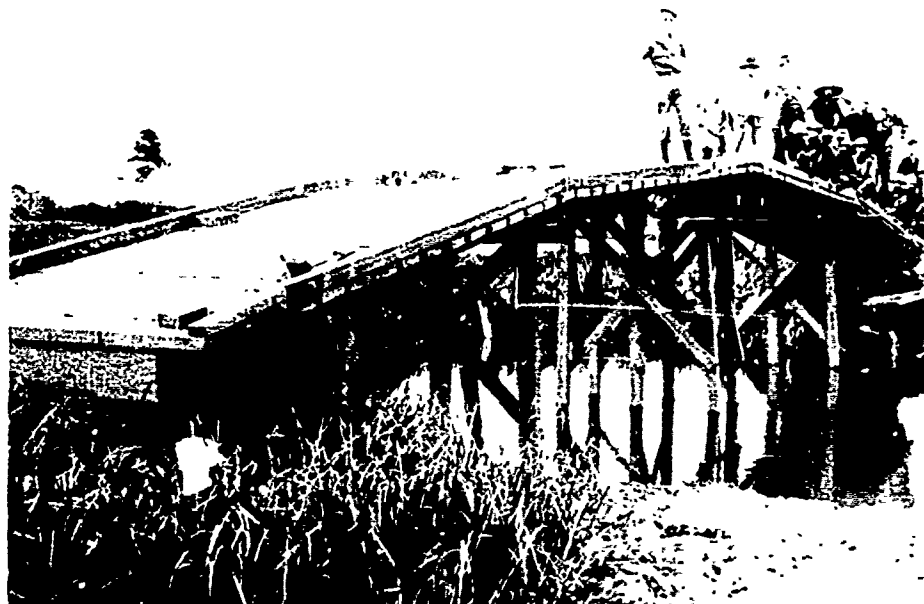
MAAG 2-5. Timber trestle bridge, 19.8 meters long, 2.1 meters roadway, class 4, at BINH QUAN village near TAN AN. Advisory team failed to provide for adequate abutment footers, permitting the bridge to twist at both ends. The civil guard squad, trained by this ECAD team, did most of the work. Project provides hamlet with access to vehicular farm-to-market road.

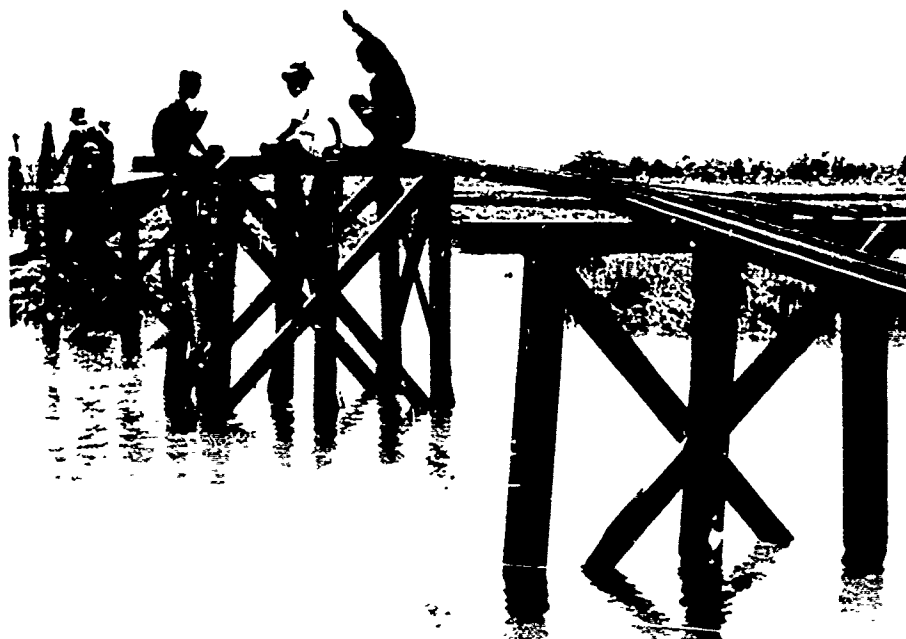
MAAG 2-5. Bridge under construction. As work progressed on this project, VC activity increased in the immediate area. Local homes were burned, trenches were cut across roads, and several inhabitants received threats. Bridge approaches and abutments were mined on two known occasions. Vietnamese authorities countered with increased security for the site, and would not permit the ECAD team to get on the job until the access road and the immediate area had been cleared. Three civil guards providing security and engaged in clearing operations were killed during the period of construction. Security requirements reduced supervision time to as little as one half hour per day. It is difficult to maintain the highest quality of construction under these circumstances.

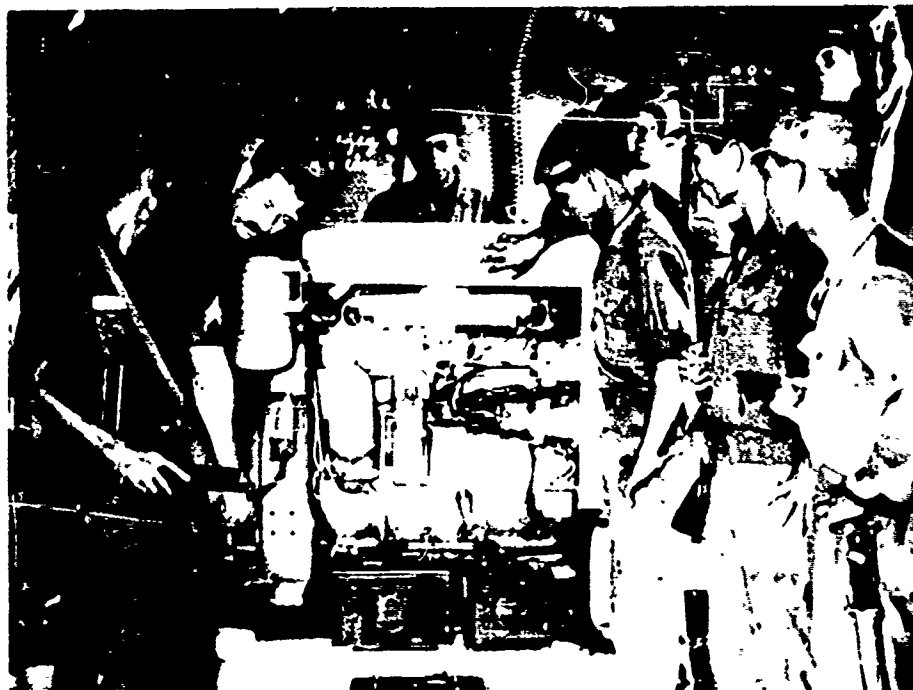
MAAG 2-6. Generator repair in hamlet near TAN AN. Sergeant Ollis, equipment maintenance supervisor, is discussing with civil guard squad the repairs required to get this generator back in operation. Project included rewiring of power unit and redistribution of electrical load. Generator produces power for village security and residential lighting.

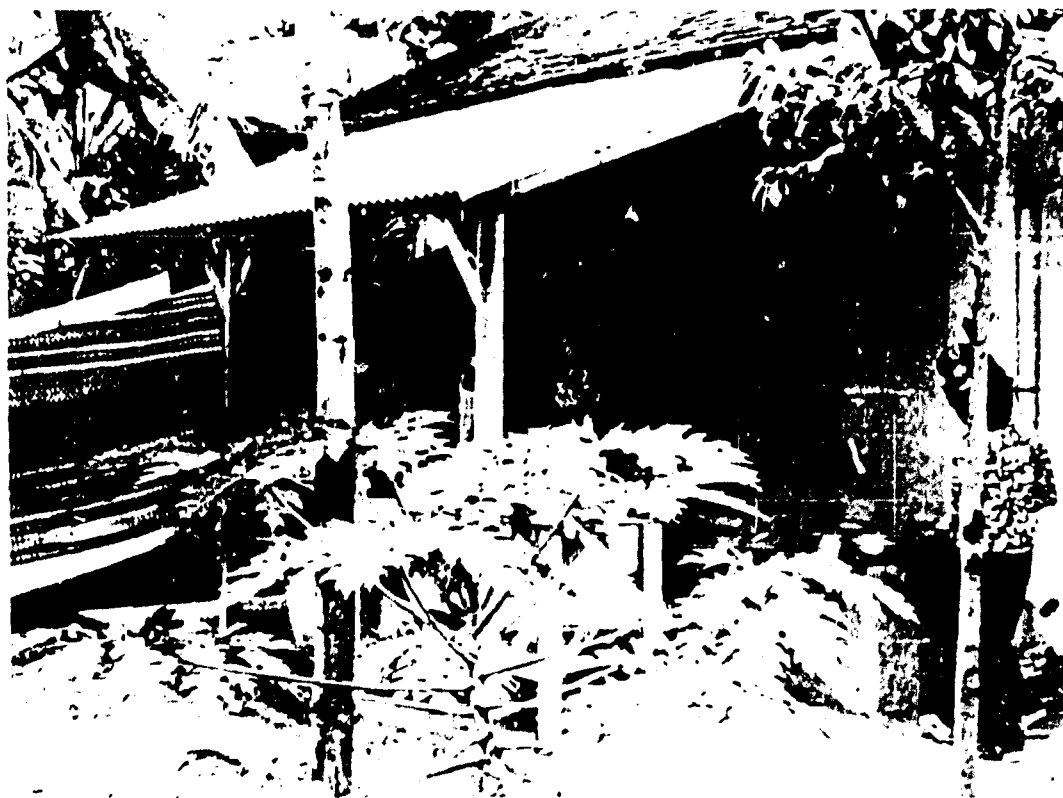
MAAG 2-12. Clothes washing and drying shelter built over a concrete slab. Sidewalk may be seen at lower left.

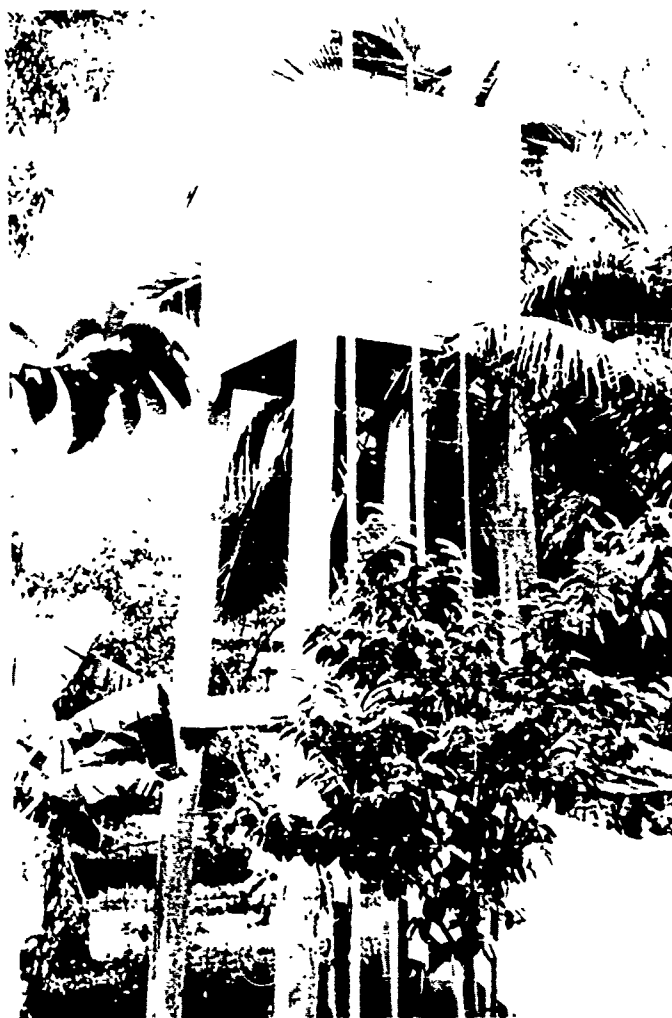
MAAG 2-12. Interior of water tower tank was cleaned thoroughly. Pump under tower was rebuilt. Tank provides storage for potable water supply.

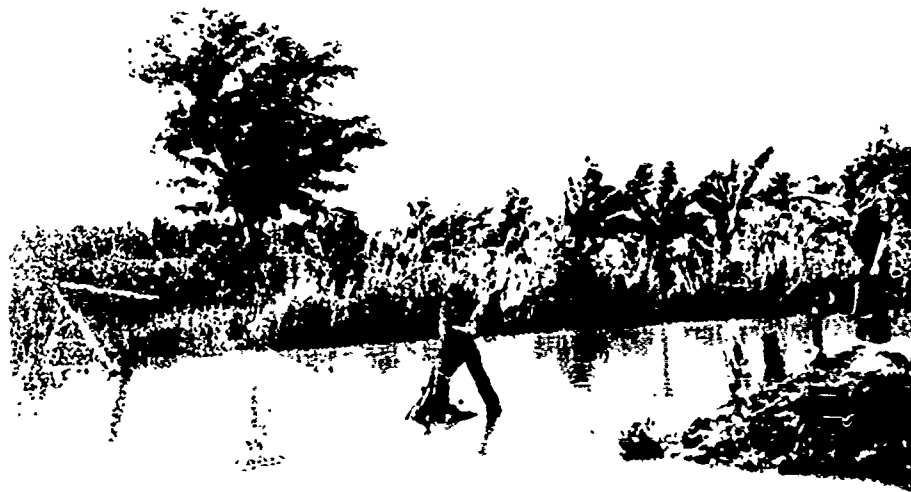
MAAG 2A-1 Bridge repair project located in a strategic hamlet 8 miles east of U'U LANH. The project included repair of abutments, reinforcement of pile bents, and replacement of an 18X3-meter deck. All work was completed except the redecking. While materials were expected from Saigon, the VC destroyed the incomplete bridge. The best estimate is that a mine was floated into position against the center pile bent and detonated electrically. This bridge was on an alternate MSR to Saigon. Materials and labor were provided by the local populace. The advisory team left Vietnam before the bridge could be replaced.

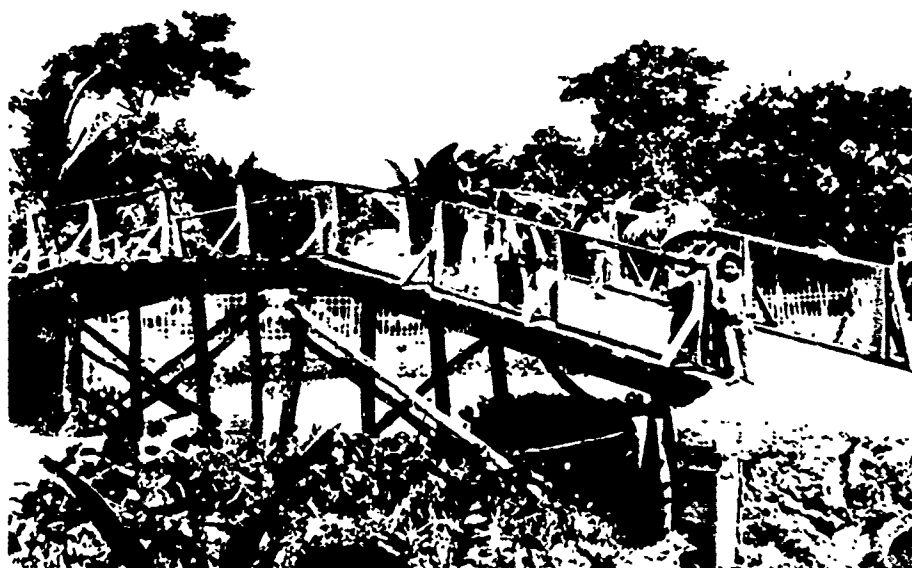
MAAG 2A-3. Completed bridge at strategic hamlet number 2, AP MY TAN AN village, approximately 12 miles east of CAO LANH. Materials used were native timber piles provided by the village; steel WF-beams by USOM, and lumber for decking and wingwalls from ECAD funds. Bridge replaces former palm log footbridge and is rated at class 3. Light vehicular traffic now has access from the two hamlets of AP MY TAN AN to the highway running northeast to Saigon and west to CAO LANH. It took 6 weeks to complete delivery of the lumber ordered for this project from Saigon by the advisory team. Labor was donated by the hamlet beneficiaries.

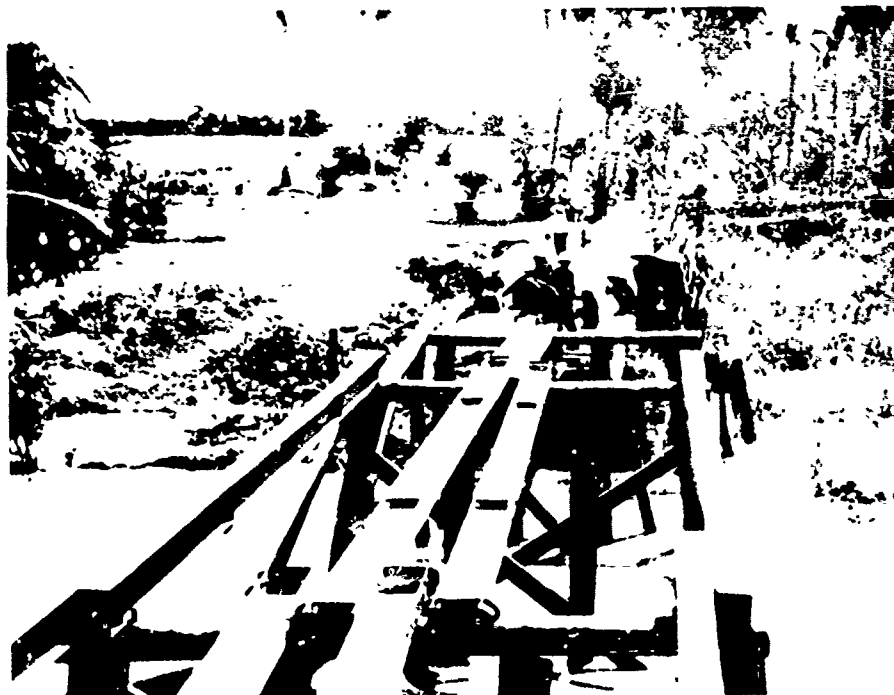
MAAG 2A-4. Bridge under construction in KIEN PHONG province on the Plain of Reeds. USOM-provided WF-beam stringers being positioned on bents. Suitable materials for bridge construction are not available throughout the Plain and all materials must be shipped from Saigon by barge or highway through VC-harrassed territory. Consequently, the advisory team experienced many extensive delays while awaiting materials.

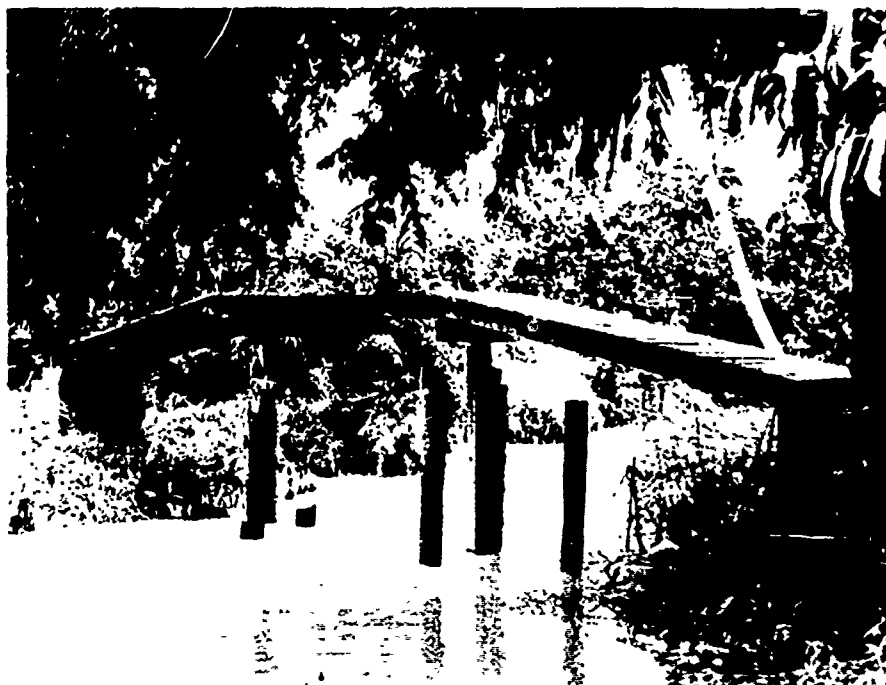
MAAG-3-8. Footbridge at BIN PHO hamlet, near CAN THO. Bridge of 3 spans is 1.50 meters wide by 10 meters long. Piles are USOM-provided 8WF14 steel beams left over from other projects. Cross members were welded to piles to form "T" supports. Welding equipment was rented. Civilian welding rod was replaced by rod from stocks donated by ARVN. Bridge provides access between 2 hamlets and connects path with farm-to-market road. Bridge replaced structure shown on the next page.

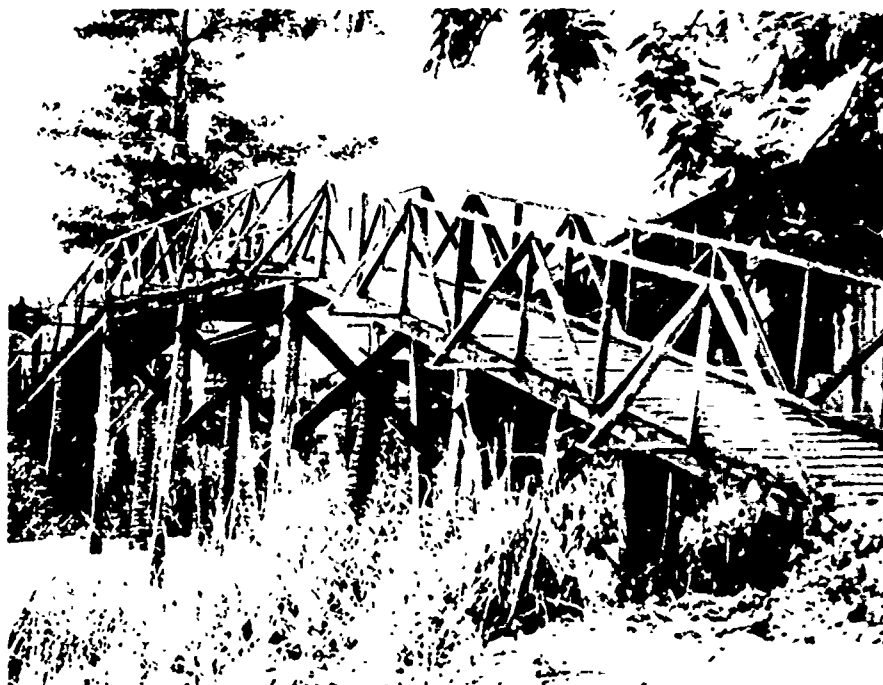
MAAG-3-9. Completed footbridge in the strategic hamlet of AN HUNG near CAN THO. Project is timber trestle design using 8X8 inch posts and 2X8 stringers. Decking is 1-inch material. Bridge has 6 spans, is 1.50 meters wide and 24 meters long. This was a self-help project with all volunteer labor. USOM provided approximately \$217.00 worth of materials. Bridge provides for intrahamlet foot traffic. It replaced a dilapidated palm log bridge.

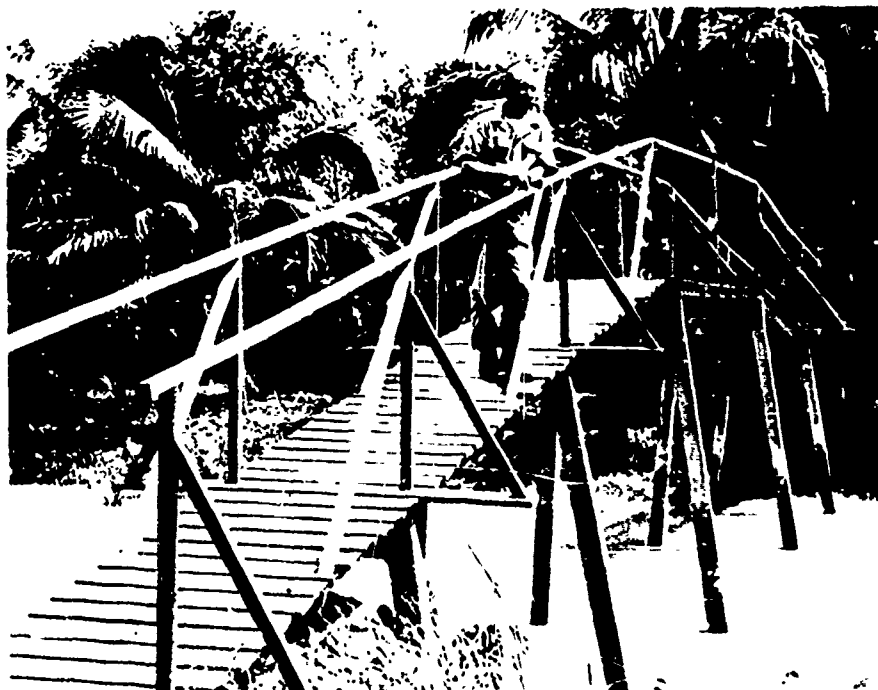
MAAG-3-10. Sergeant Bunch, construction supervisor on footbridge just completed at BINH PHO hamlet, near CAN THO. Bridge is 21 meters long, 0.85 meters wide and has 7 spans. Superstructure was built over sound concrete bents remaining from previous bridge. Most materials used were excess to other ECAO projects in the area. Bridge assists travel between hamlets and connects path to farm-to-market road. Site is typical of many in the Mekong Delta area, where dense jungle areas, frequently lining rivers and canals, make VC infiltration difficult to detect. Most tributaries in the Delta area receive tidal action. Bridge design and construction must permit clearance for canal traffic at high tide.

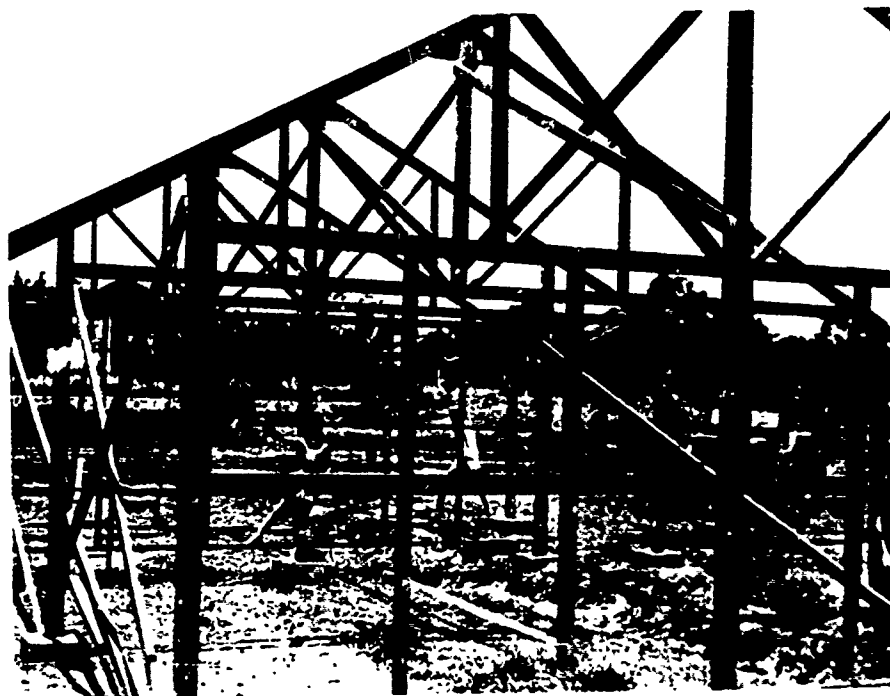
MAAG-3-14. Details of framing and rooters.

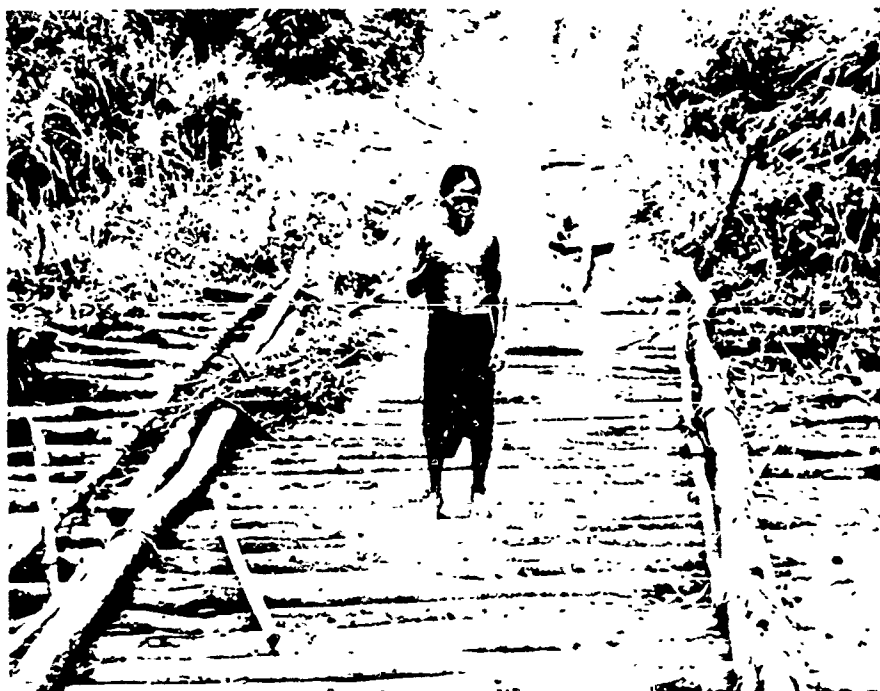
SF-1-2. Tactical bridge, 4 meters long, single span, class 20. Construction is of local material hewn from the adjacent jungle. This structure is used in support of clear and hold operations and is located approximately 7 kilometers west of POLIE KRONG. Old Montagnard woman tossed away a native cheroot in favor of an American cigarette offered by photographer. Debris on deck indicates mountain stream had overflowed its banks, with no damage to the bridge. Twelve-inch log stringers are placed on approximately 20-inch centers.

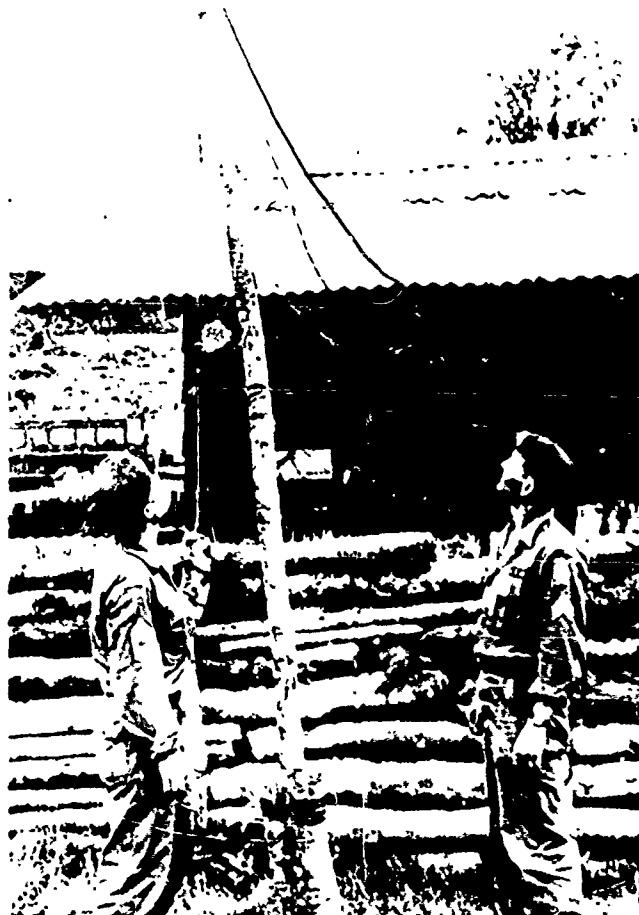
SF-1-3. Rewiring special forces A detachment camp in POLEI, KRONG. With few exceptions, wiring in these remote-located detachments has been accomplished by inexperienced personnel using such expedients as WWII communications wire. Excessive voltage drop and fire hazards are the obvious consequence. An ECAD equipment maintenance sergeant supervised the rewiring of this camp to improve electrical efficiency and reduce fire hazards.

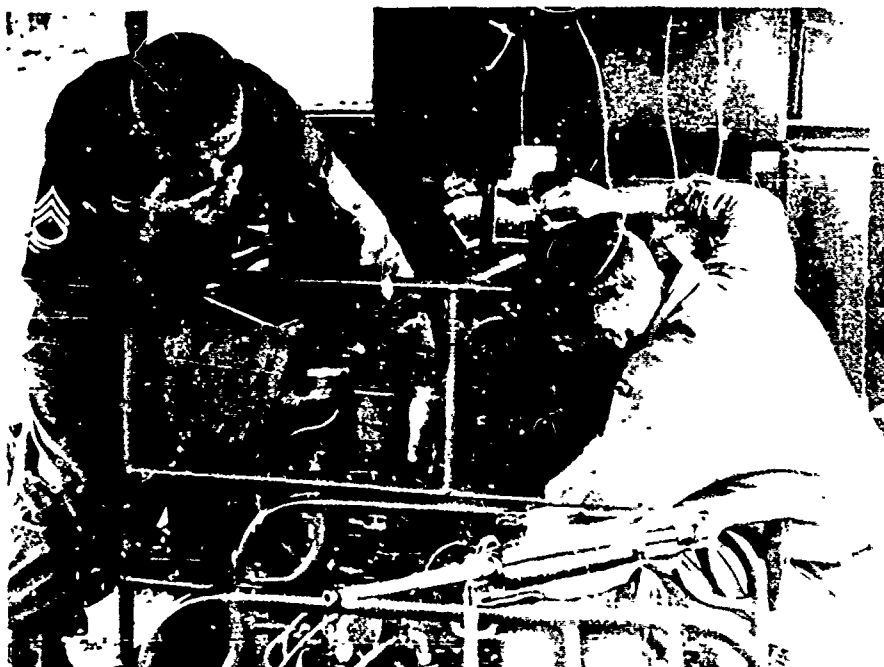
SF-1-4. Repair of 6 generators in the A detachment camp at POLEI KRONG. The ECAD equipment maintenance supervisor is pointing out to the special forces detachment communications sergeant where the trouble lies in this overworked generator. The ECAD sergeant "scrunged" the parts necessary to repair these 6 generators.

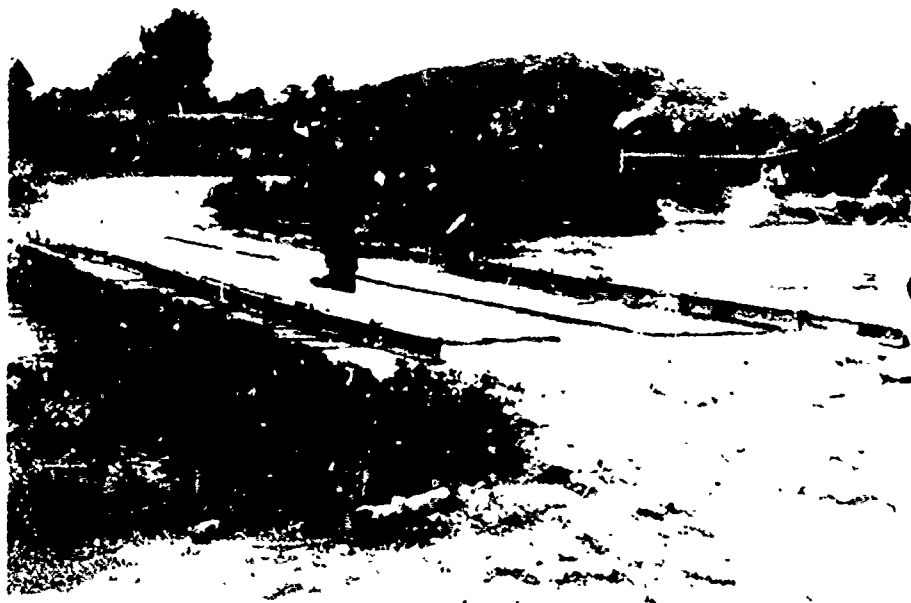
SF-1-15. Replacement of decking and treadway on light vehicular bridge in the vicinity of HA THANH, Vietnam. Material was purchased for this project by the local special forces A detachment, prior to the arrival of advisory team personnel. Lumber used is 1X4 inches. Rail stock curbing is secured to heavy steel stringer by locally fabricated U bolts. Sergeant Kuhn, of the 539th EC&D, in charge of construction, is shown above on the completed bridge. The work force was provided by the local strike force unit. Bridge is located on road between HA THANH and BA GIA.

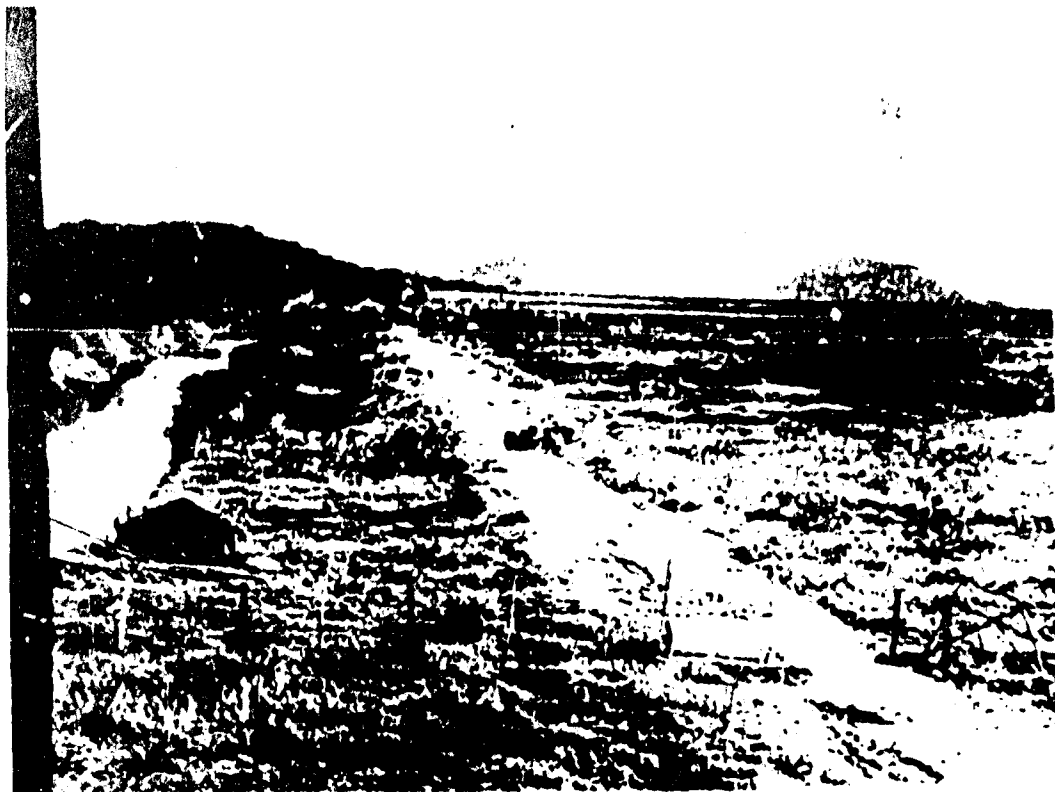
SF-2-8. Road leading from the fortified strategic hamlet of THO SON, west toward the "3-mountains" area. Project was to construct drainage structures and 600 meters of corduroy surface on 12 kilometers of road as part of a planned clear-and-hold operation. THO SON is the last friendly village on the road that goes northwest from RACH GIA to HA TIEN. It is located about 20 kilometers from the city of RACH GIA. The 3 mountains, from which the area gets its name, rise abruptly from abandoned Delta rice paddies. The most distant of these mountains, on the left, rests on the sea of SIAM, and is reputed to accommodate a VC depot and reoutfitting activity. All 3 mountains contain tunnels, from which clay is mined for terra cotta type potteryware, manufactured in the local area. Some of the clay is transported by sampans down the canal, shown on the right, to THO SON, where it is transferred to larger sampans operating on the RACH GIA-HA-TIEN canal. Detailed reconnaissance by Sergeant Donahue, of special forces ECAD advisory team number 2, indicated that 5 culverts would be required. Labor on this project was provided by the village of THO SON.

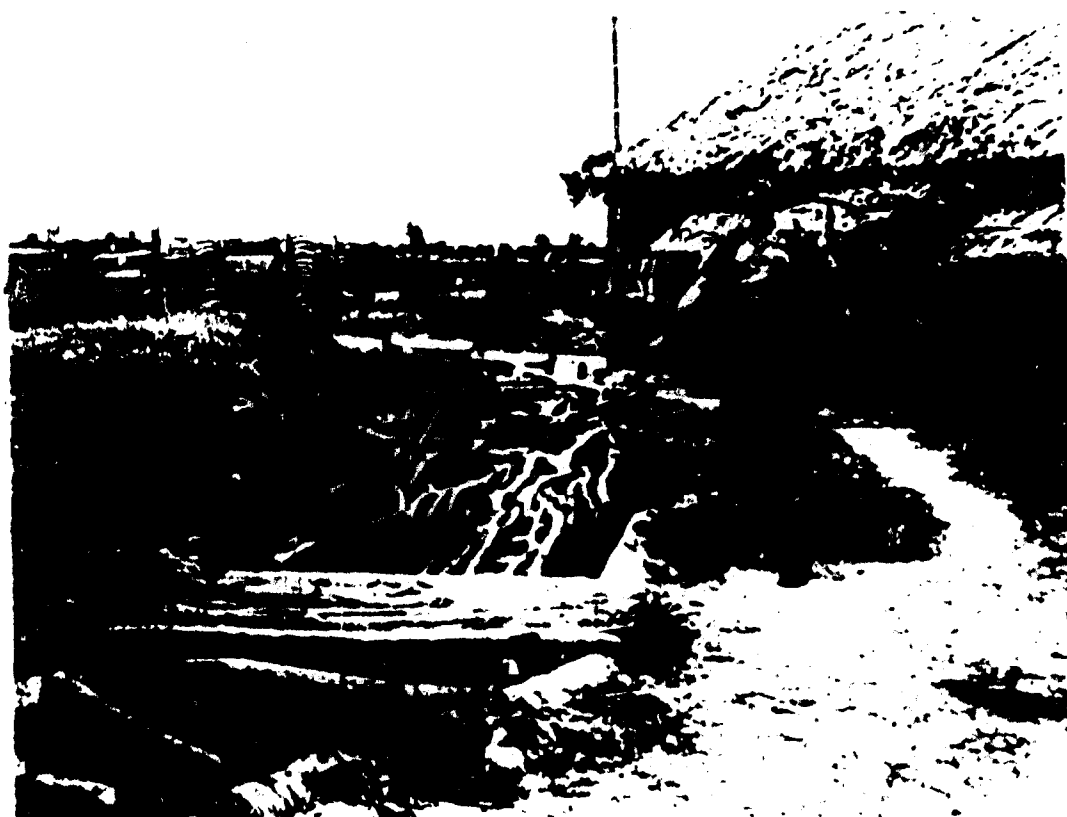
SF A-2-12. Storm sewer in special forces camp at HA TIEN. The A detachment commander, Captain Dougherty, is shown describing the extent and importance of this project. The sewer drains away waste material from the special forces and adjacent Vietnamese strike force mess halls and kitchen facilities. The original plan called for an earth-covered drainage structure. Timber branches, still in place, were to be used to support an earth cover contained by palm frond matting material. The medical technician of the detachment suggested to Captain Dougherty that he could keep the drainage flowing and chemically treat sewage better if he had unlimited access to the structure. The earth cover was not installed. This drainage ditch is revetted with palm logs. Strike force soldiers worked under the supervision of an ECAD construction sergeant on this project.

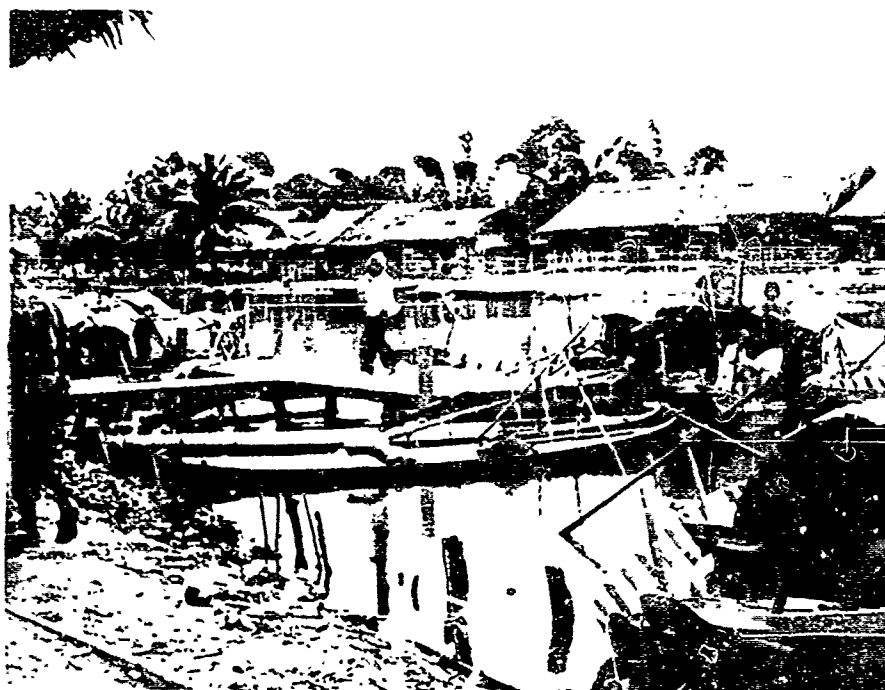
SF-2-17. Public pier for the village of TAN PHU. This "T" shaped landing facility was constructed by unskilled village volunteers under the supervision of an ECAD construction supervisor, Sergeant Blas. It is located adjacent to the market place, and local farmers use it to unload wares, brought down the canal in small sampans for resale. This is the busiest spot in town early in the morning.
