**THEORY, DEVELOPMENT, AND TEST
OF A CRASH FIRE-INERTING SYSTEM
FOR RECIPROCATING ENGINE HELICOPTERS**

December 1963

TRECOM Technical Report 63-49

AVIATION SAFETY ENGINEERING AND RESEARCH
PHOENIX, ARIZONA
A DIVISION OF
FLIGHT SAFETY FOUNDATION, INC.
NEW YORK, NEW YORK

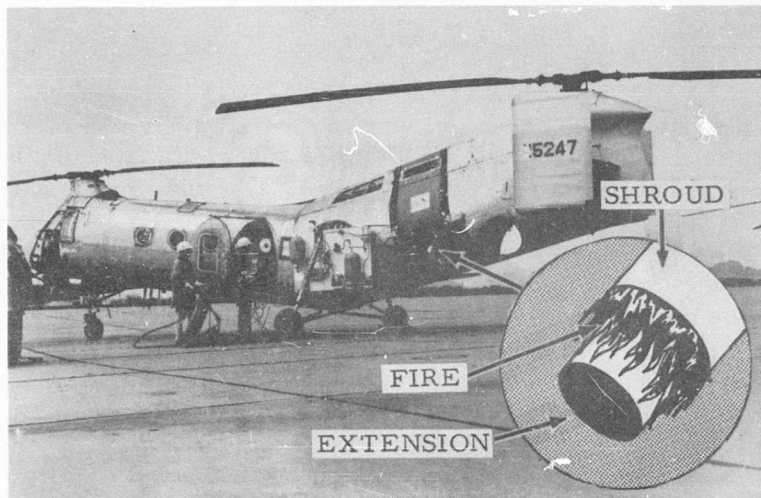
Figure 15. Fire Suppression Test.

Fire is visible in the space between the exhaust extension and the shroud, during the early "time to suppress" fire tests.

The effectiveness of the inert atmosphere surrounding the exhaust collector ring was determined by "fire suppression" tests. While the engine was running at maximum operating temperature, raw fuels were sprayed into the space between the shroud and the exhaust collector ring. The spray was controlled by the regulated, low-pressure air in a movable spray gun. When a definite fire was established, the nitrogen-water system was activated and the time between activation of the inerting system and fire suppression was observed. Figure 15 is a photograph of the test panel in operation. A fire is visible extending out of the shroud on top of the extension attached to the exhaust collector ring.

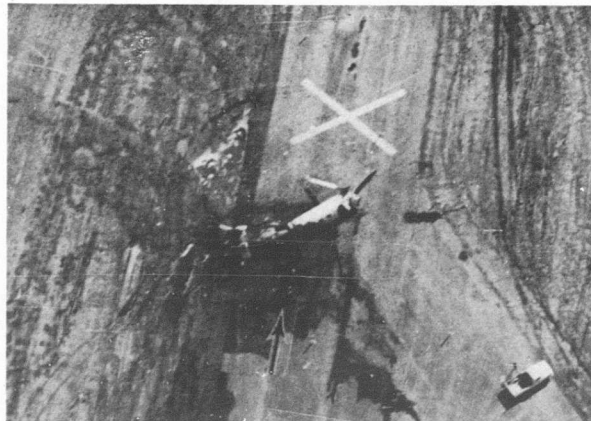
Figure 18. Postcrash View.

As the aircraft struck the ground and skidded forward, it yawed to the right and came to rest at approximately 45 degrees from the line of flight and in the upright position as shown in Figure 18. The sequence of photographs (Figure 25) presented in Appendix III illustrates the kinematic behavior of the aircraft during the first 3 seconds following impact. At 1.46 seconds after nose-wheel impact, a fire involving the 3-1/2 gallons of aviation gasoline in the main fuel tank appeared. The possible ignition sources are discussed in the following section.

This photograph illustrates the final resting position of the helicopter. The forward portion of the helicopter is yawed approximately 45 degrees from the line of flight (arrow) and the aft section is yawed an additional 15 degrees.

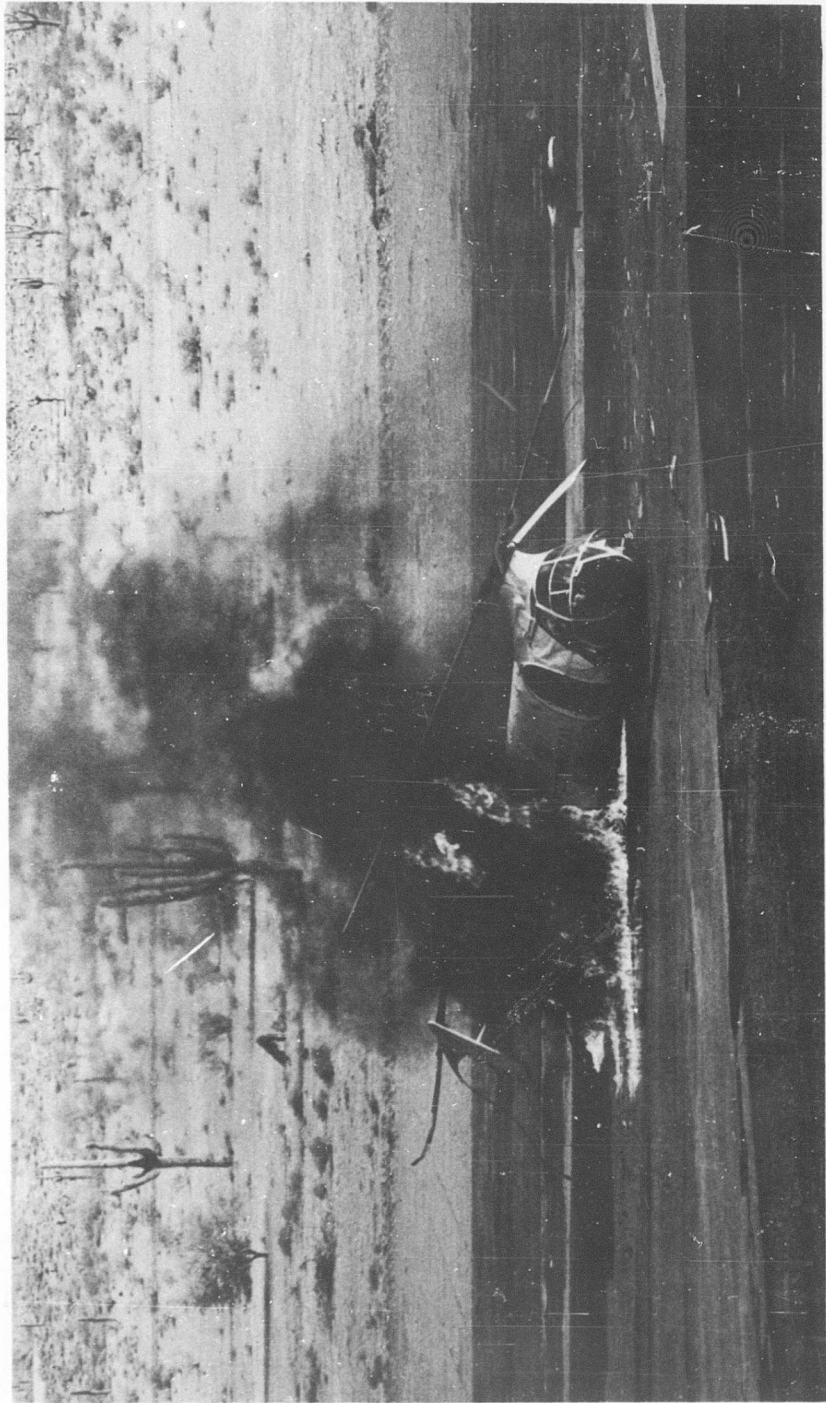
Figure 25G. In this photograph the aircraft has come to rest, and the flash fire is beginning to die down.
Time: + 60.0 Seconds
