A LIMITED EVALUATION OF ULTRASONIC SPOT WELDS  
IN X2020-T6 ALUMINUM ALLOY SHEET

REPORT A461 SERIAL NO. 3

WARNING  
The status of this report has not been  
**MCDONNELL**  
Aircraft Corporation  
St. Louis, Missouri  
WARNING

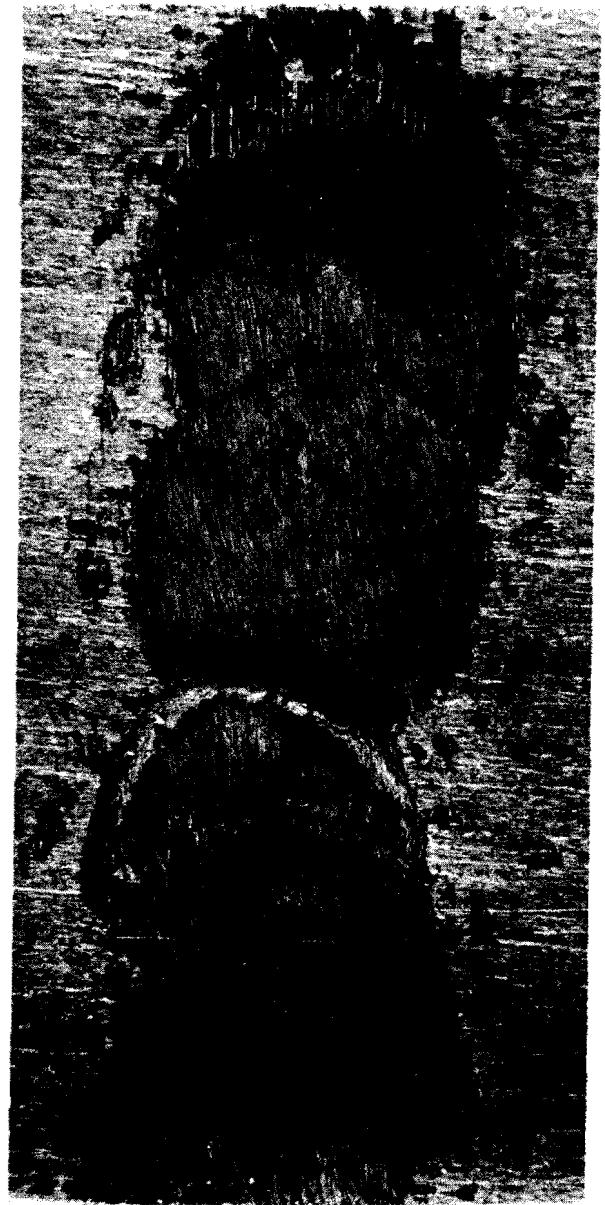
FIGURE 9

VIEWS OF BOTH SIDES OF ULTRASONIC OVERLAPPING SPOT  
SEAM WELD IN X2020-T6 ALUMINUM ALLOY, .010" TO .010" SHEET

SPECIMEN NO. A<sub>22</sub>

Figures 9 and 10 illustrate typical appearance of single spot and overlapping spot seam welds.
