LIFT FAN FLIGHT RESEARCH AIRCRAFT PROGRAM

# XV-5A

XV-5A LIFT FAN  
FLIGHT RESEARCH AIRCRAFT

QUARTERLY TECHNICAL PROGRESS REPORT NO. 8.  
For Period August 16, 1963 to November 15, 1963.

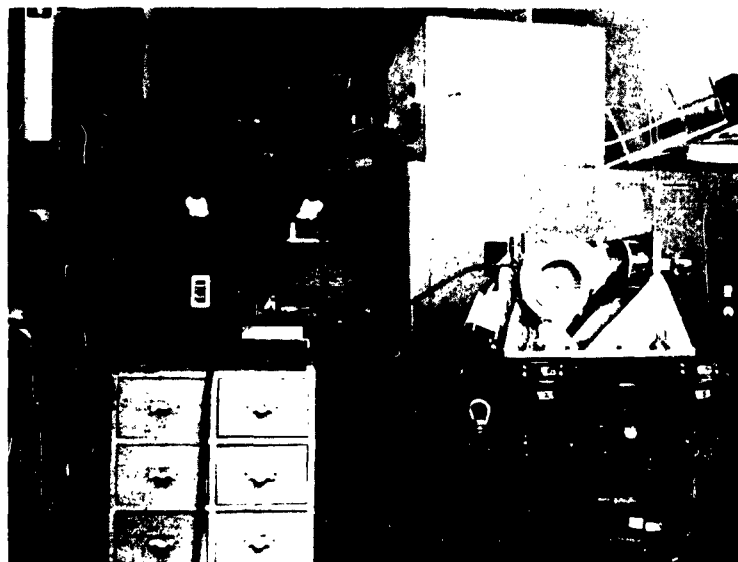
Figure 26 Fan-Gear Box Vibration Test

The engine driven cooling fan-gear box assembly was structurally tested at the vendor's factory. While the vendor was conducting life cycle tests, the fan rotor failed. The Ryan Test Group investigated the failure and determined by micrographic inspection that the rotor had been brazed at too high a temperature, resulting in reduced strength of the parent material. Large grain growth resulting from the high temperature reduced the fatigue characteristics to the point of failure. New redesign rotors were in work at the end of this period.

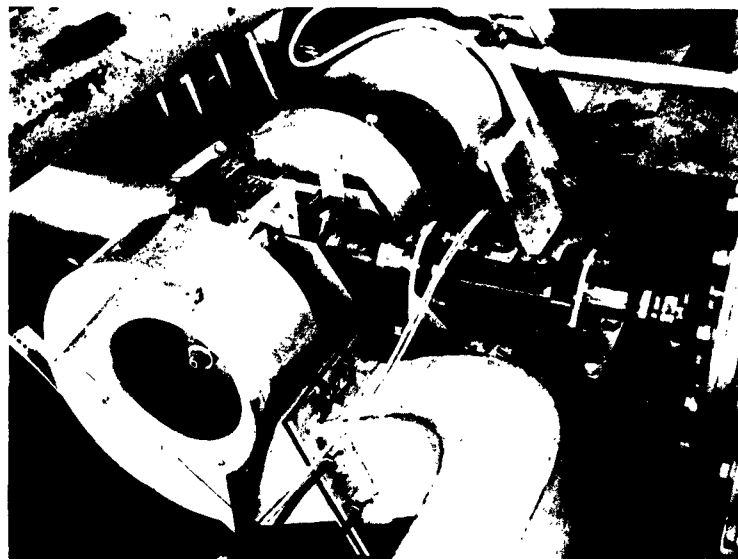
Fig. 27 Fan-Gear Box Performance Test  
Rig Showing Torque Transducer

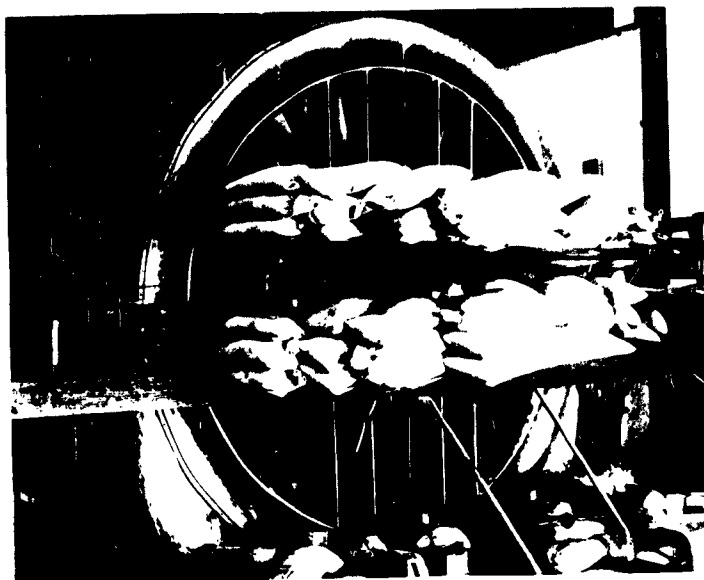
Figure 30 Fan Closure Door Structural Proof Load -  
High Speed Fan Powered With Yaw Condition

With the static structural proof test completed at the Convair facility, the remaining test of the wing fan door was successfully conducted. A simulated high speed, 4 g load condition was applied using whiffle trees for loading and an actual fan to react the loads, (Figure 29). Door open simulated loads were applied using shot bags to test the most critical fan operating case, during transition speed while yawing, (Figure 30).

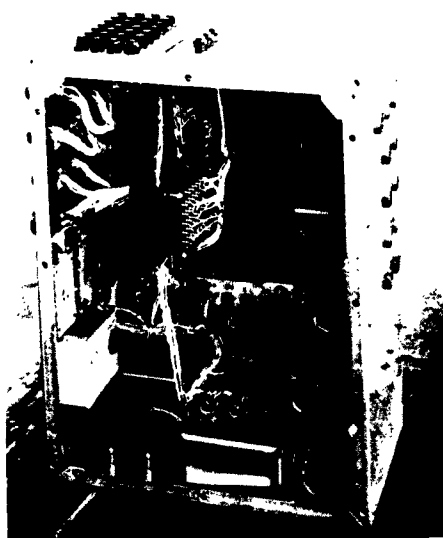
Figure 31 Signal Conditioner  
Box - Cover Removed

Ground test instrumentation design and fabrication was completed and 90 percent installed in both aircraft. The signal conditioner box fabrication (Figure 31), was completed. The signal conditioner conditions the various transducer signals so they can be accepted by the Pulse Code Modulation In-Flight Recording System.
