VUF-2600  
FINAL REPORT

# VELA UNIFORM PROJECT **SHOAL**

Project 1.6  
**IN-SITU STRESS IN GRANITE**  
Lucius Pitkin, Inc.

OPERATION SHOAL  
PROJECT OFFICERS REPORT - PROJECT 1.6  
IN-SITU STRESS IN GRANITE  
F. H. Wright, Project Officer

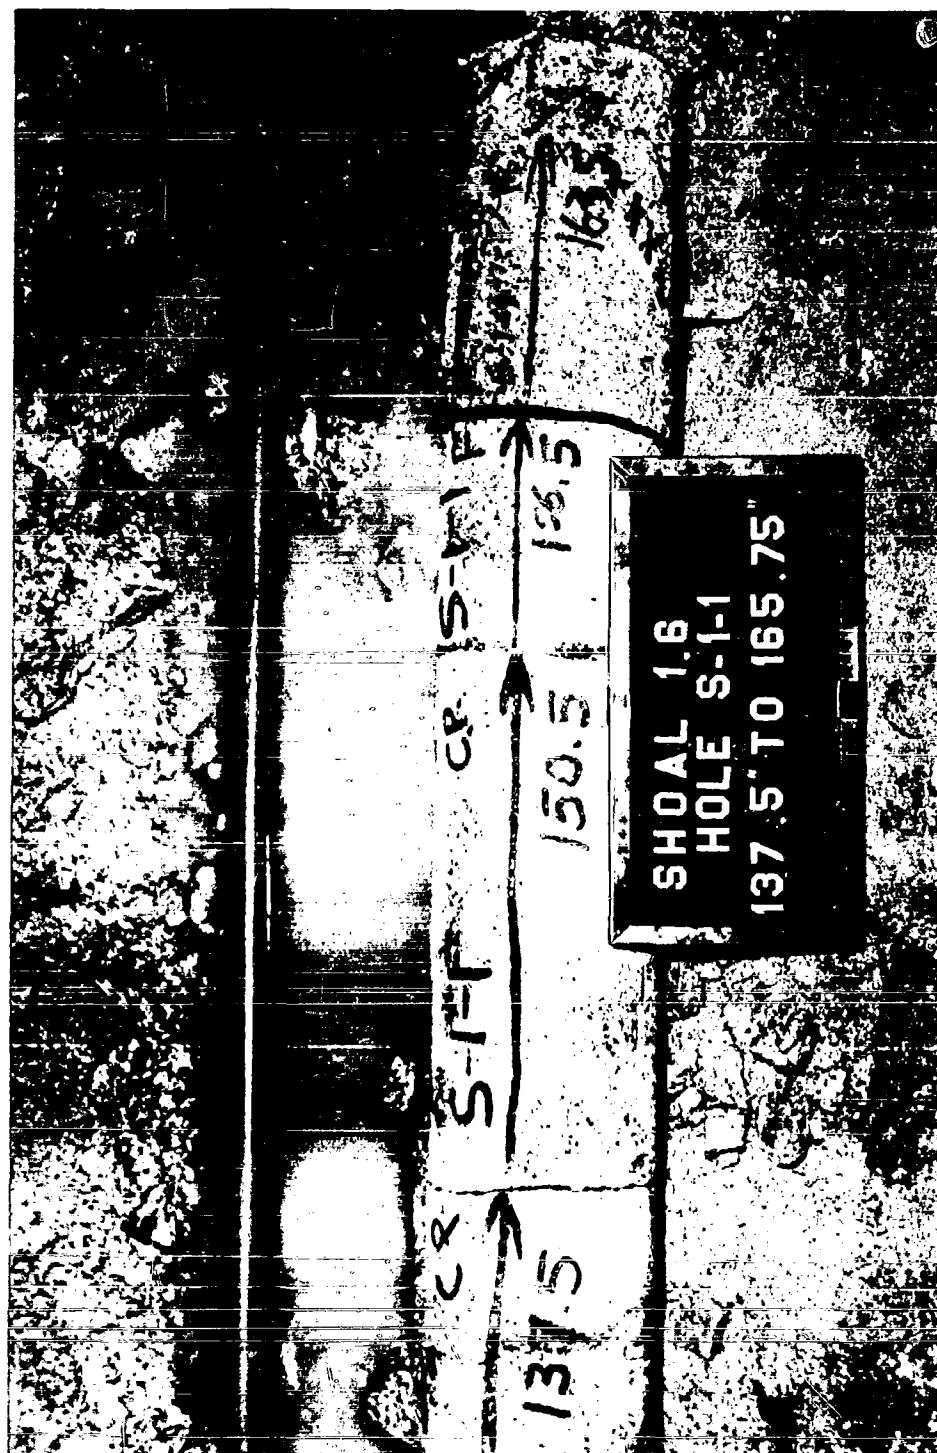
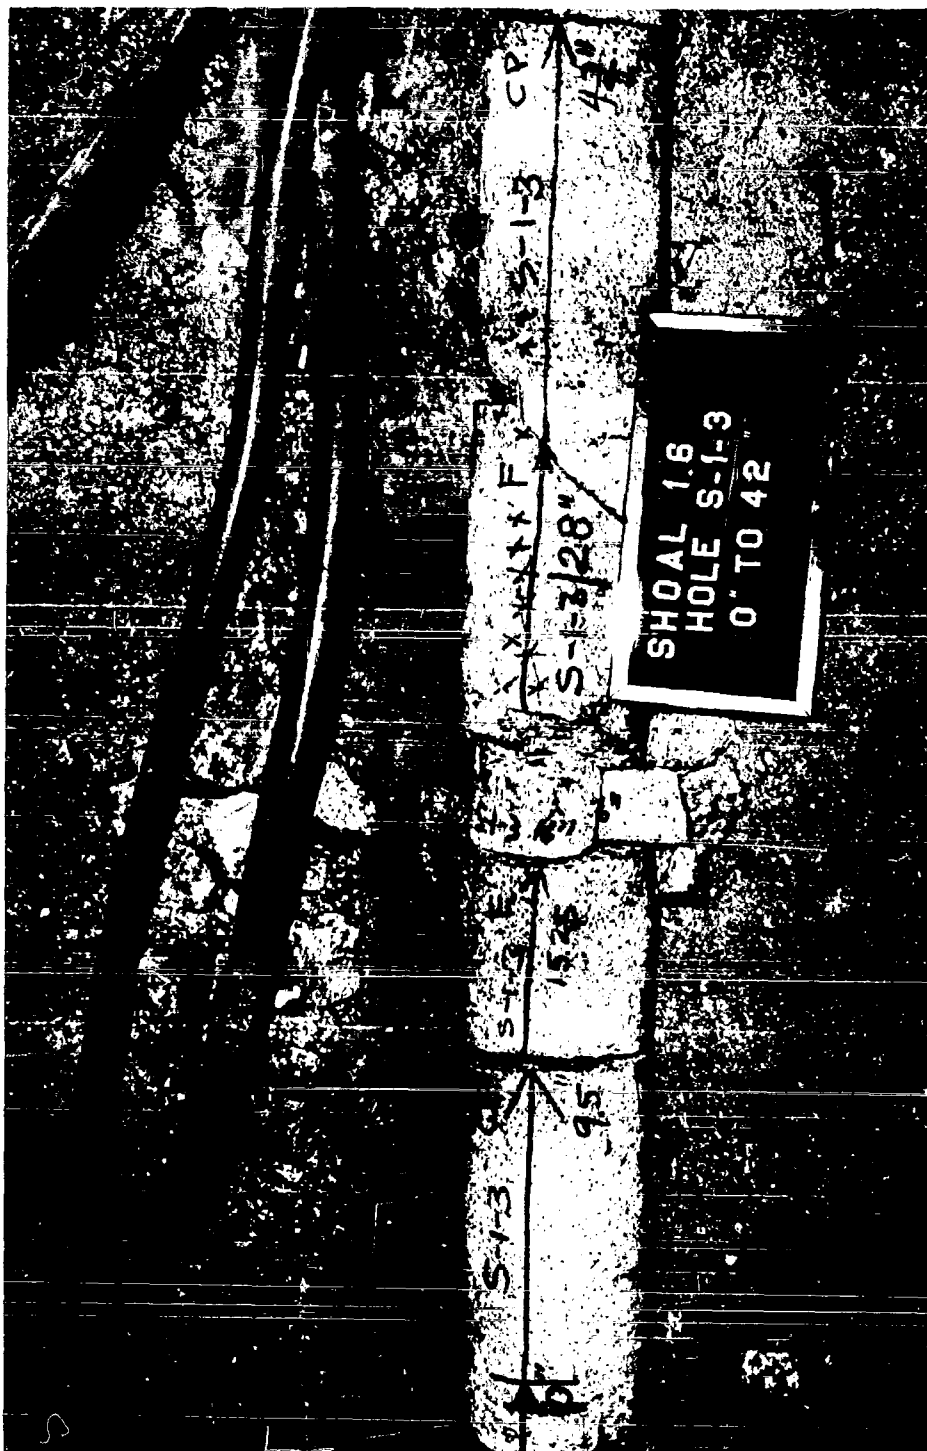
Photographs 1 through 6, taken by DASA personnel, show all cores recovered from overcoring operation. The cores were marked to indicate nature of the numerous fractures encountered at the various hole depths. The meaning of symbols used in marking these cores is given in Table 2.
