Report No. AAEE/Tech/275/Eng.

# AEROPLANE AND ARMAMENT EXPERIMENTAL ESTABLISHMENT

EROSION AND NOISE ATTENUATION TESTS ON A 50 FT. CHALK TUNNEL  
USED AS A JET ENGINE NOISE MUFFLER

Report No. AAEE/Tech/275/Eng.  
30 November 1964

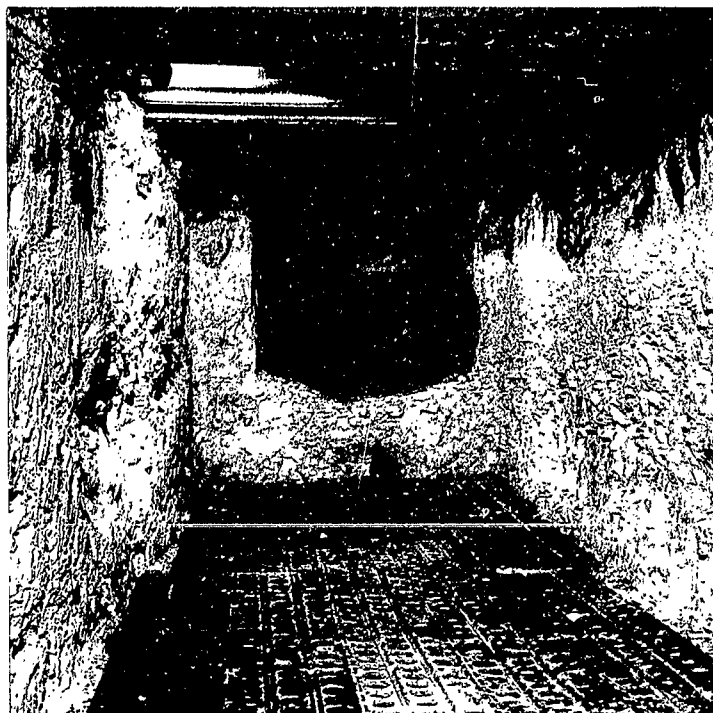
FIG. 3. THE CHALK TUNNEL BEFORE AND AFTER THE TEN (10)  
MINUTE ENGINE RUN WITH A HUNTER AIRCRAFT.

The erosion of the tunnel floor and walls may be estimated from the photographs in figs. 2 and 3 which show the inlet into the tunnel looking from the  $30^\circ$  bend both before and after the test runs with the Hunter. Fig. 2 shows the erosion which occurred during the initial two minute run and it can be seen that the majority of the damage is confined to the lower portion of the walls and floor. Careful examination will reveal that it was the floor which sustained the greater damage and because of this P.S.P. was provided for the second run of ten minutes duration. The effect of this second test may be assessed from the pictures in fig. 3 to be only slight. In fact the loose debris found inside the tunnel was less than  $\frac{1}{3}$  of that which had to be removed after the first test.
