WT-1012  
(Supersedes ITR-1062)

*Operation*  
**WIGWAM**

DETERMINATION OF RADIOLOGICAL HAZARD  
TO PERSONNEL

# DETERMINATION OF RADIOLOGICAL HAZARD TO PERSONNEL

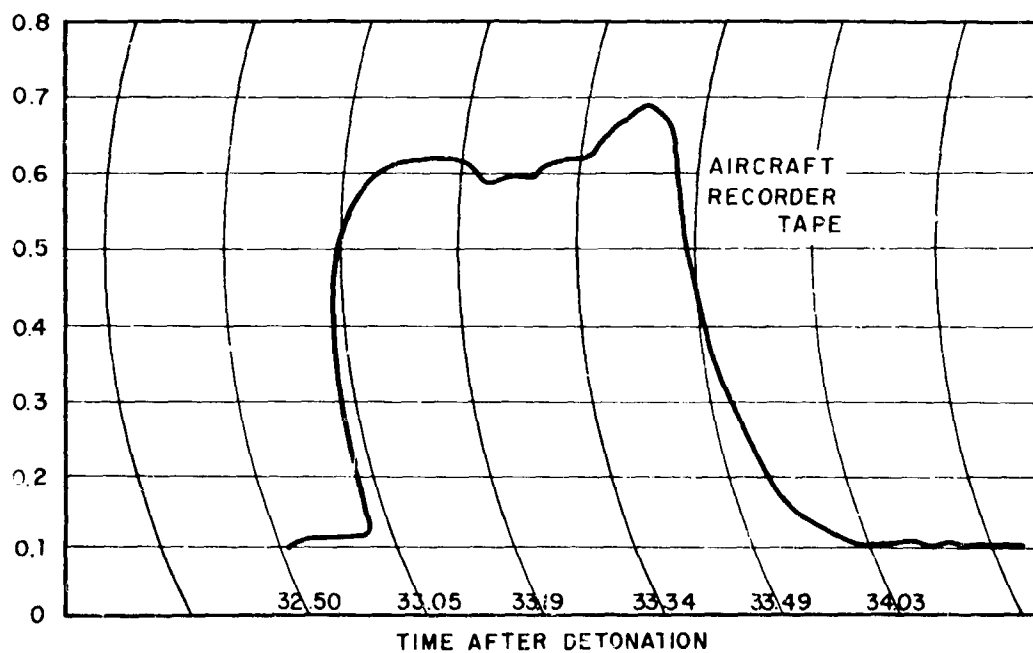
Fig. 3.7—Aerial survey data handling.

since, after D-day, the decay was not rapid enough to introduce significant errors. Figure 3.7 indicates the data-handling technique.
