TECHNICAL REPORT NO. 8785 (LL 101)

MOBILITY ENVIRONMENTAL RESEARCH STUDY
ONE-PASS PROGRAM

by PETER W. HALEY

LAND LOCOMOTION LABORATORY

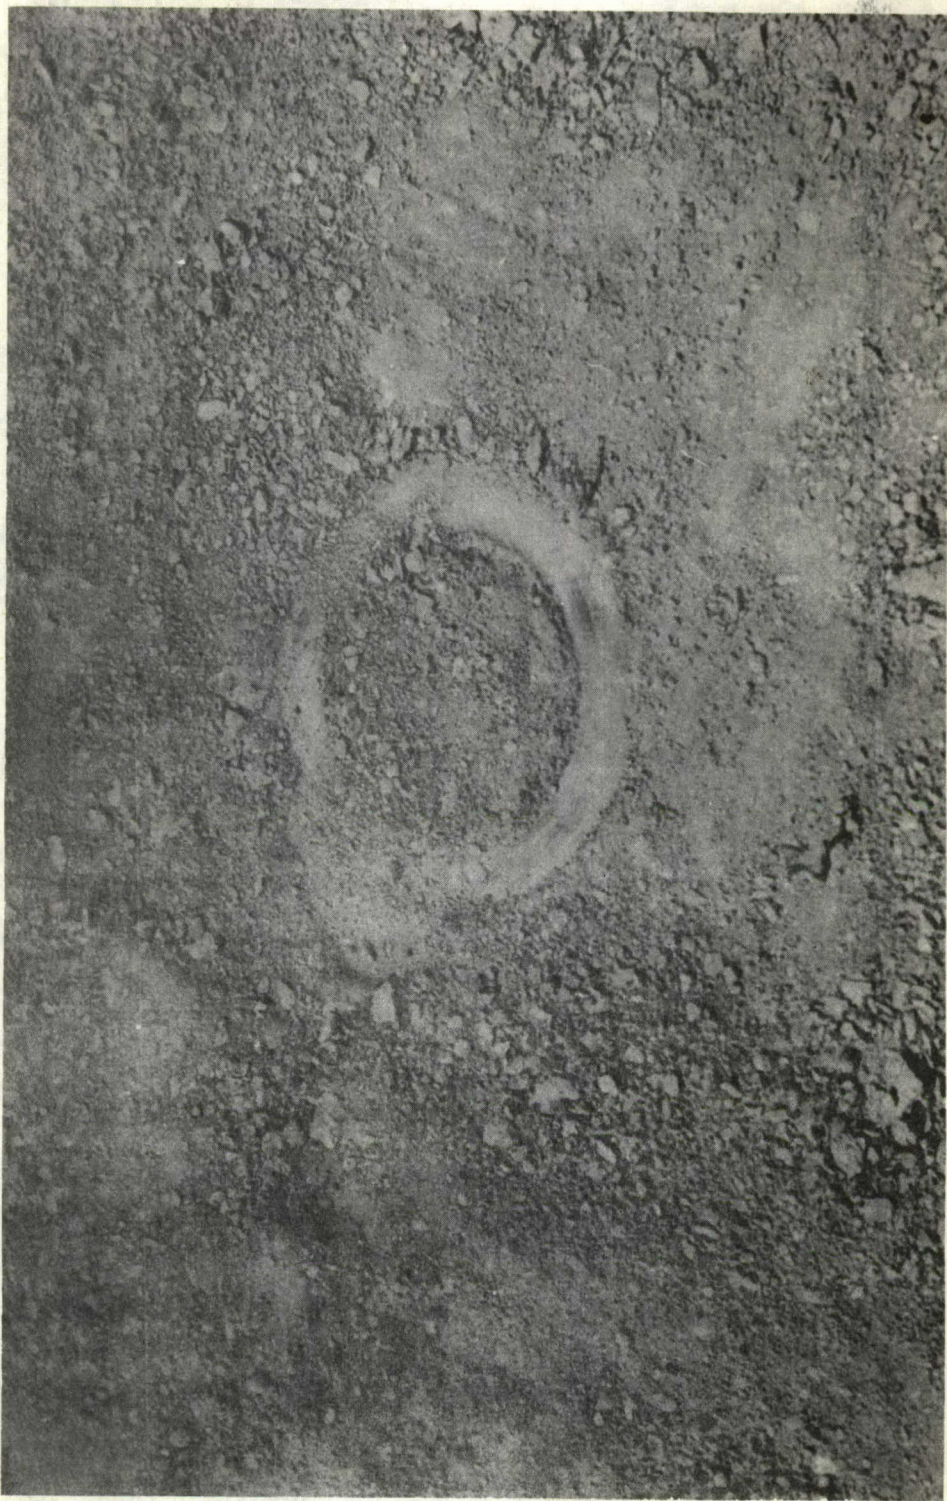
Fig. 4 SHEAR ANNULUS IMPRESSION ON HARD SURFACE, SILT COURSE, WES, VICKSBURG, JUNE, 1964.

The use of a rubber annulus is realistic from the viewpoint that slipping occurs between a rubber pneumatic tire and the soil surface for the wheeled vehicles. Shear readings were taken with the grouser annulus when it was noted that the M29C track vehicle would actually dig into the surface rather than ride on its road pads.

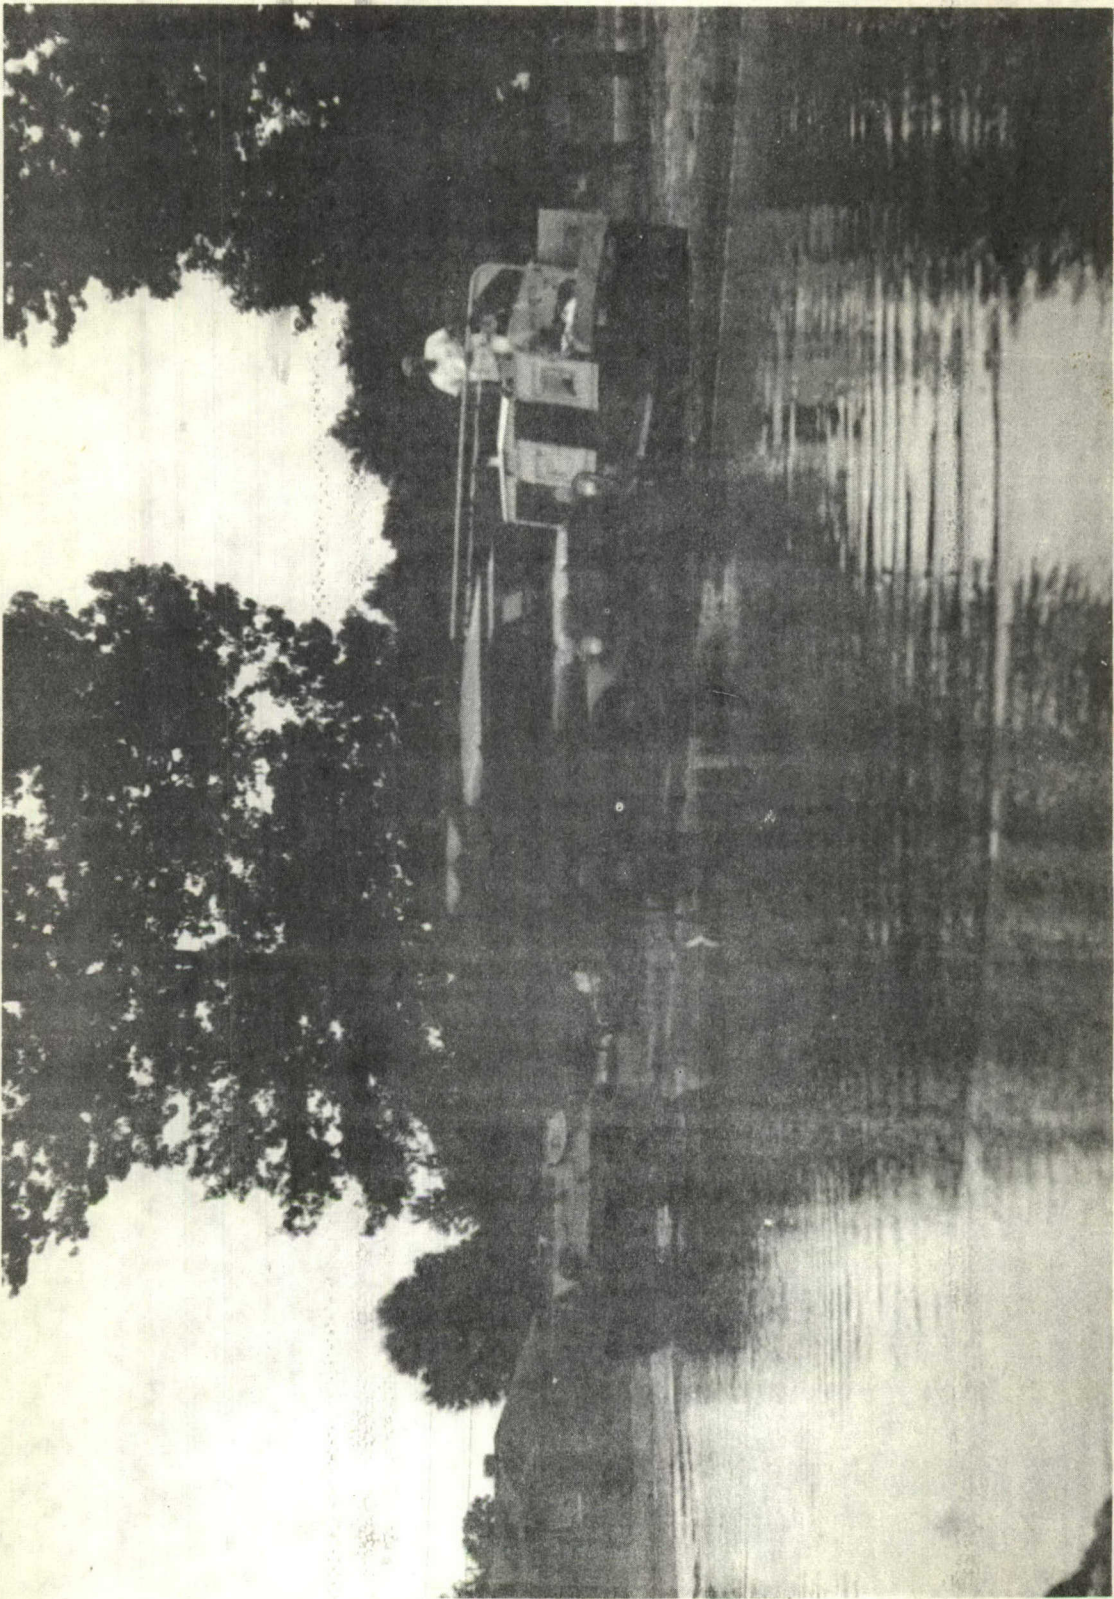
Fig. 6 DRAWBAR PULL TEST, M37. FLOODED SILT COURSE, WES, VICKSBURG, JUNE, 1964.

The most uniform course was achieved for the flooded condition shown in Figure 5, and was reflected in satisfactory agreement between the vehicle test results and predicted performance. Figure 6 shows a typical drawbar test in the flooded condition.

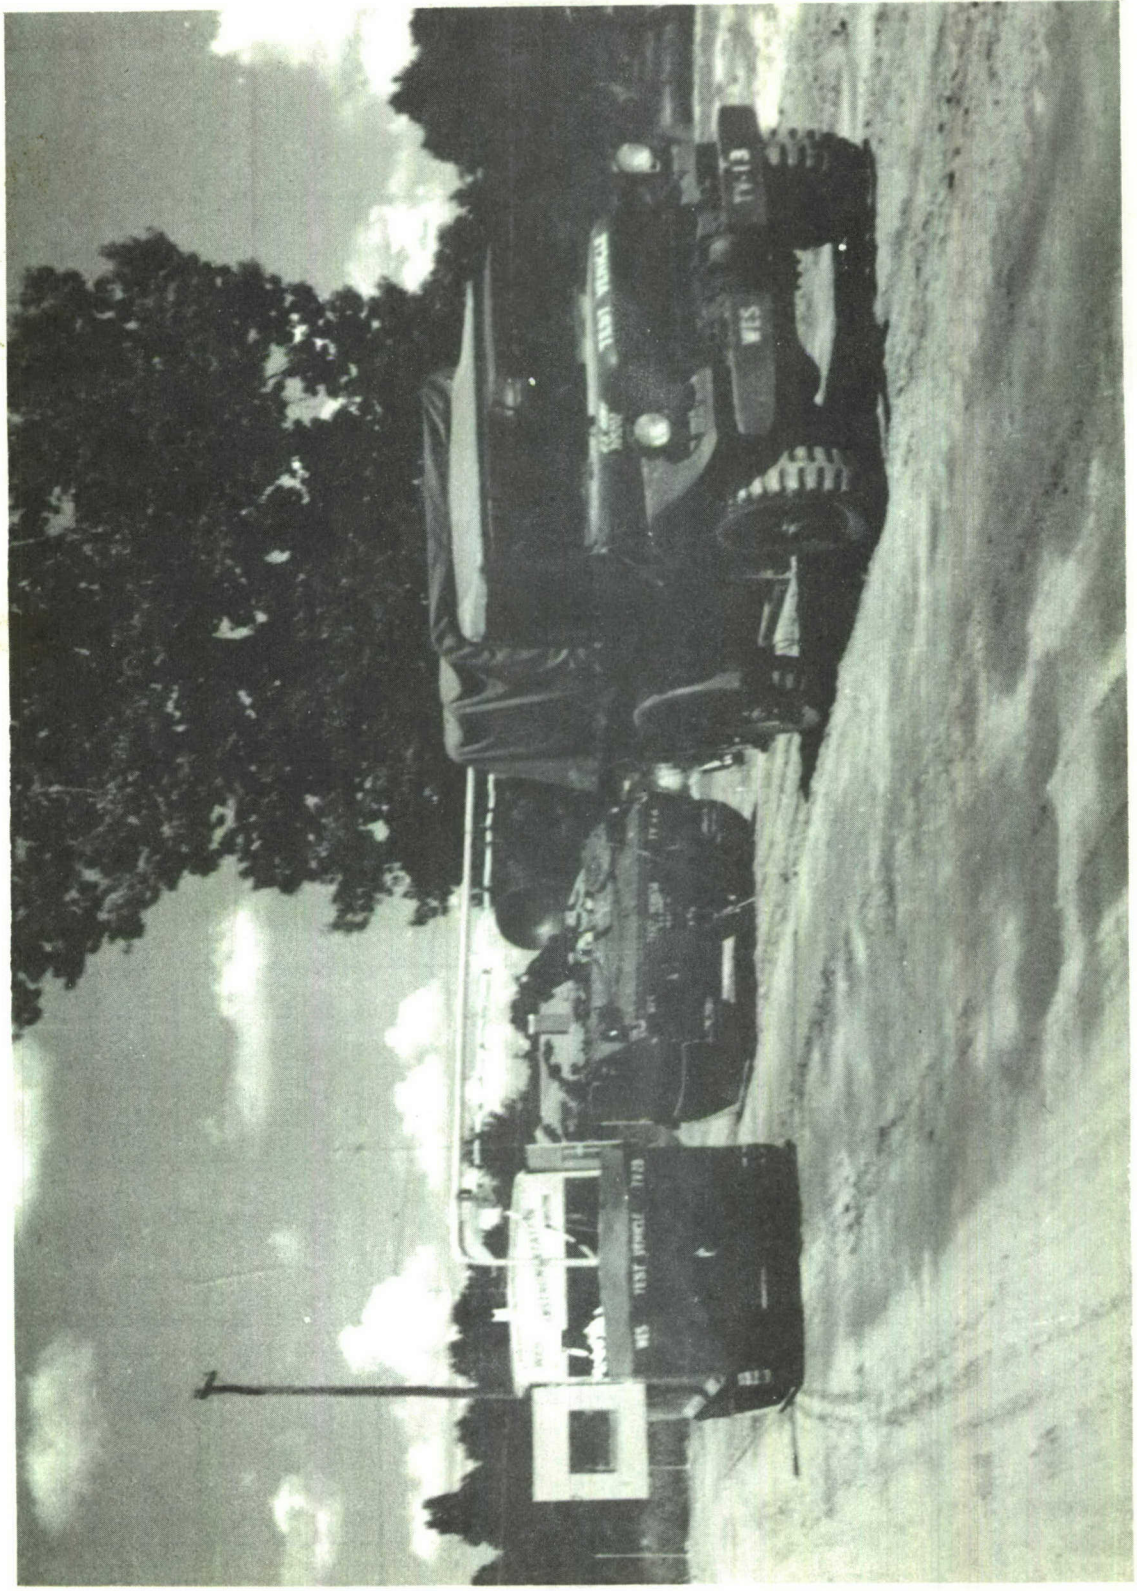
Fig. 7 DRAWBAR - PULL TEST, M37. HARD SURFACE, SILT COURSE, WES, VICKSBURG, JUNE, 1964.

To obtain better predicted values for the hard soil surface tests, the shear stress values occurring at the peak of the shear vs rotation curves were chosen. The surface material, being very brittle, could sustain high shear loads before encountering failure. The three vehicles tested on the hard soil surface never failed this brittle soil, but skidded along its surface. This was readily noticed in the case of the M29C which left skid marks of its road pads aft of the vehicle, Figure 7 shows a typical hard surface traction test.
