EFFECT OF

SONIC BOOMS

VARYING OVERPRESSURES

SNOW AVALANCHES

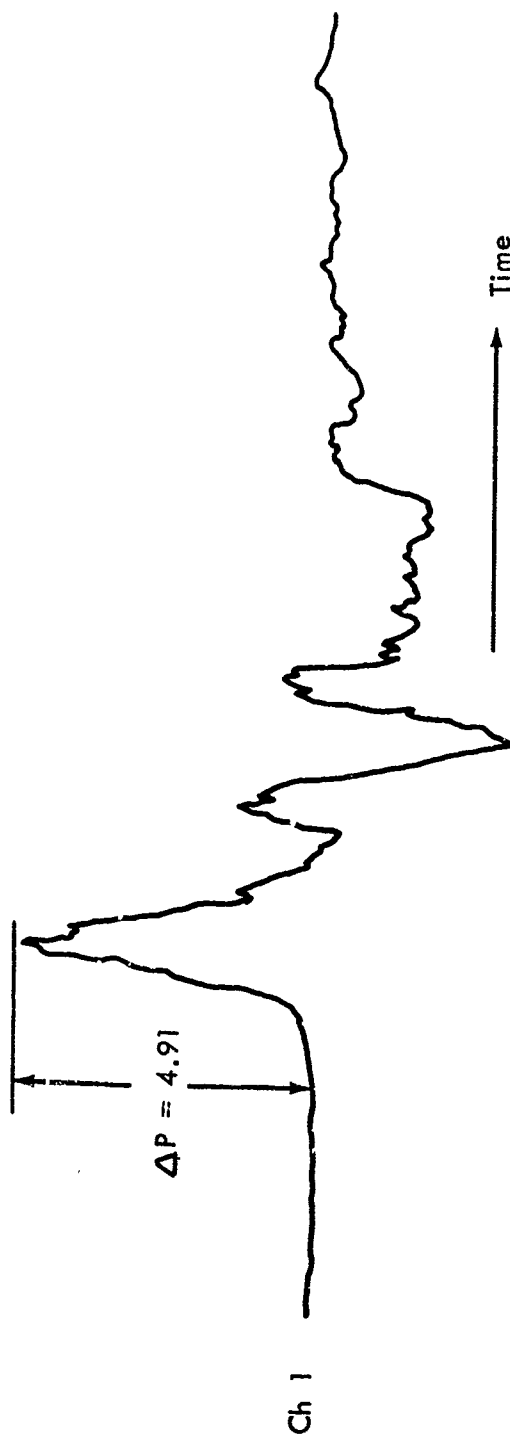
Figure 6C

→ .1 sec. ←

(c) Run No. 11

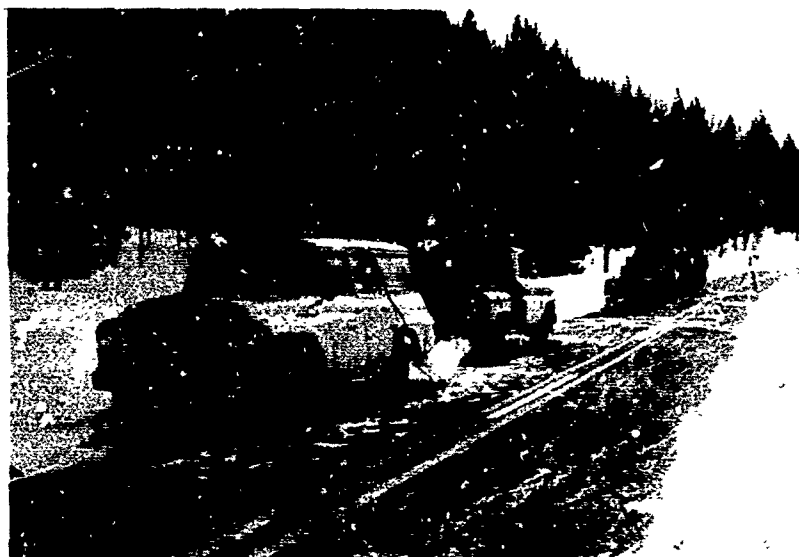
Figure 9

Left to Right - N.A.S.A. instrumentation truck;  
with generator furnishing power for instruments;  
U.S.A.F. radio communications truck with generator  
trailer.

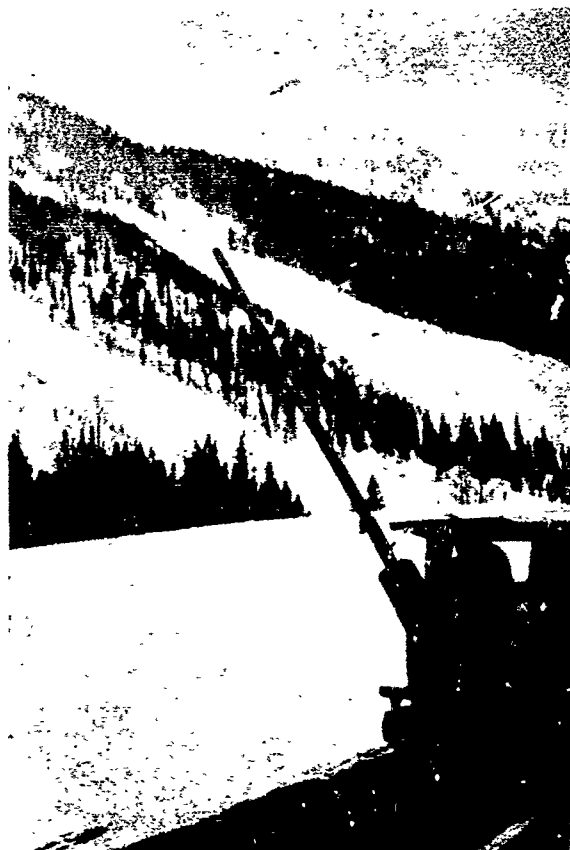
Figure 11

Readying avalauncher to fire  
on "Test Area No. 2". Over-snow  
vehicles necessary to gain access  
to site.  
"Cristy" snow cat on left, and  
"Ski-Do" snow scooter on right.

"Avalauncher" ready for firing.  
Compressed nitrogen gas is put  
into cylinder. High explosive  
charge is put down barrel.  
Trigger is pulled and a special  
valve releases the gas almost  
instantaneously pushing charge  
to range of 1000 yards.

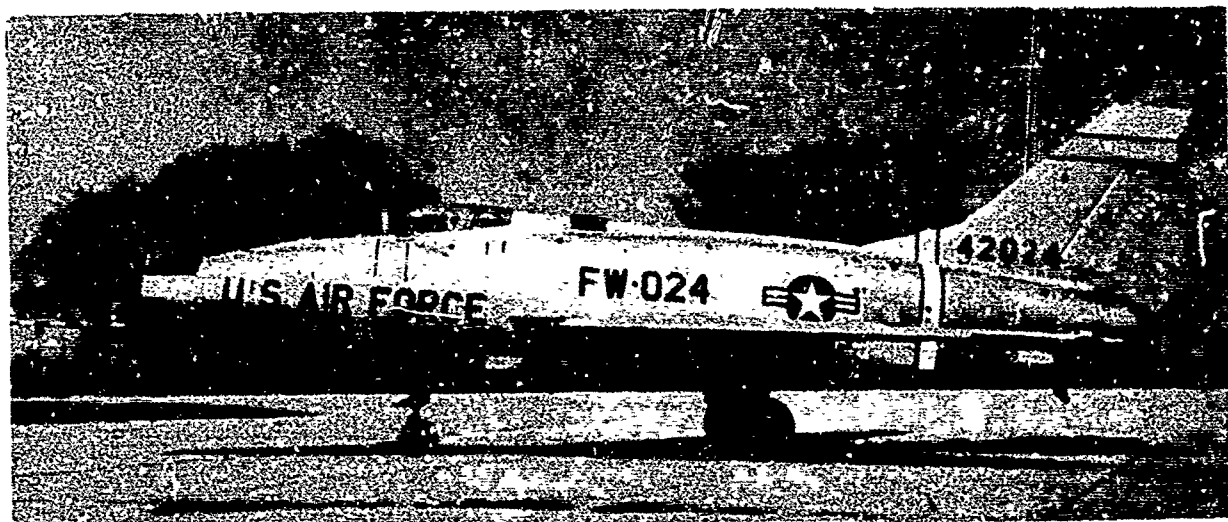
Figure 12B F-100
