**FIRST QUARTERLY PROGRESS REPORT ON
THE EVALUATION OF HIGH TEMPERATURE MATERIALS**

**Mr. Lawrence N. Hjelm
Research and Technology Division
Wright-Patterson Air Force Base, Ohio
Contract No. AF 33(615)-1312**

10 April 1964

**University of Dayton
Research Institute
Dayton 9, Ohio**

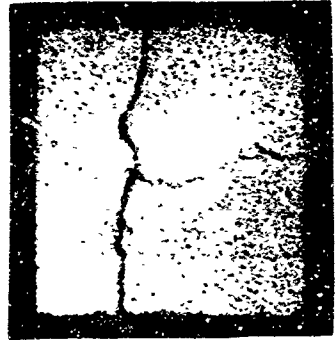
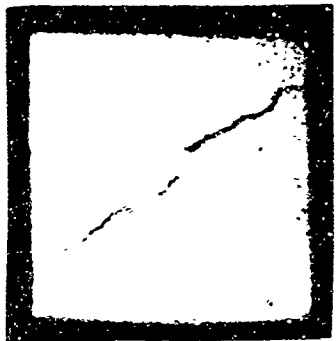
Table 10. Test Conditions and Results for Manufacturer I Foamed ZrO₂ Specimens

Material	Low Density Foam	Medium Density Foam	High Density Foam
Heat Flux (BTU/ft ² -sec)	275	275	275
Gas Enthalpy (BTU/lb)	2580	2580	2580
Test Duration (sec)	300	300	300
Stagnation Pressure (psig)	0.57	0.570	0.577
Gas Temperature (°F)	5910	5960	5910
Gas Velocity (ft/sec)	890	890	890
Decrease in Weight %	0.52	0.55	0.47
Density (gm/cc)	1.9	2.0	1.6
	0.99	0.99	1.06
	0.99	0.99	1.06
Depth of Erosion (in.)	-0.005	-0.003	-0.012
Volume of Erosion (in ³)	--	--	--
Final Back Face Temp (°F)	2260	2310	1450
Final Front Face Temp (°F)	4245	4225	4155
Remarks	Both specimens cracked during test.	One specimen (shown below) cracked during test; the other remained intact.	One specimen (shown below) cracked during test; the other remained intact.
Sample Appearance

The performance of the unfilled foams was rather impressive. Unlike previously evaluated foamed zirconia from this manufacturer and others, which failed in thermal shock after a few seconds of heating, these specimens all survived a full 300-second exposure. Thermal stress cracking was observed with both of the two low density foams and one each of the medium and high density foams. These failures were evident from the back surface temperature behavior which either stabilized at a higher level or increased abruptly at the time of thermal stress cracking. Front surface temperatures of the unfilled foams were coincident; however, back surface temperatures stabilized at levels inversely proportional to foam density. Despite these failures, attrition of material was only minor and in no instance did weight loss exceed 2%.
