**Technical Report 145**  
**MEASUREMENT**  
**OF**  
**FROST HEAVING FORCES ON PILES**

by  
**F. E. Crory**  
and  
**R. E. Reed**

**OCTOBER 1965**

by  
**U.S. ARMY MATERIEL COMMAND**  
**COLD REGIONS RESEARCH & ENGINEERING LABORATORY**  
**HANOVER, NEW HAMPSHIRE**

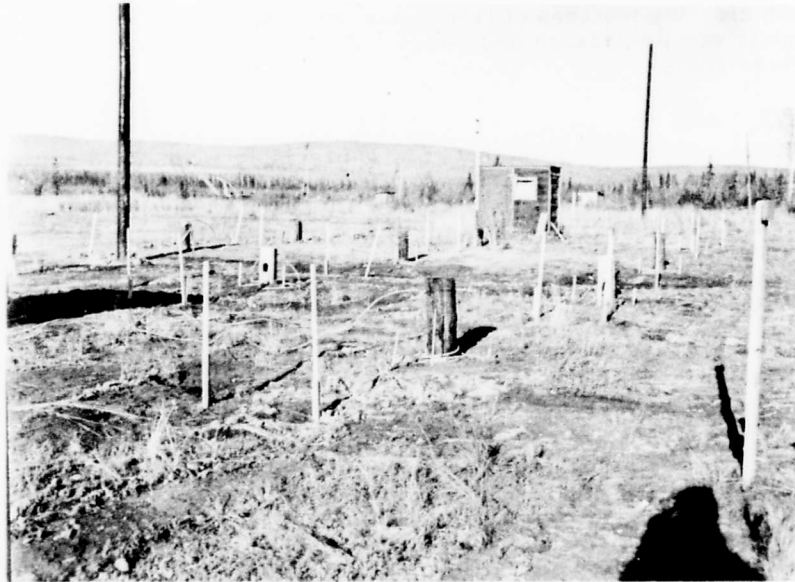
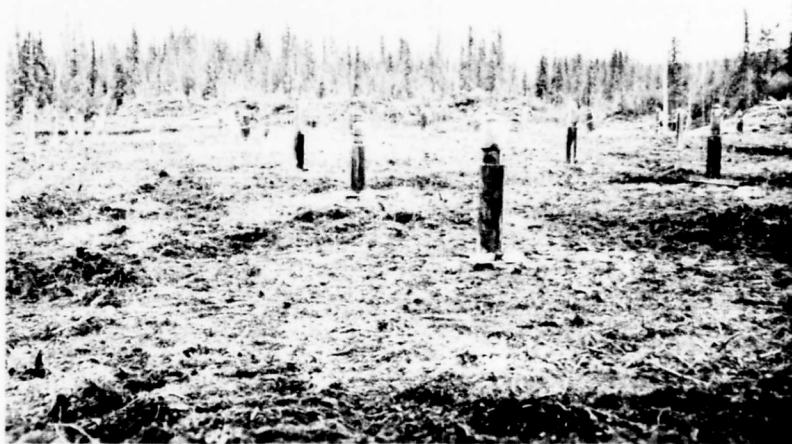
a. General view of pile site B - October 1953.

b. General view of pile site C - May 1957.

Figure 3. Photographs of pile sites B and C.

underlain by a 4- to 9-in. layer of black organic material. The lush moss cover, undisturbed in clearing the area of trees, has since been replaced by an ever increasing density of wild grasses and weeds. Photographs of pile sites B and C are shown in Figure 3.

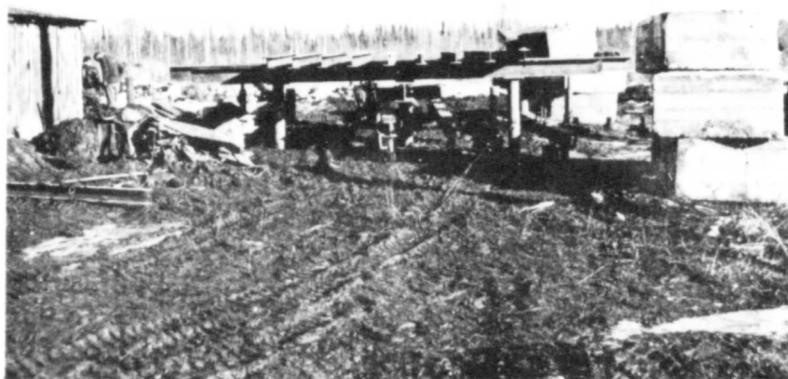
Figure 11. General view of load platform, 1957-1958 heave test.

The load platform, 12 x 10 ft, was constructed of 10 BP42 girders welded to plates on top of the support piles. The floor beams were 6 WF25 beams placed 18 in. O. C. and spot welded to the girders. A 10 BP42 beam was welded to the bottom of the girders to serve as a reaction beam. Safety cribbing was placed beneath each end of the reaction beam. The computed weight of the load platform was 8000 lb. An additional load of 70,000 lb (5000-lb concrete blocks) was added to the platform. Figure 11 is a photograph of the installation showing the load platform and concrete load blocks.

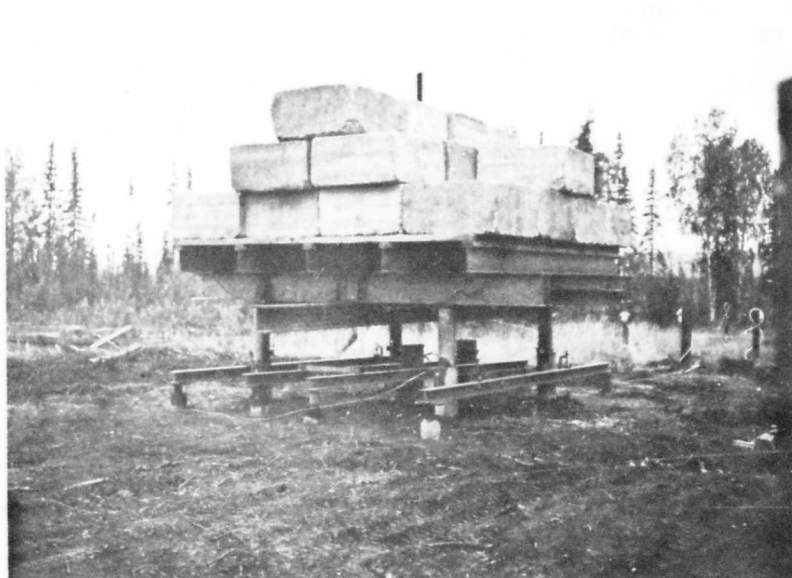
Figure 13. General view of test installation, 1958-1959 heave test.

The reaction to the heave force was provided by a load platform similar to the 1957-1958 installation. The platform was supported by four 8-in. standard steel pipe piles installed in dry-augered holes to a depth of about 22.0 ft. Each platform support pile was cased through the active layer with 12-in. casing filled with oil-wax to eliminate frost heave forces. The location of the piles and the details of the load platform are shown in Figure 12. The instrumentation beams were supported on 4-in. pipe driven to approximately 15 ft below ground surface with the top 6 ft encased in 8-in. pipe filled with oil-wax. The complete installation is shown in Figure 13.

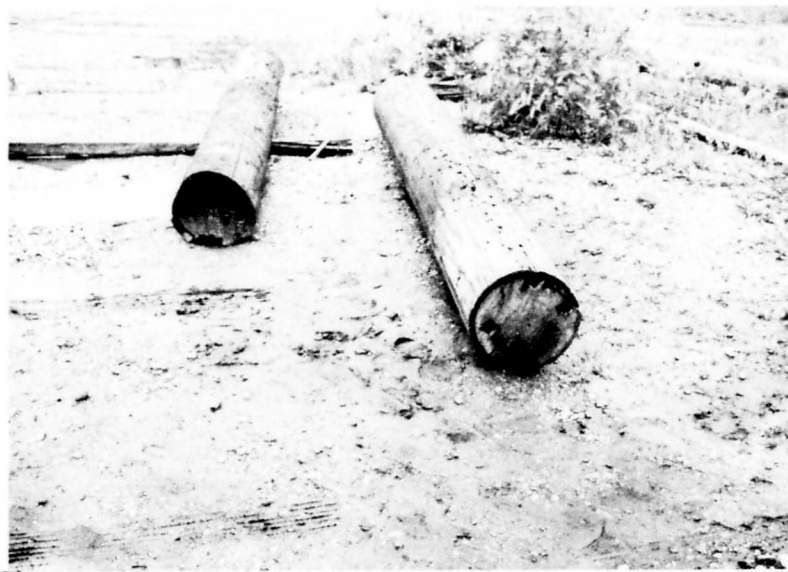
Figure 15. End view of timber test pile - 1962-1963 test.

The timber test and dummy pile sections were cut from the creosote-treated butts of power poles. Both pile sections were 10.0 ft in length and the average diameters of the heave and dummy piles were 14.03 and 12.13 in., respectively. To provide for the passage of the 1 in. diam rods through the timber test pile, longitudinal slices were cut along two sides of the pile and four  $1\frac{1}{2}$ -in. slots were then cut out of the pile. The two sections sliced from the pile were then replaced in their original positions and refastened to the pile with nails, as shown in the end view of the piles in Figure 15. The test pile was installed 6.5 ft in the ground, and the bottom of the dummy pile was installed 6.25 ft below the ground surface.
