AEDC-TR-66-123

**VACUUM DEPLOYMENT TEST  
OF A LARGE EXPANDABLE  
AEROSPACE SHELTER**

**F. W. Nelms  
ARO, Inc.**

**August 1966**

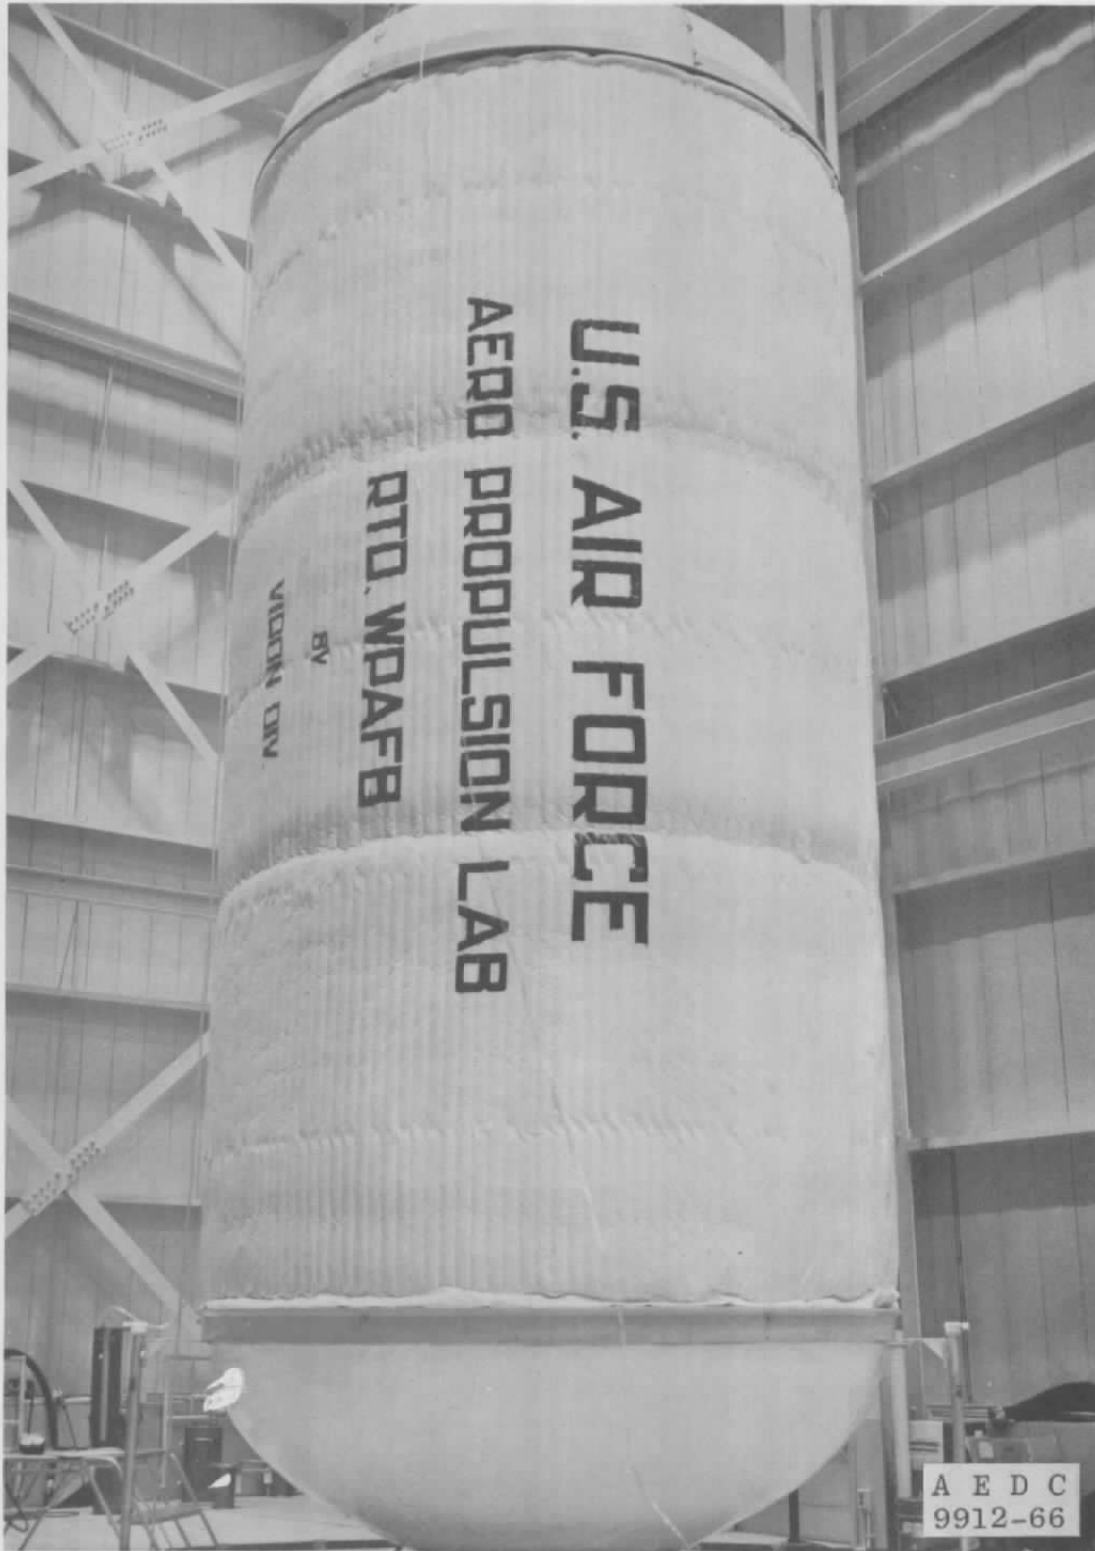
Fig. 6 Deployed Expandable Aerospace Shelter

The test article is shown in the packaged and deployed condition in Figs. 5 and 6, respectively. The structure is similar to the models tested earlier in the Aerospace Research Chamber (12V).<sup>1</sup>

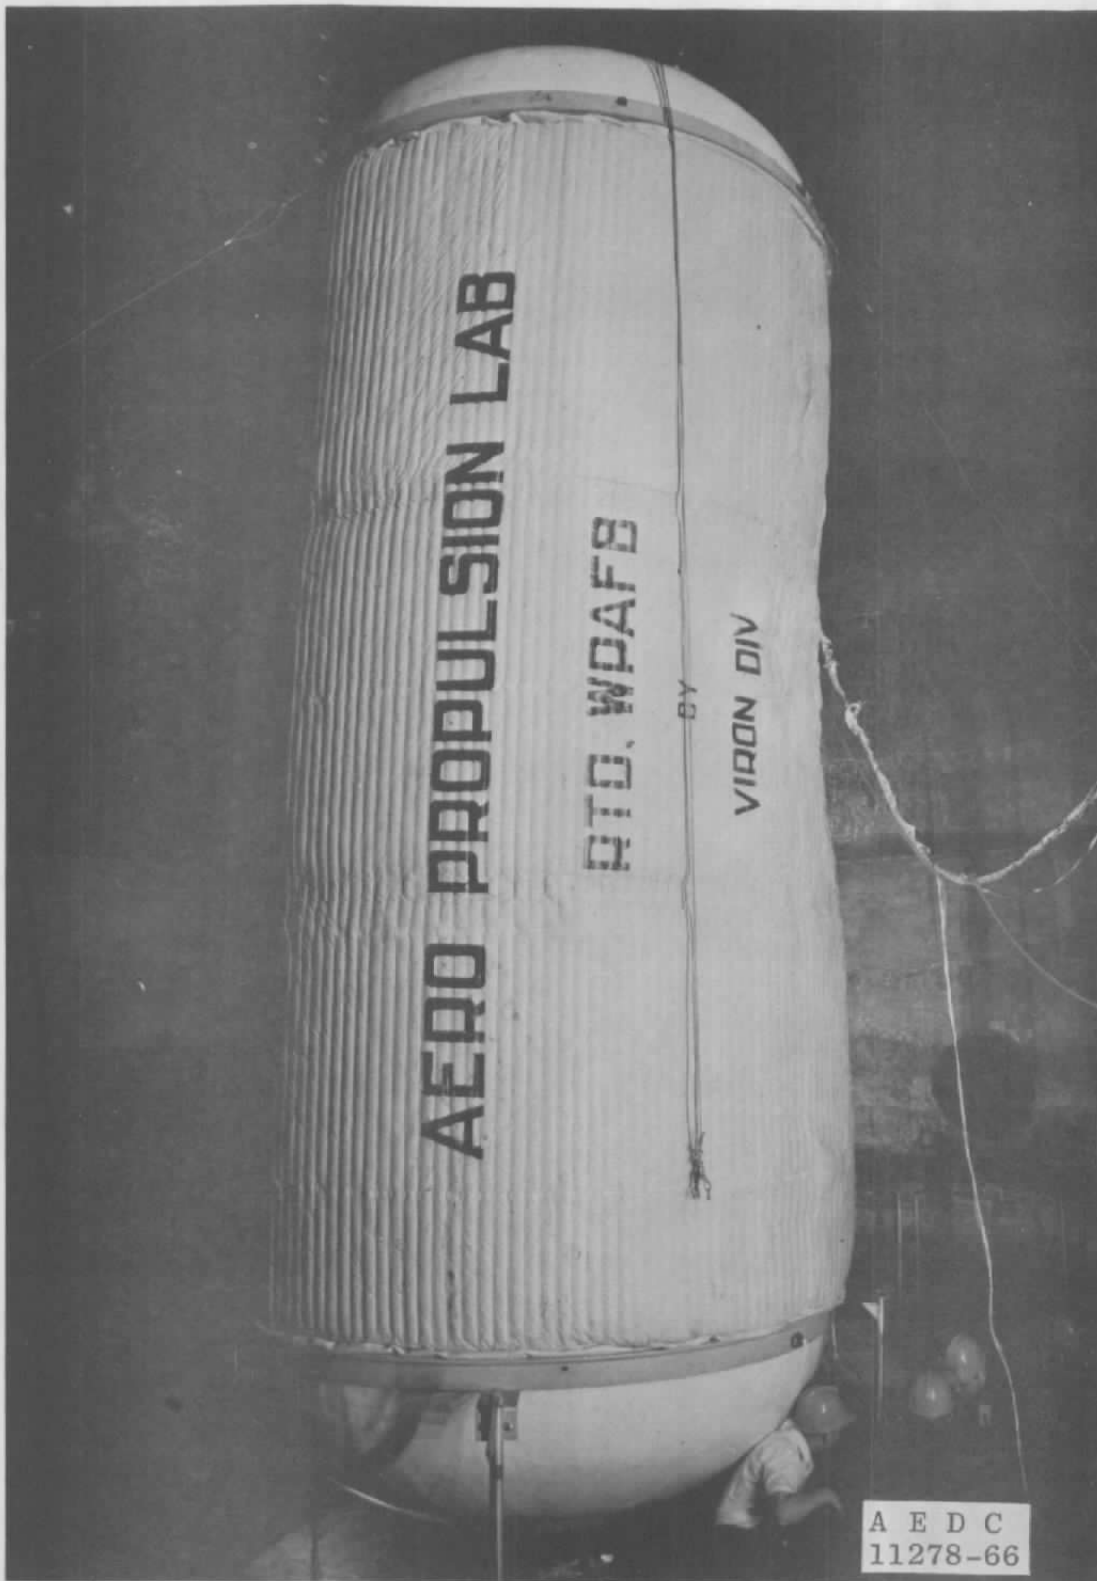
Fig. 10 Expanded Shelter during Rigidization

The second configuration, the resin-impregnated shelter minus the Gemini model, is shown during installation (Fig. 8). The expanded cylinder during rigidization is shown in Fig. 10.

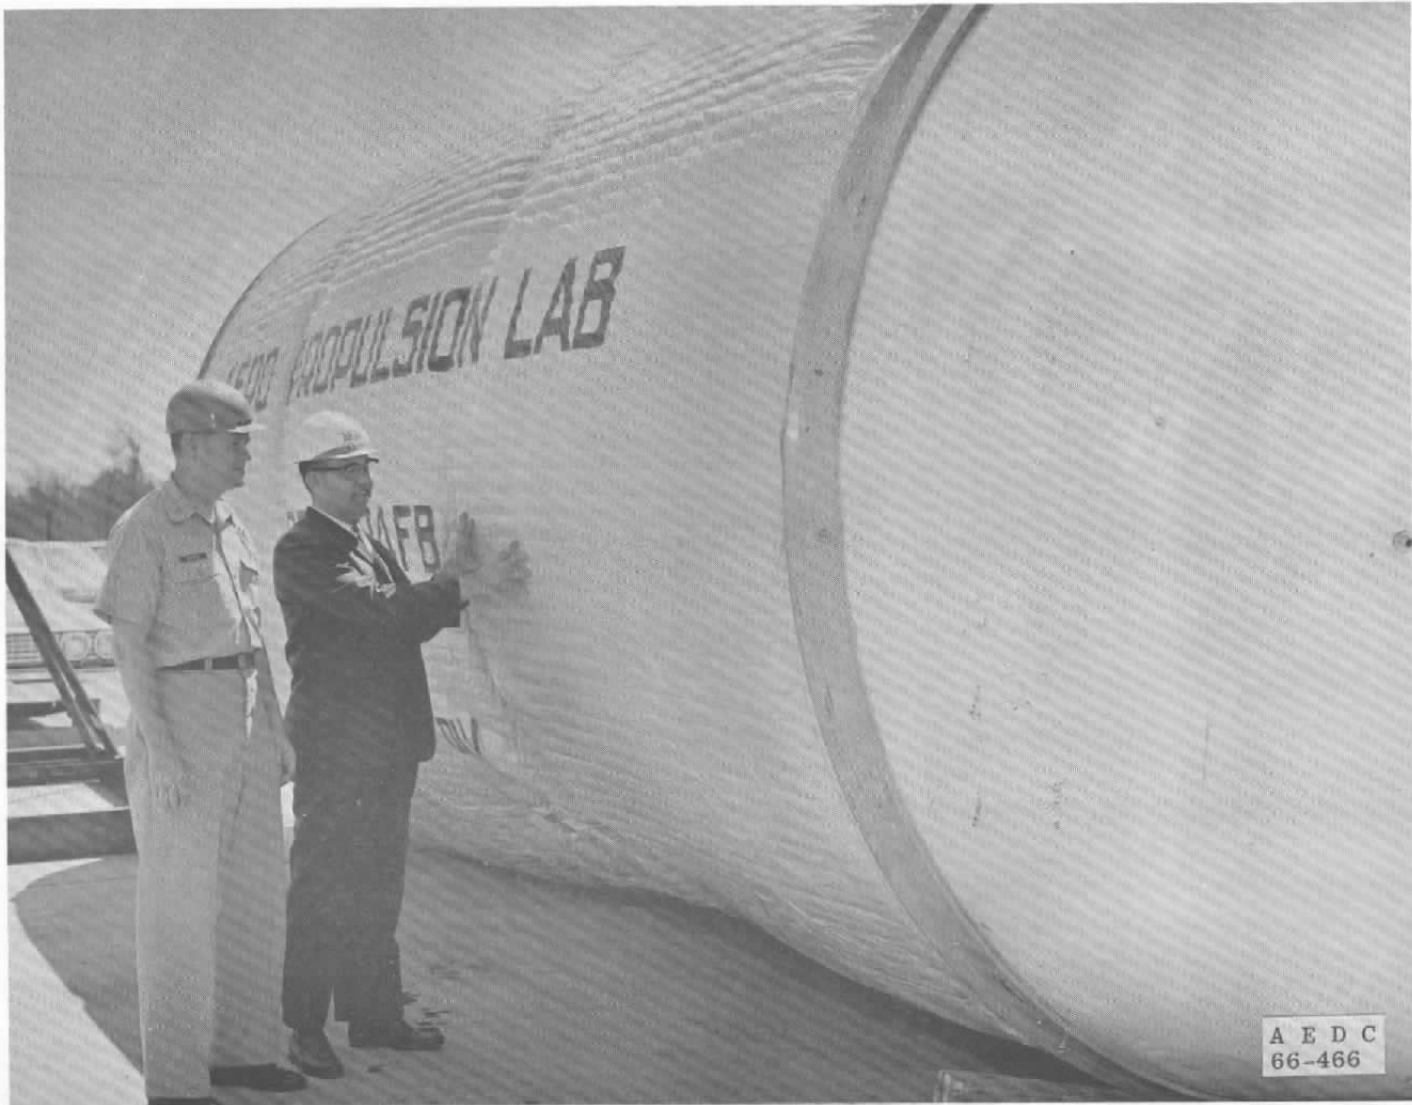
Fig. 16 Expanded and Rigidized Shelter

The test run was not completely successful. All systems operated normally until immediately after the firing of the explosive bolts. Complete deployment of the cylinder occurred almost immediately after the bolts released the restraining ring. The cylinder expanded unevenly, bending and leaning toward the side containing the heavy, eccentrically positioned floor. Figure 13 shows the shelter floor location. The expansion rate and the asymmetrical weight distribution caused the almost fully expanded shelter to fall to the chamber floor. The bending moments on the load cells in the support stands destroyed the cells. The pressure transducers, catalyst valves, and catalyst tank were torn from the upper bulkhead when it struck the floor and side of the chamber. Figure 14 shows the shelter 1.125 sec after deployment began. Figure 15 shows the upper bulkhead striking the floor and chamber wall 2.33 sec after deployment began. The violent deployment with its resultant damage precluded continuation of the test with the expanded cylinder resting horizontally on the chamber floor. The chamber was returned to atmospheric pressure. The cylinder was positioned with its longitudinal axis vertical and was pressurized to 8 in. of water gage. Rigidization of the resin-impregnated fiber glass section of the shelter was then accomplished at ambient conditions. Figure 16 shows the rigidized cylinder after removal from the chamber.

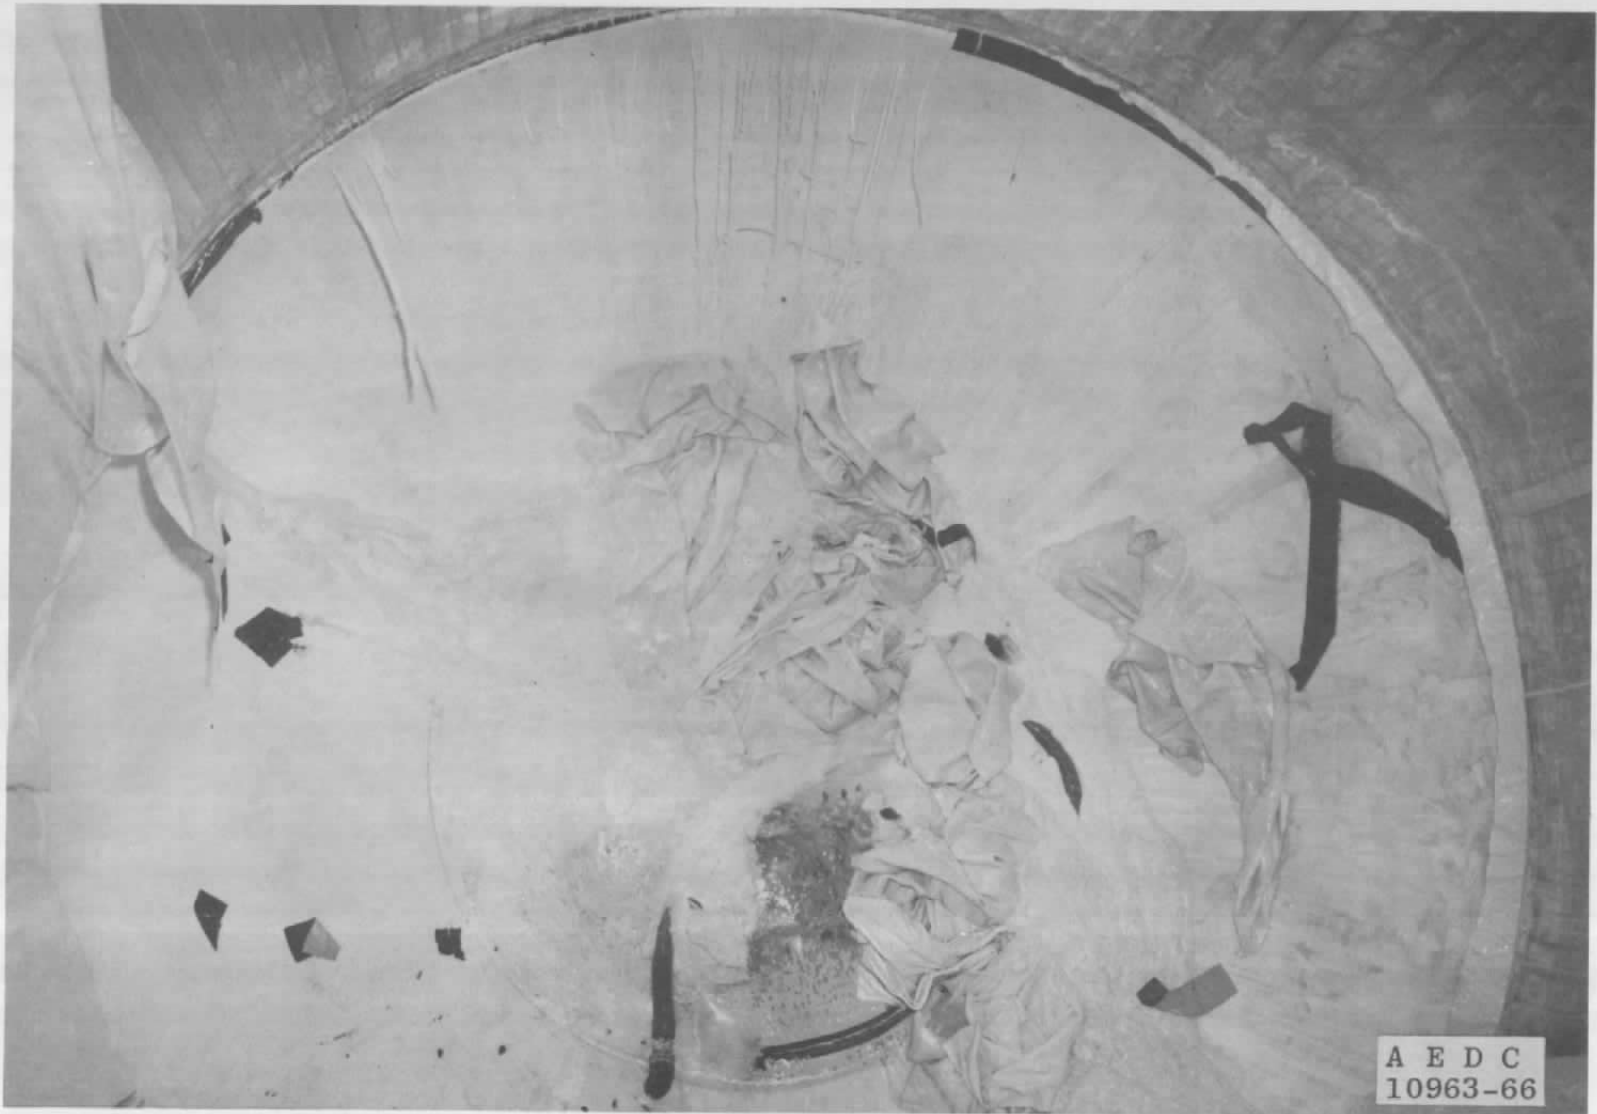
Fig. 17 Inside of Lower Bulkhead after Shelter Rigidization

The shelter was inspected immediately after removal from the chamber. Although no structural strength tests were conducted, the fabric section was examined closely and was found to be very hard and completely rigidized. Most of the damage suffered during the violent deployment and fall

was to the interior portion of the shelter. The bladder was torn from the lower bulkhead, and the fiber glass floor supports were cracked at the support-to-bulkhead joints. Figure 17 shows the interior of the lower portion of the cylinder and the bottom bulkhead.
