Project NY-013-02B-3

Technical Note N-102

COLD WEATHER TRAIL AND LIVABILITY TEST OF  
MARK III VANIGAN.

U. S. Naval Civil Engineering Research and Evaluation Laboratory  
Port Hueneme, California

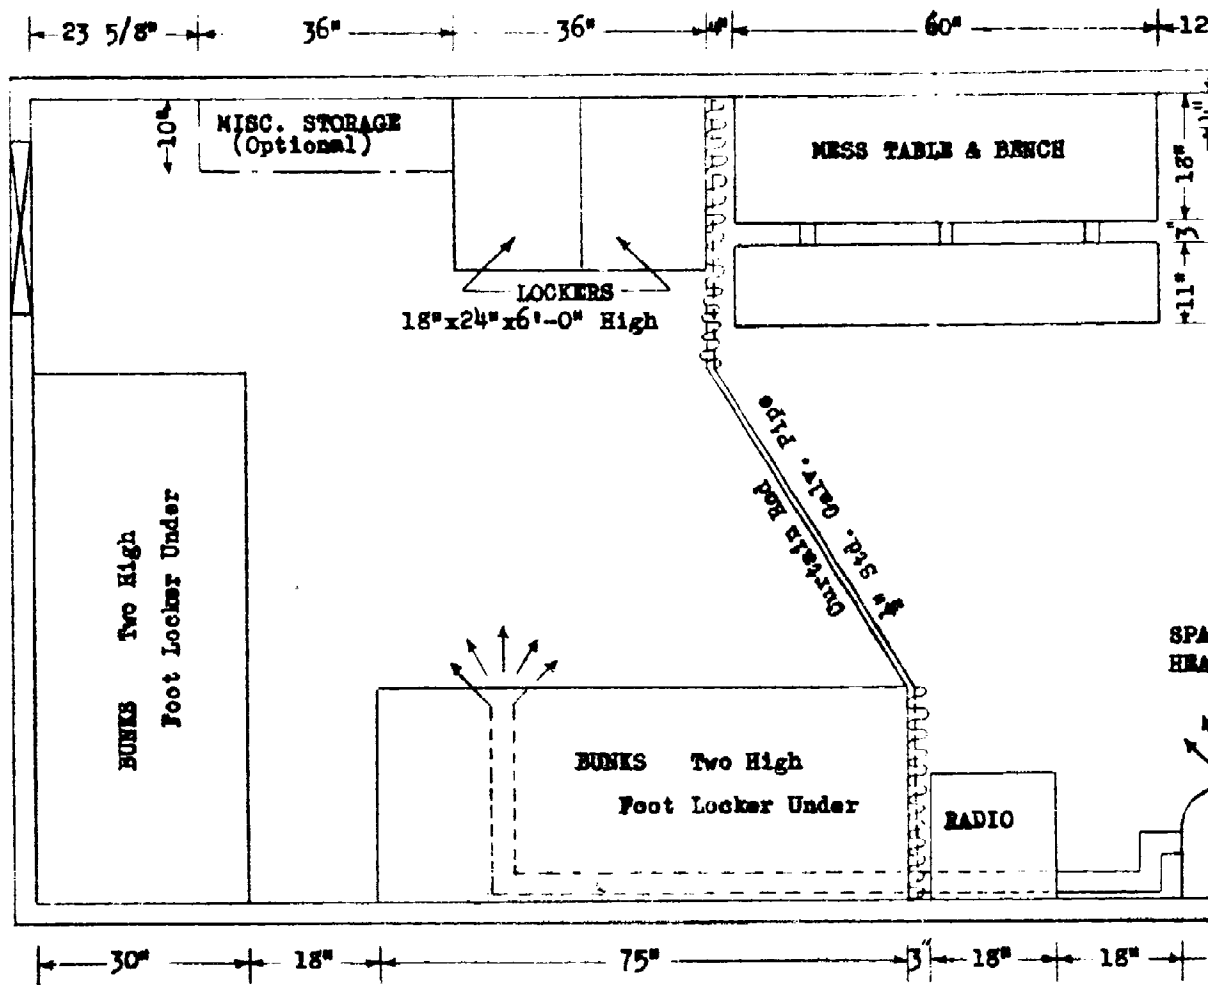
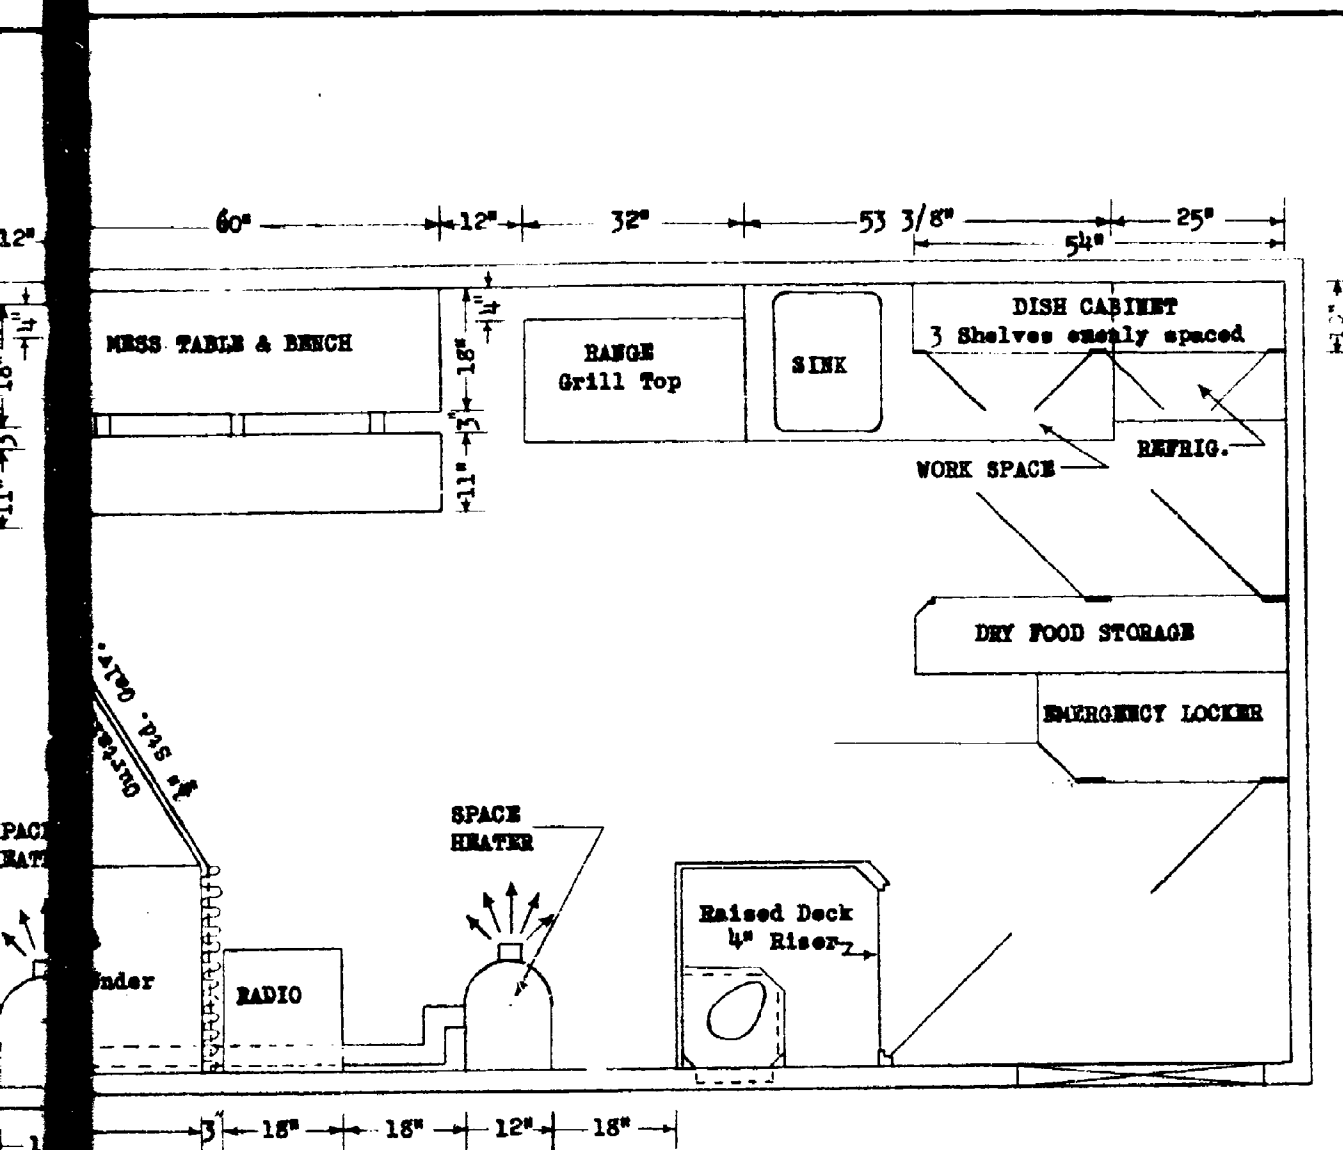
Figure 3. General layout of the Mark

**DIMENSIONS OF NEW EQUIPMENT:**

Cooking Range: 32" x 18" x 31 1/2" high  
 Refrigerator: 20" x 25" x 44 3/4" high  
 Space Heater: 12" x 16" x 36 3/2" high

General layout of the Mark III Wanigan

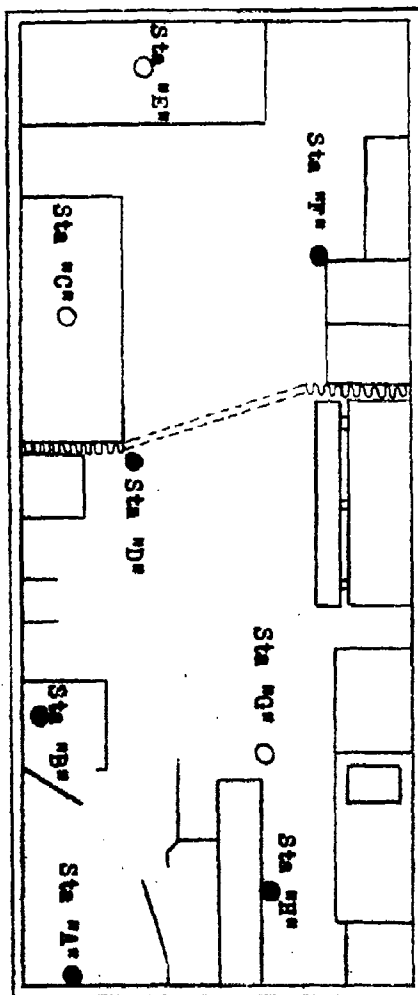
SK. 535

LOCATION OF TEMPERATURE AND AIR MOVEMENT STATIONS

The wanigan is assembled and mounted on an Arctic Type-I sled, which is twenty-four feet long and eight feet wide, two feet narrower than the completed wanigan. Brackets were fabricated and mounted on the sled to secure the wanigan. The sled "hold-downs" furnished were inadequate and were replaced the previous season at the Arctic Test Station with five lengths of 1/2-inch wire rope. Instrumentation for the tests consisted of a set of thermocouples to measure temperatures at various stations as shown in Figure 4, and an anemometer to record air movements within the wanigan.
