Operation TEAPOT

Project 3.6

EVALUATION OF EARTH COVER AS PROTECTION
TO ABOVEGROUND STRUCTURES

Report to the Test Director

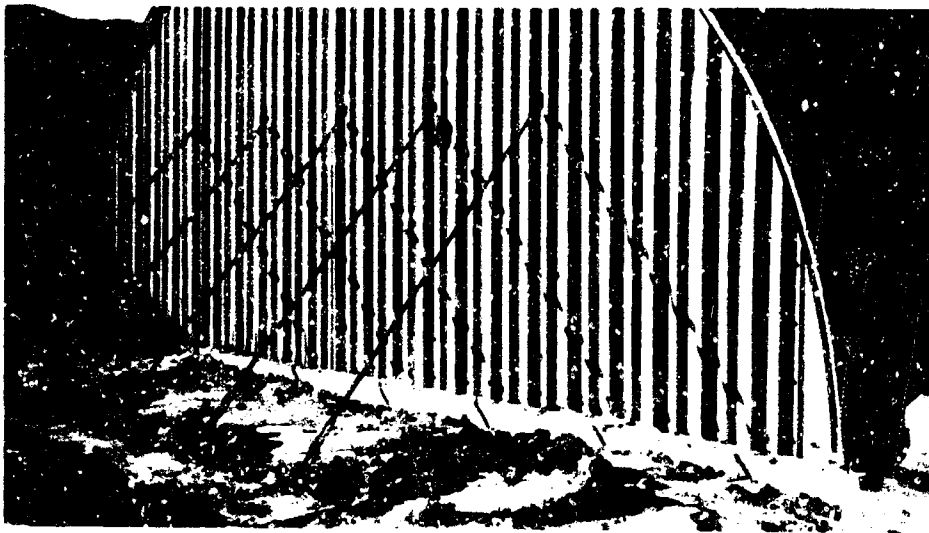
Figure 2.4 End-wall strengthening.

The rear-end wall of the building was reinforced by diagonal tension bracing as indicated in the photograph and sketch of Figures 2.4 and 2.5. It is to be noted that the dead man on the outside of the building could safely be placed flush with original ground level because it had at the time of the blast both the load of some 15 feet of earth cover on it and some additional air pressure loading. As noted in Section 1.2, this reinforcement of the end wall was intended simply to strengthen the end wall for this specific test so that its performance would not interfere with the evaluation of the strength of the arch in the center plane where it is not appreciably supported by the end walls. The design of the bracing did not include consideration of the possible stresses if the building had been oriented end-on to ground zero.

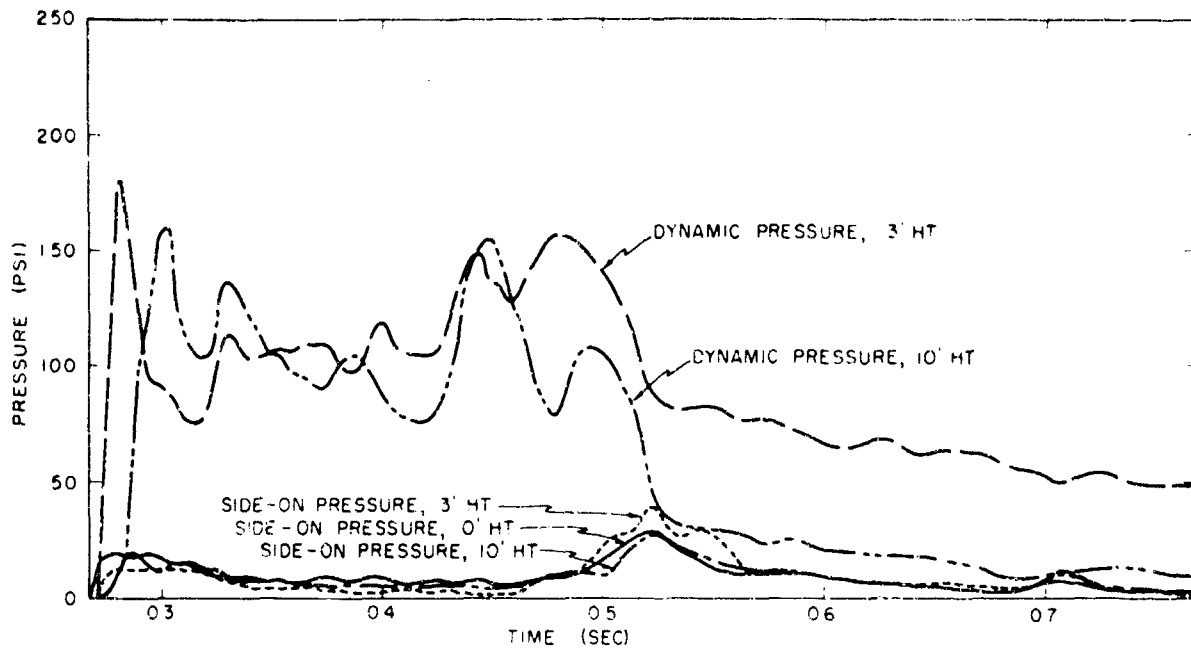
Figure 4.1 Pressure-time, desert line, 1,500 feet.

Figure 4.1 presents the measurements of the blast effects from Shot 12 in the open on the desert line at 1,500 feet. The peak dynamic pressure of 160 psi shown on Figure 4.1 at a 10-foot height is equivalent to a wind velocity of about 3,000 mph in clear air at sea level. It will be noted from this figure that: (1) the dynamic pressure was much larger than the side-on overpressure; (2) all the pressure curves show two major peaks separated by the order of 100 or 200 msec; and (3) there is a significant difference between measurements taken at a 3-foot height and those at a 10-foot height. In addition, it should be remarked that the curves shown on this figure have been considerably smoothed in the data-processing procedure. The original gage records, as reproduced in Reference 4, show numerous short-time variations having periods ranging between 2 and 10 msec. Both these short-time variations and the apparently unrelated differences in the q measurements at 3 feet and 10 feet may well have been the result of severe turbulence.

prototype; this model was not collapsed although it did sustain rather extensive crown deflection. There was no blastline station at 1,400 feet; by interpolation between measurements at 1,250 feet and 1,500 feet, the peak dynamic pressure at a 3-foot height at 1,400 feet was 200 psi. At 1,500 feet the peak dynamic pressure at a 3-foot height was 180 psi (Figure 4.1). At 2,000 feet it was 64 psi.

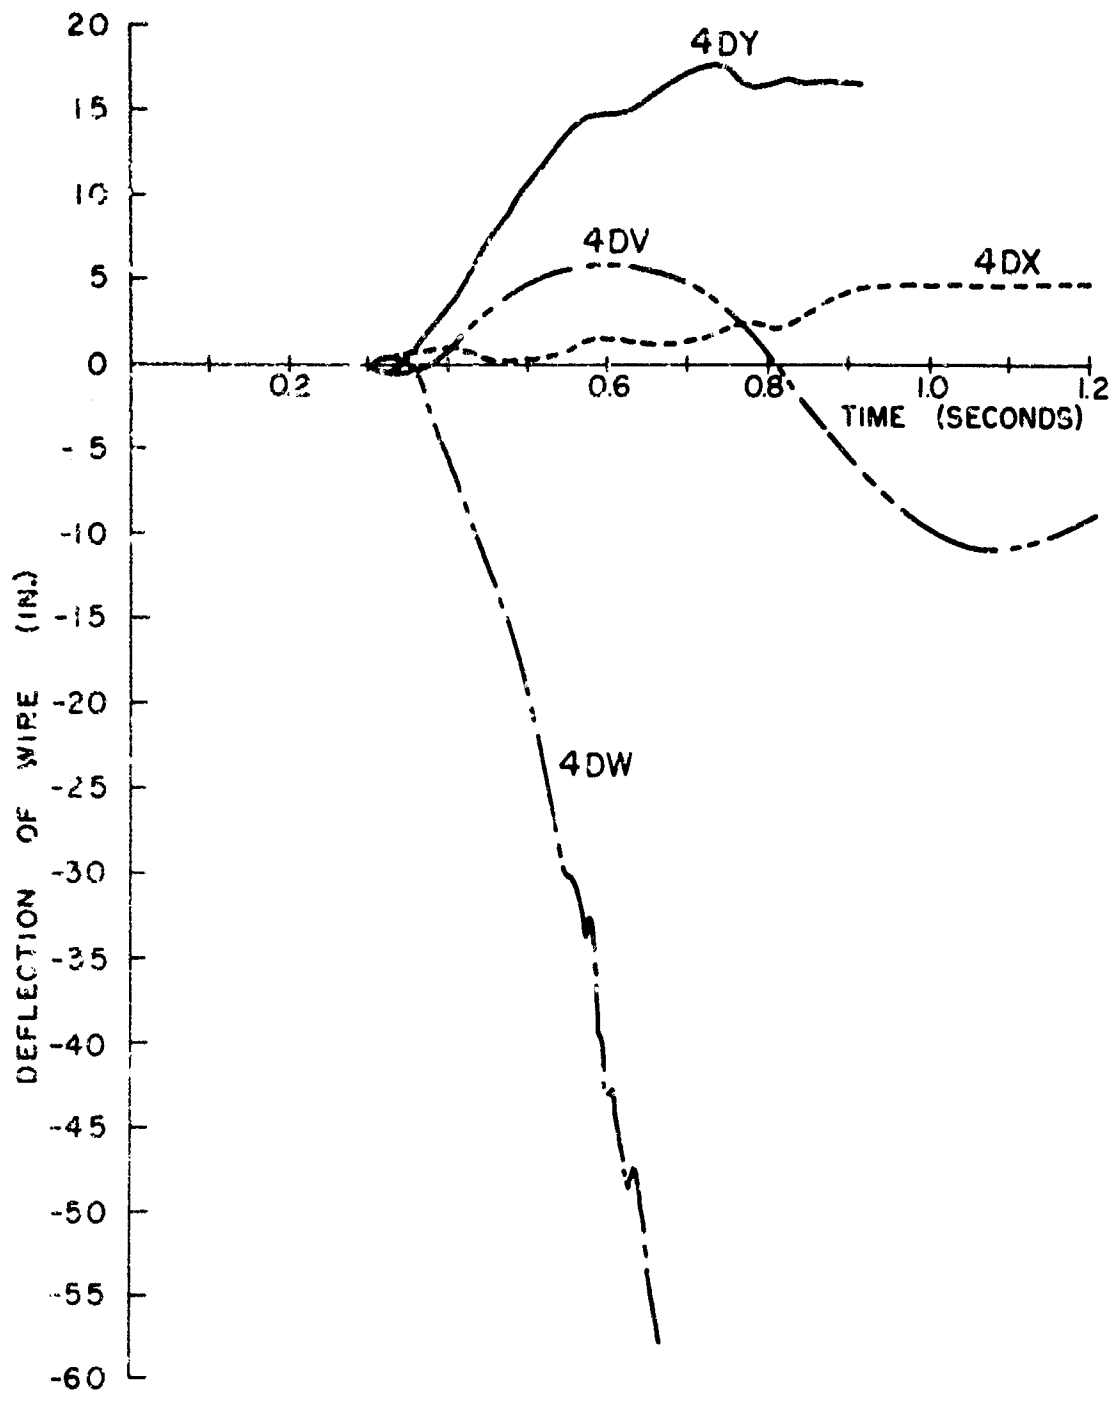
Figure 4.7 Deflection gage records, Building 3.6.

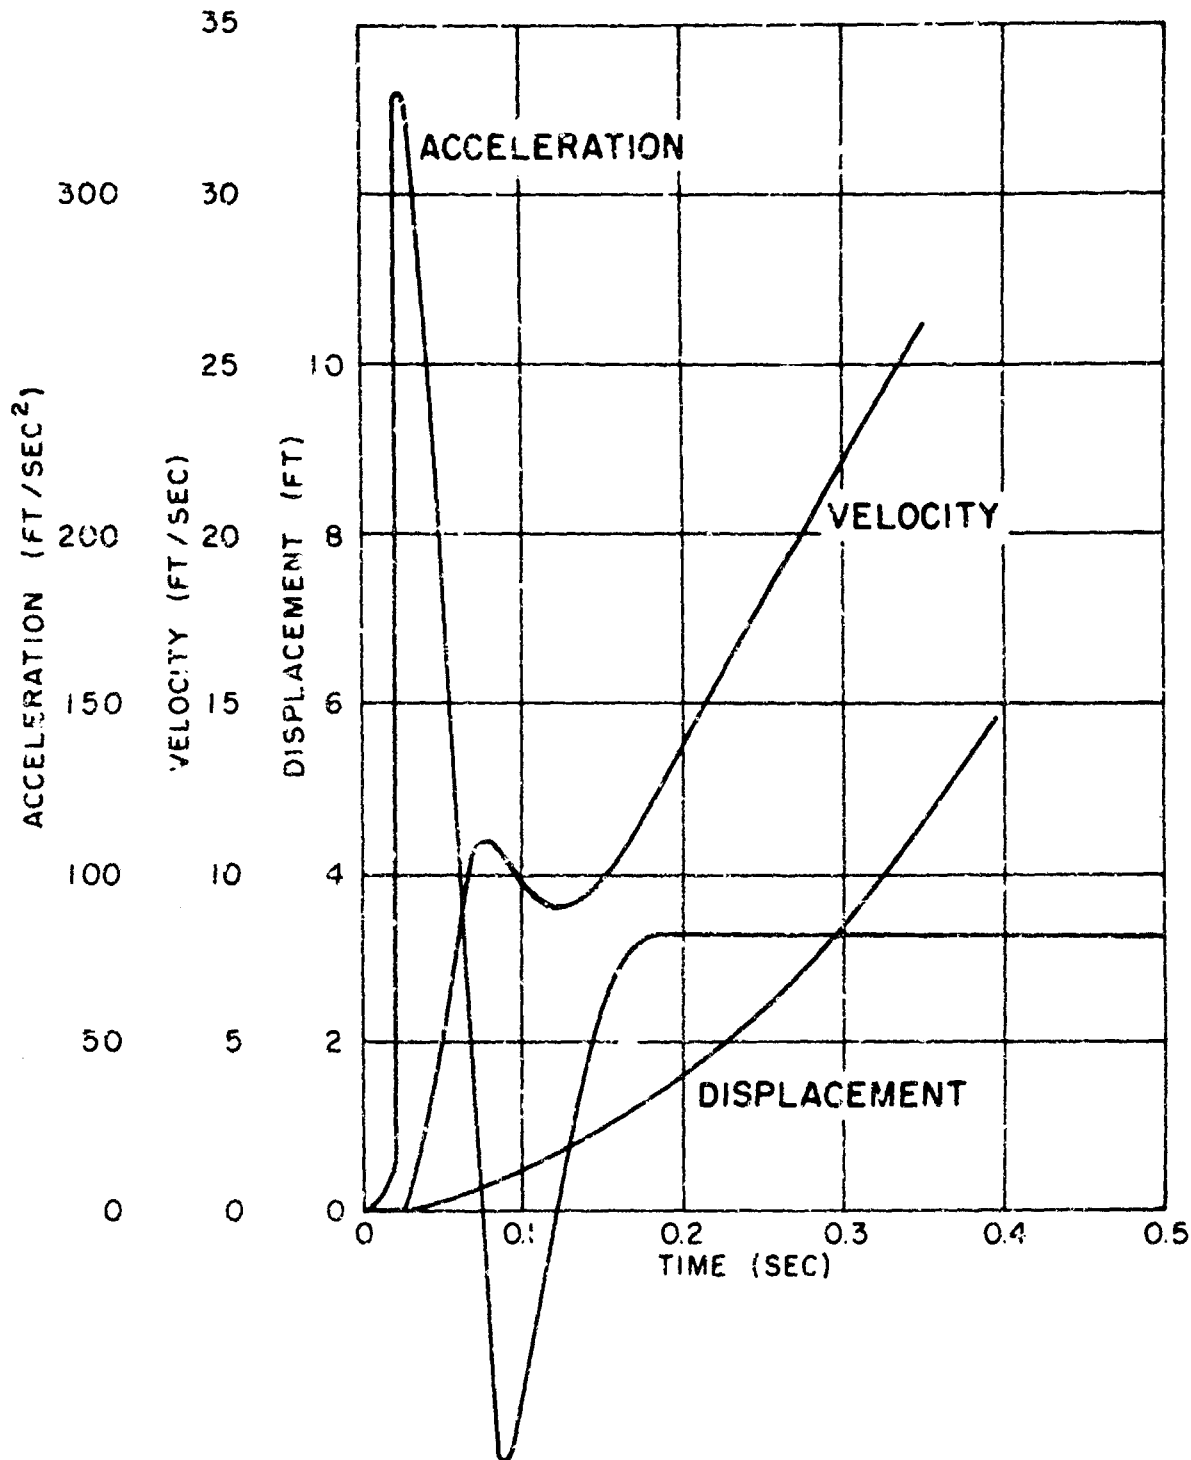
Figure 4.9 Approximate response of the windward haunch, Building 3.6.

The significance of the analysis indicated in Figure 4.9 is simply to confirm the reasonable nature of the assumptions required in the development of Figure 4.8 from the measured displacements shown in Figure 4.7. Actually Figure 4.8 was drawn in the form shown here because this analysis performed on the alternative forms for Figure 4.8 did not show the same good comparison with the actual pressures applied.

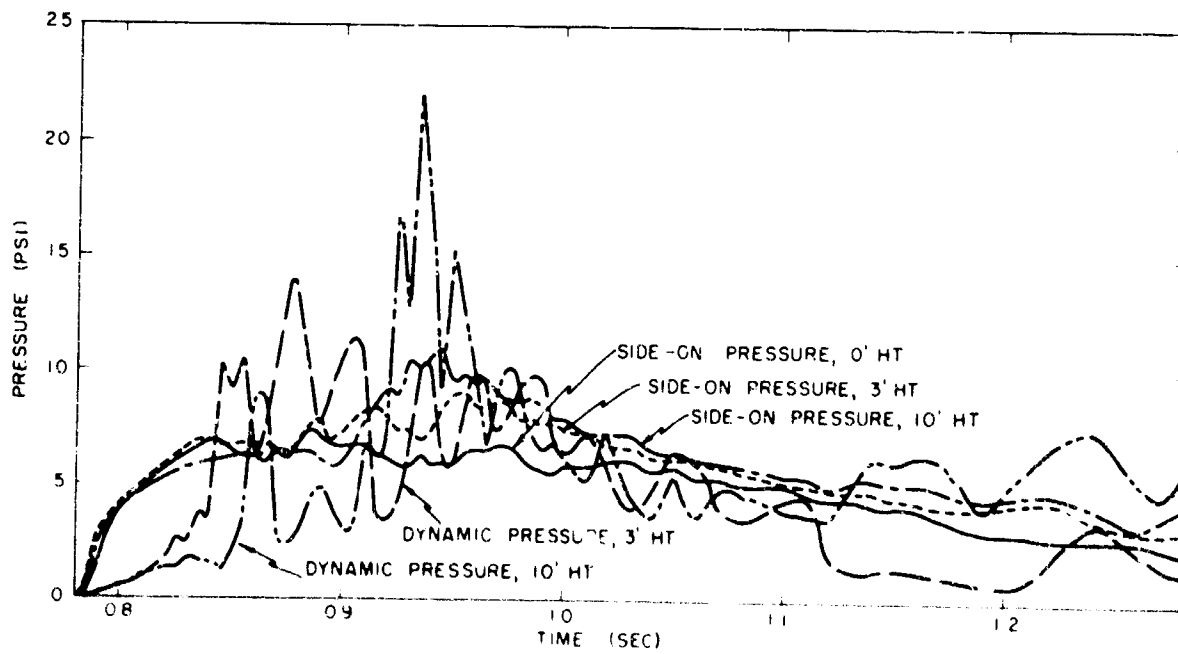
Figure 4.14 Pressure-time, desert line, 2,500 feet.

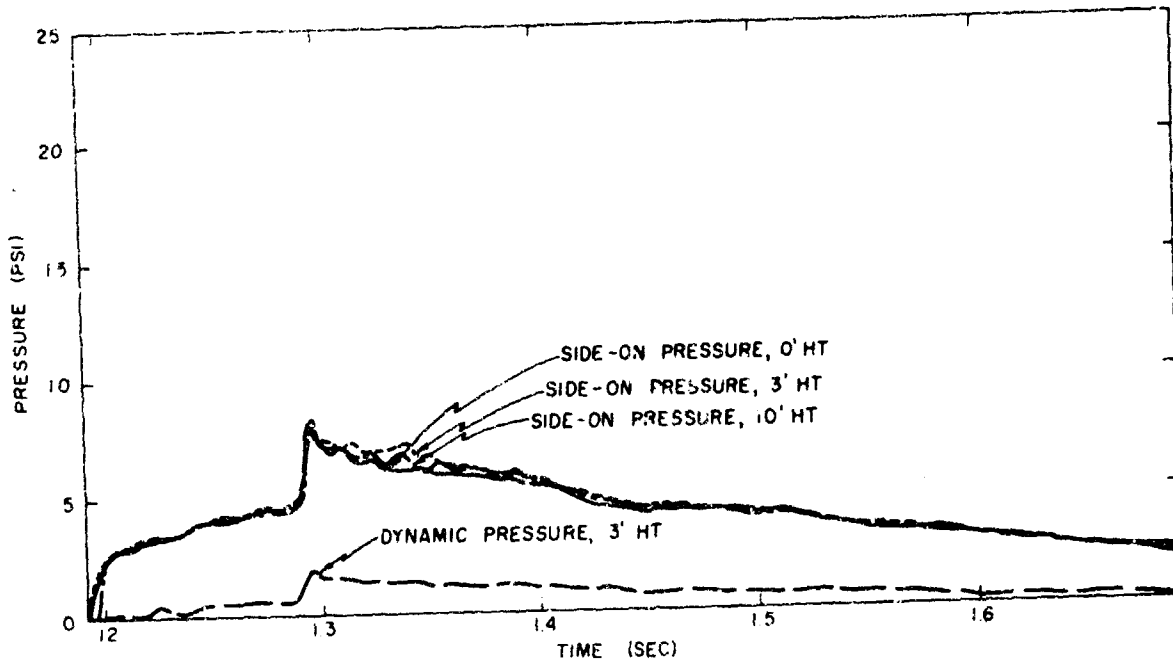
Figure 4.15 Pressure-time, desert line, 3,000 feet.

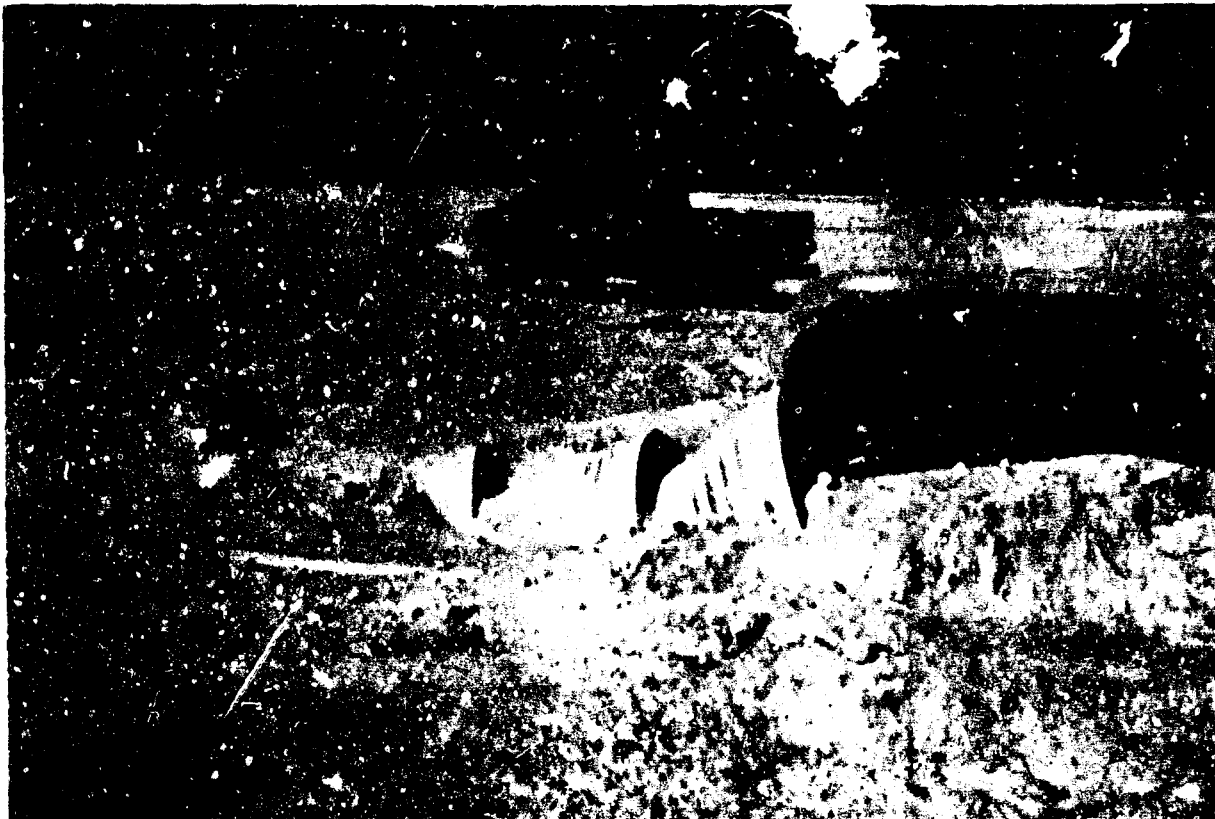
Figure 4.17 Model 2, 1,500 feet.

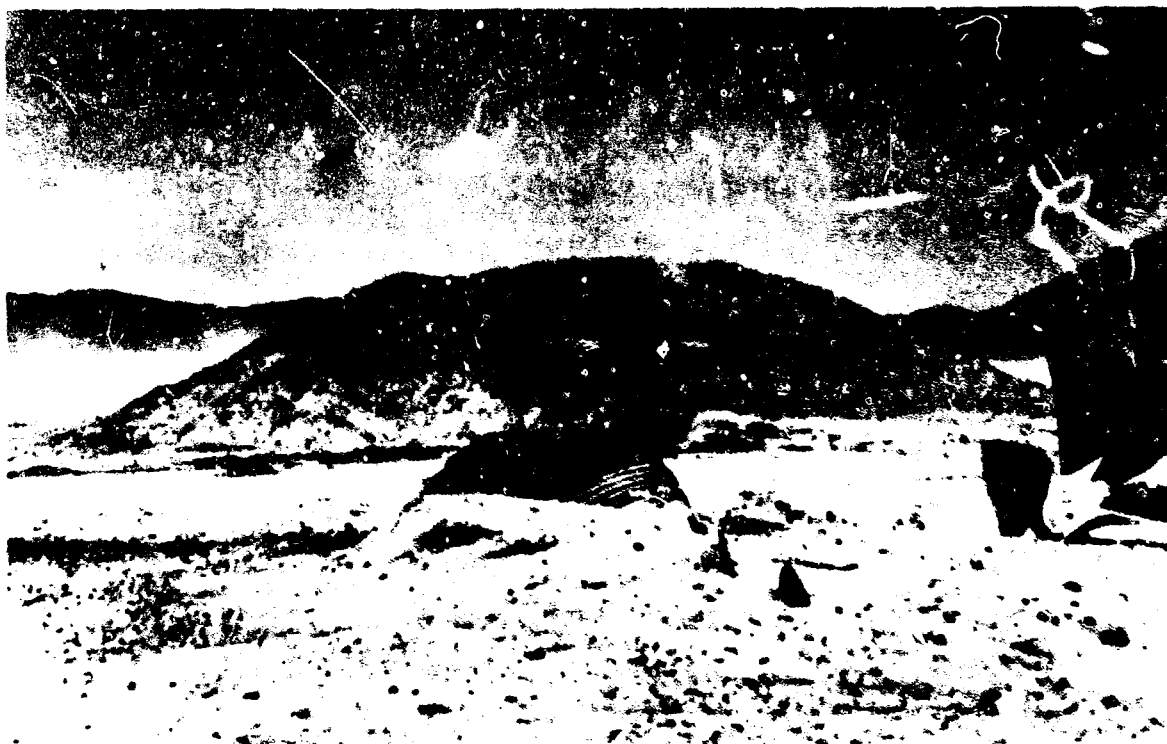
Figure 4.18 Model 2, 1,500 feet.

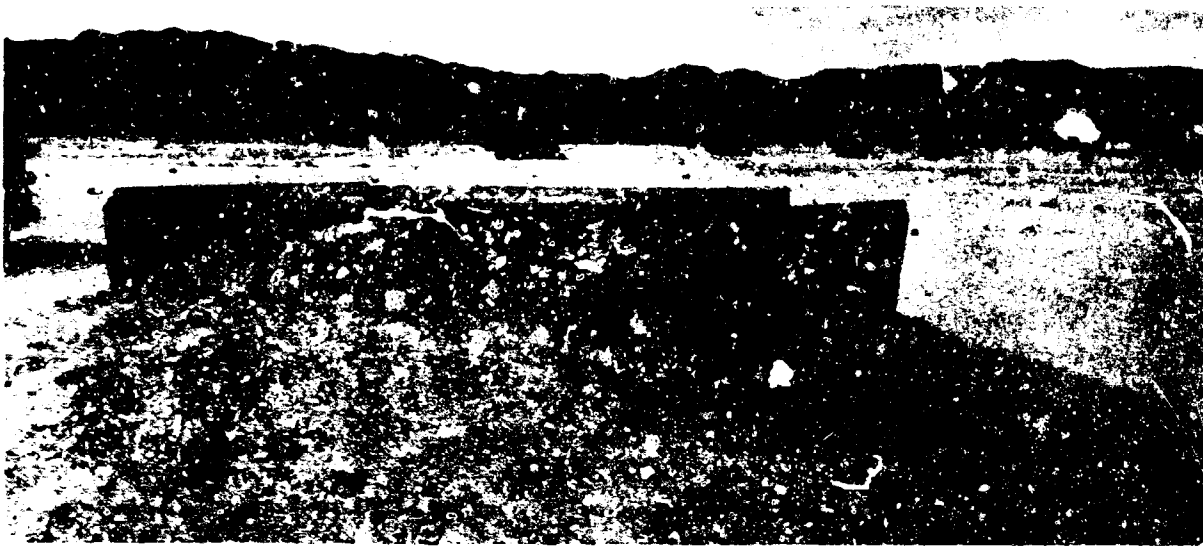
Figure 4.20 Model 5, 2,500 feet.
