REPORT OF CONSTRUCTION

CHANNELIZED TEST TRACKS
SHARONVILLE, OHIO

TECHNICAL REPORT NO. 4-7
MARCH 1957

PREPARED BY
THE RIGID PAVEMENT LABORATORY OF
THE OHIO RIVER DIVISION LABORATORIES
MARIEMONT, OHIO

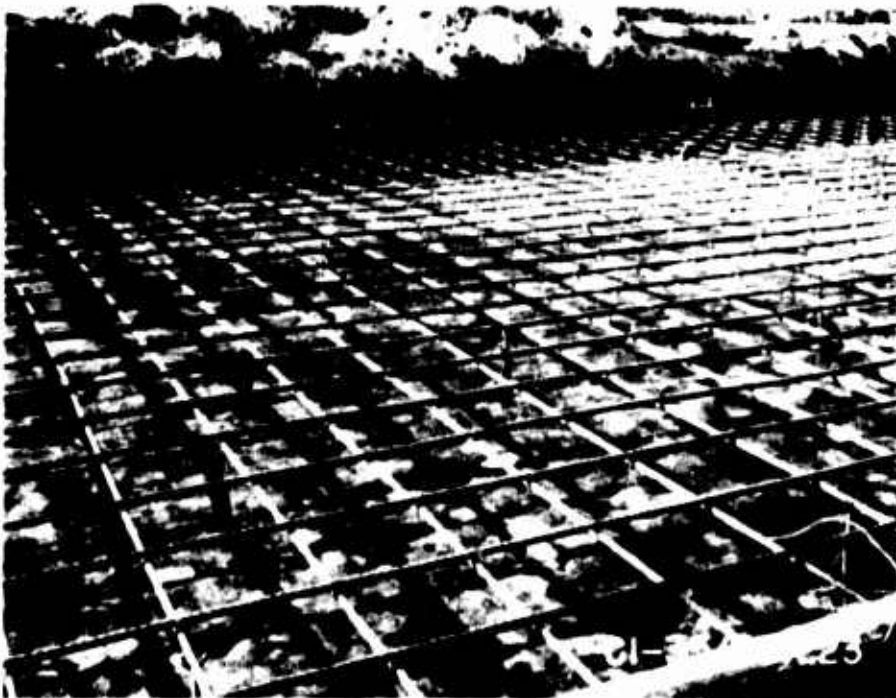
**Reinforcing Steel in Place, Item 55
Part 1, #5 on 12-Inch Centers**

d. Concreting: During concreting operations no difficulty was experienced in depositing the concrete on the steel although some sagging was noted in the #3 sections.

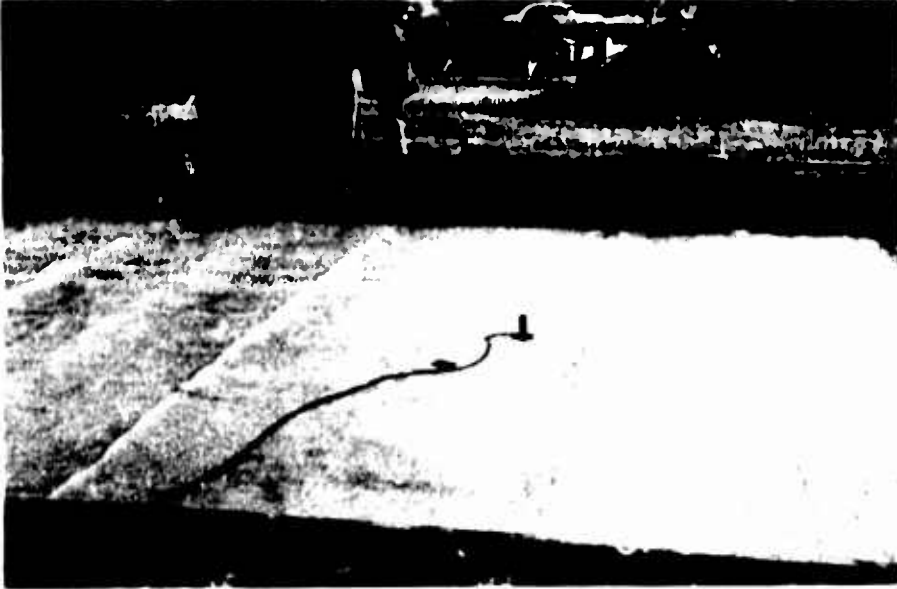
**Plastic Membrane and Deflection Gage
Item 59 - Prior to Concreting**

a. General: In order to control pumping at joints, plastic membrane was specified under Item 59; no material other than subgrade paper is present under Items 57 and 58. Membrane furnished by the Contractor was obtained from the Scioto Supply Company, Columbus, Ohio and was a flexible polyvinyl chloride. This material came in two sheets 24 1/2" wide and 45' long. Thickness of each sheet varied from .0185 to .0190 millimeters. All seams were closely examined and found to be as strong as the unseamed material.

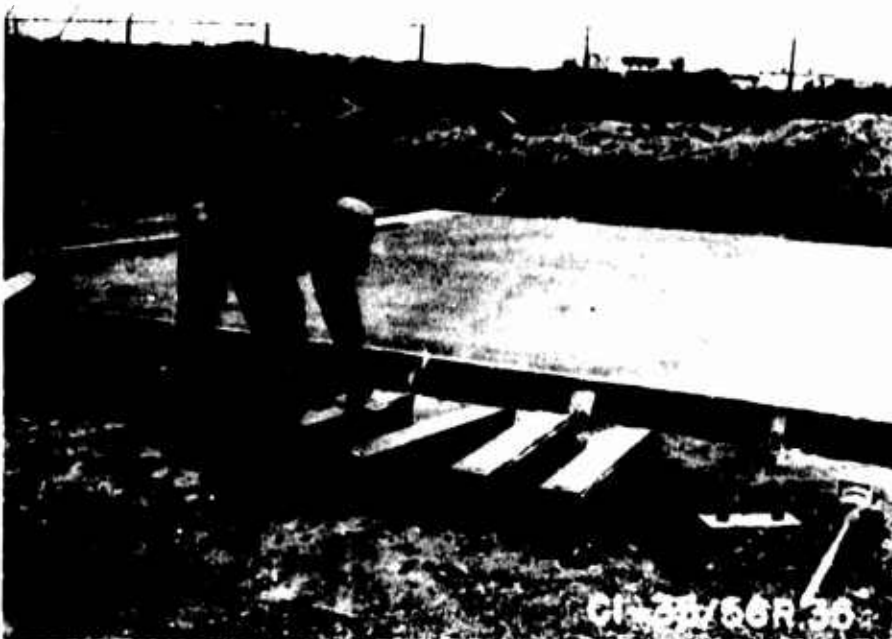
Field Beams for Laboratory Testing
Part 1

to add water to the truck contents when the concrete could not be deposited from the truck. Four 6 x 6 x 36-inch beams were made from representative concrete in each Item of both tracks. Two of the beams were taken to the laboratory for curing under controlled conditions; the remaining two were deposited on a selected area to be field cured.

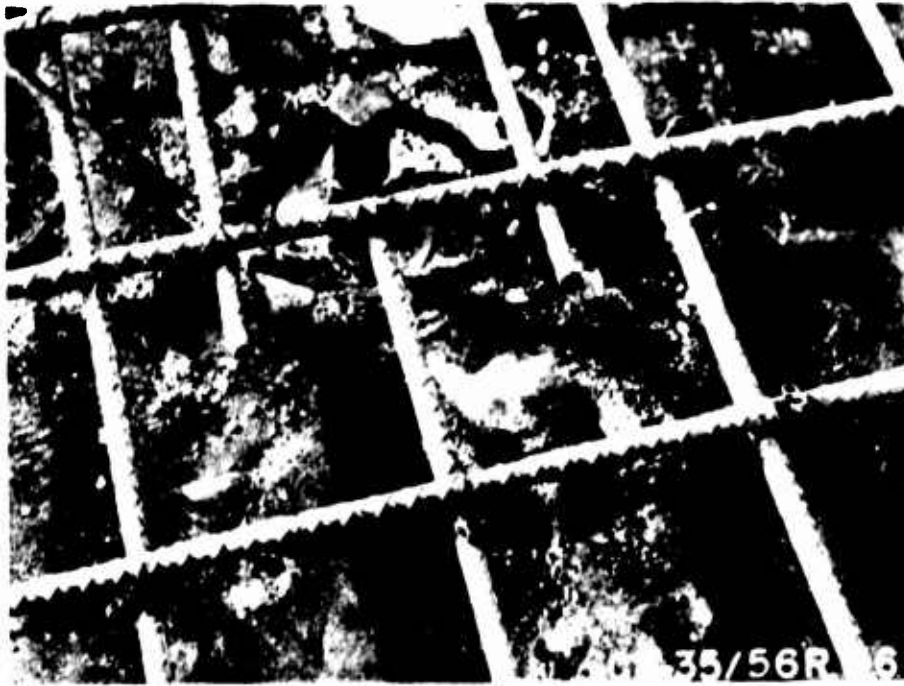
Deflection Gage Installation in Reinforced
Item - Part 2

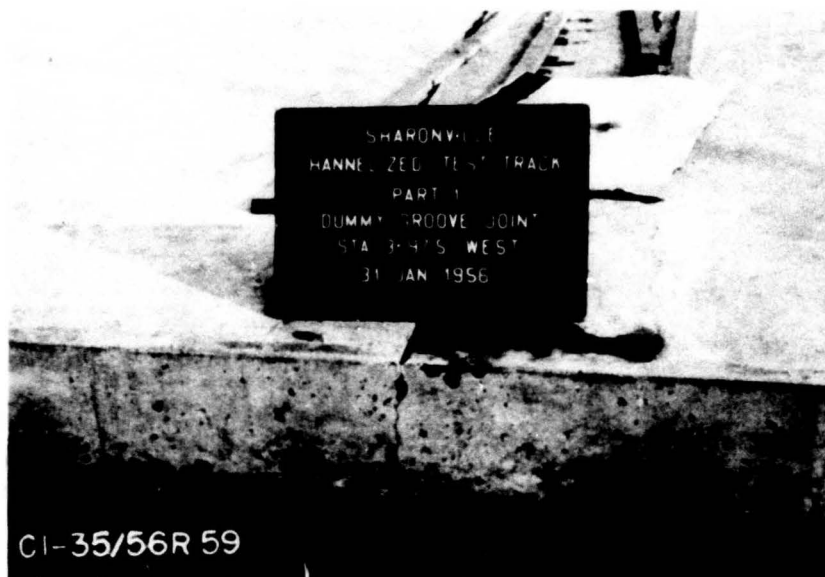
Controlled Cracking at Dummy Groove
Contraction Joint - Part 1

favorable weather with no penalty to the Contractor. Favorable conditions did not occur until early February 1956 or about one month after placement. The Contractor was prepared in advance and sealed all the joints on 7 February 1956. A jet-fuel-resistant joint seal was used identified as Aero-Sealz. This material was excess material from a recently completed job at Lockbourne Air Force Base, Ohio and had been previously tested and accepted on that project. Joint seal material was heated in a double wall Agitator-type kettle under controlled temperature and was applied with a special pressure-type joint sealing applicator. Joints had previously been blown out with compressed air and were entirely free from foreign particles and water. Inasmuch as concrete placement had taken place in cold weather, only about one-half of the dummy contraction joints had opened and these by only small amounts.
