**NAVY DEPARTMENT  
THE DAVID W. TAYLOR MODEL BASIN  
Washington 7, D.C.**

**FATIGUE TESTS OF GROUSERS FOR AMPHIBIAN TRACTORS**

**D D C  
RECEIVED  
APR 18 1967  
C  
Report 664**

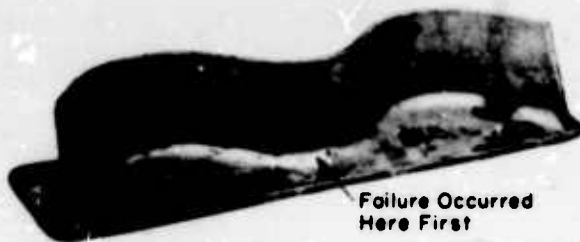
TMB 29623

Figure 6c - Design E, Cast Steel

The locations of the failures in the various designs of specimens are shown in Figure 6.

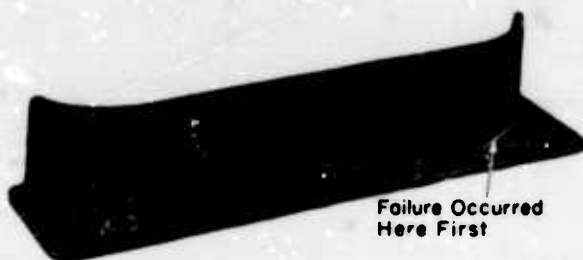
TMB 29626

Figure 6e - Design E, Cast Steel

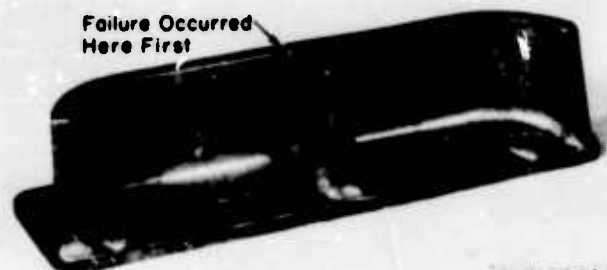
TMB 29624

Figure 6f - Design D, Cast Aluminum
