# PRESSURE GROUTING FINE FISSURES

TECHNICAL REPORT NO. 6-437

October 1956

Waterways Experiment Station  
CORPS OF ENGINEERS, U. S. ARMY  
Vicksburg, Mississippi

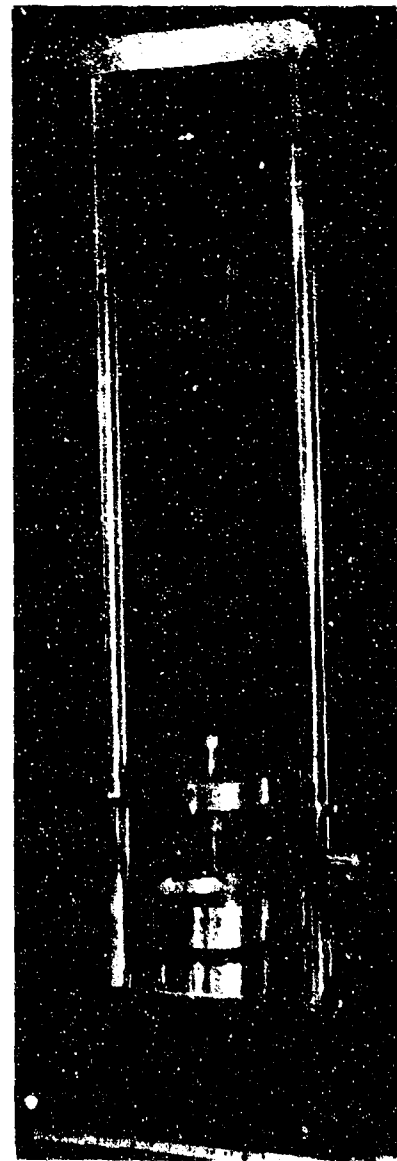
Fig. 19. Piano-wire viscosimeter

53. The viscosimeter is an instrument developed by Professor R. E. Davis of the University of California, Berkeley, and the Bureau of Reclamation. The viscosity or consistency of a slurry is measured by placing a sample in a shallow metal container mounted on a motor-driven turntable. A wire spider is suspended from a piano wire and is submerged in the sample of grout. A weight holds the piano wire taut. Torque is imparted to the spider and piano wire by the turning container of grout. The number of degrees of torque varies with the consistency of the sample being tested.
