Lab. Project 9300-44  
Technical Memorandum No. 6  
SF 020-01-02, W.U. 3406

**FATIGUE PROPERTIES  
OF  
UNCOATED AND GALVANIZED  
IMPROVED PLOW STEEL WIRES**

16 June 1967

**U. S. NAVAL APPLIED SCIENCE LABORATORY  
BROOKLYN, NEW YORK**

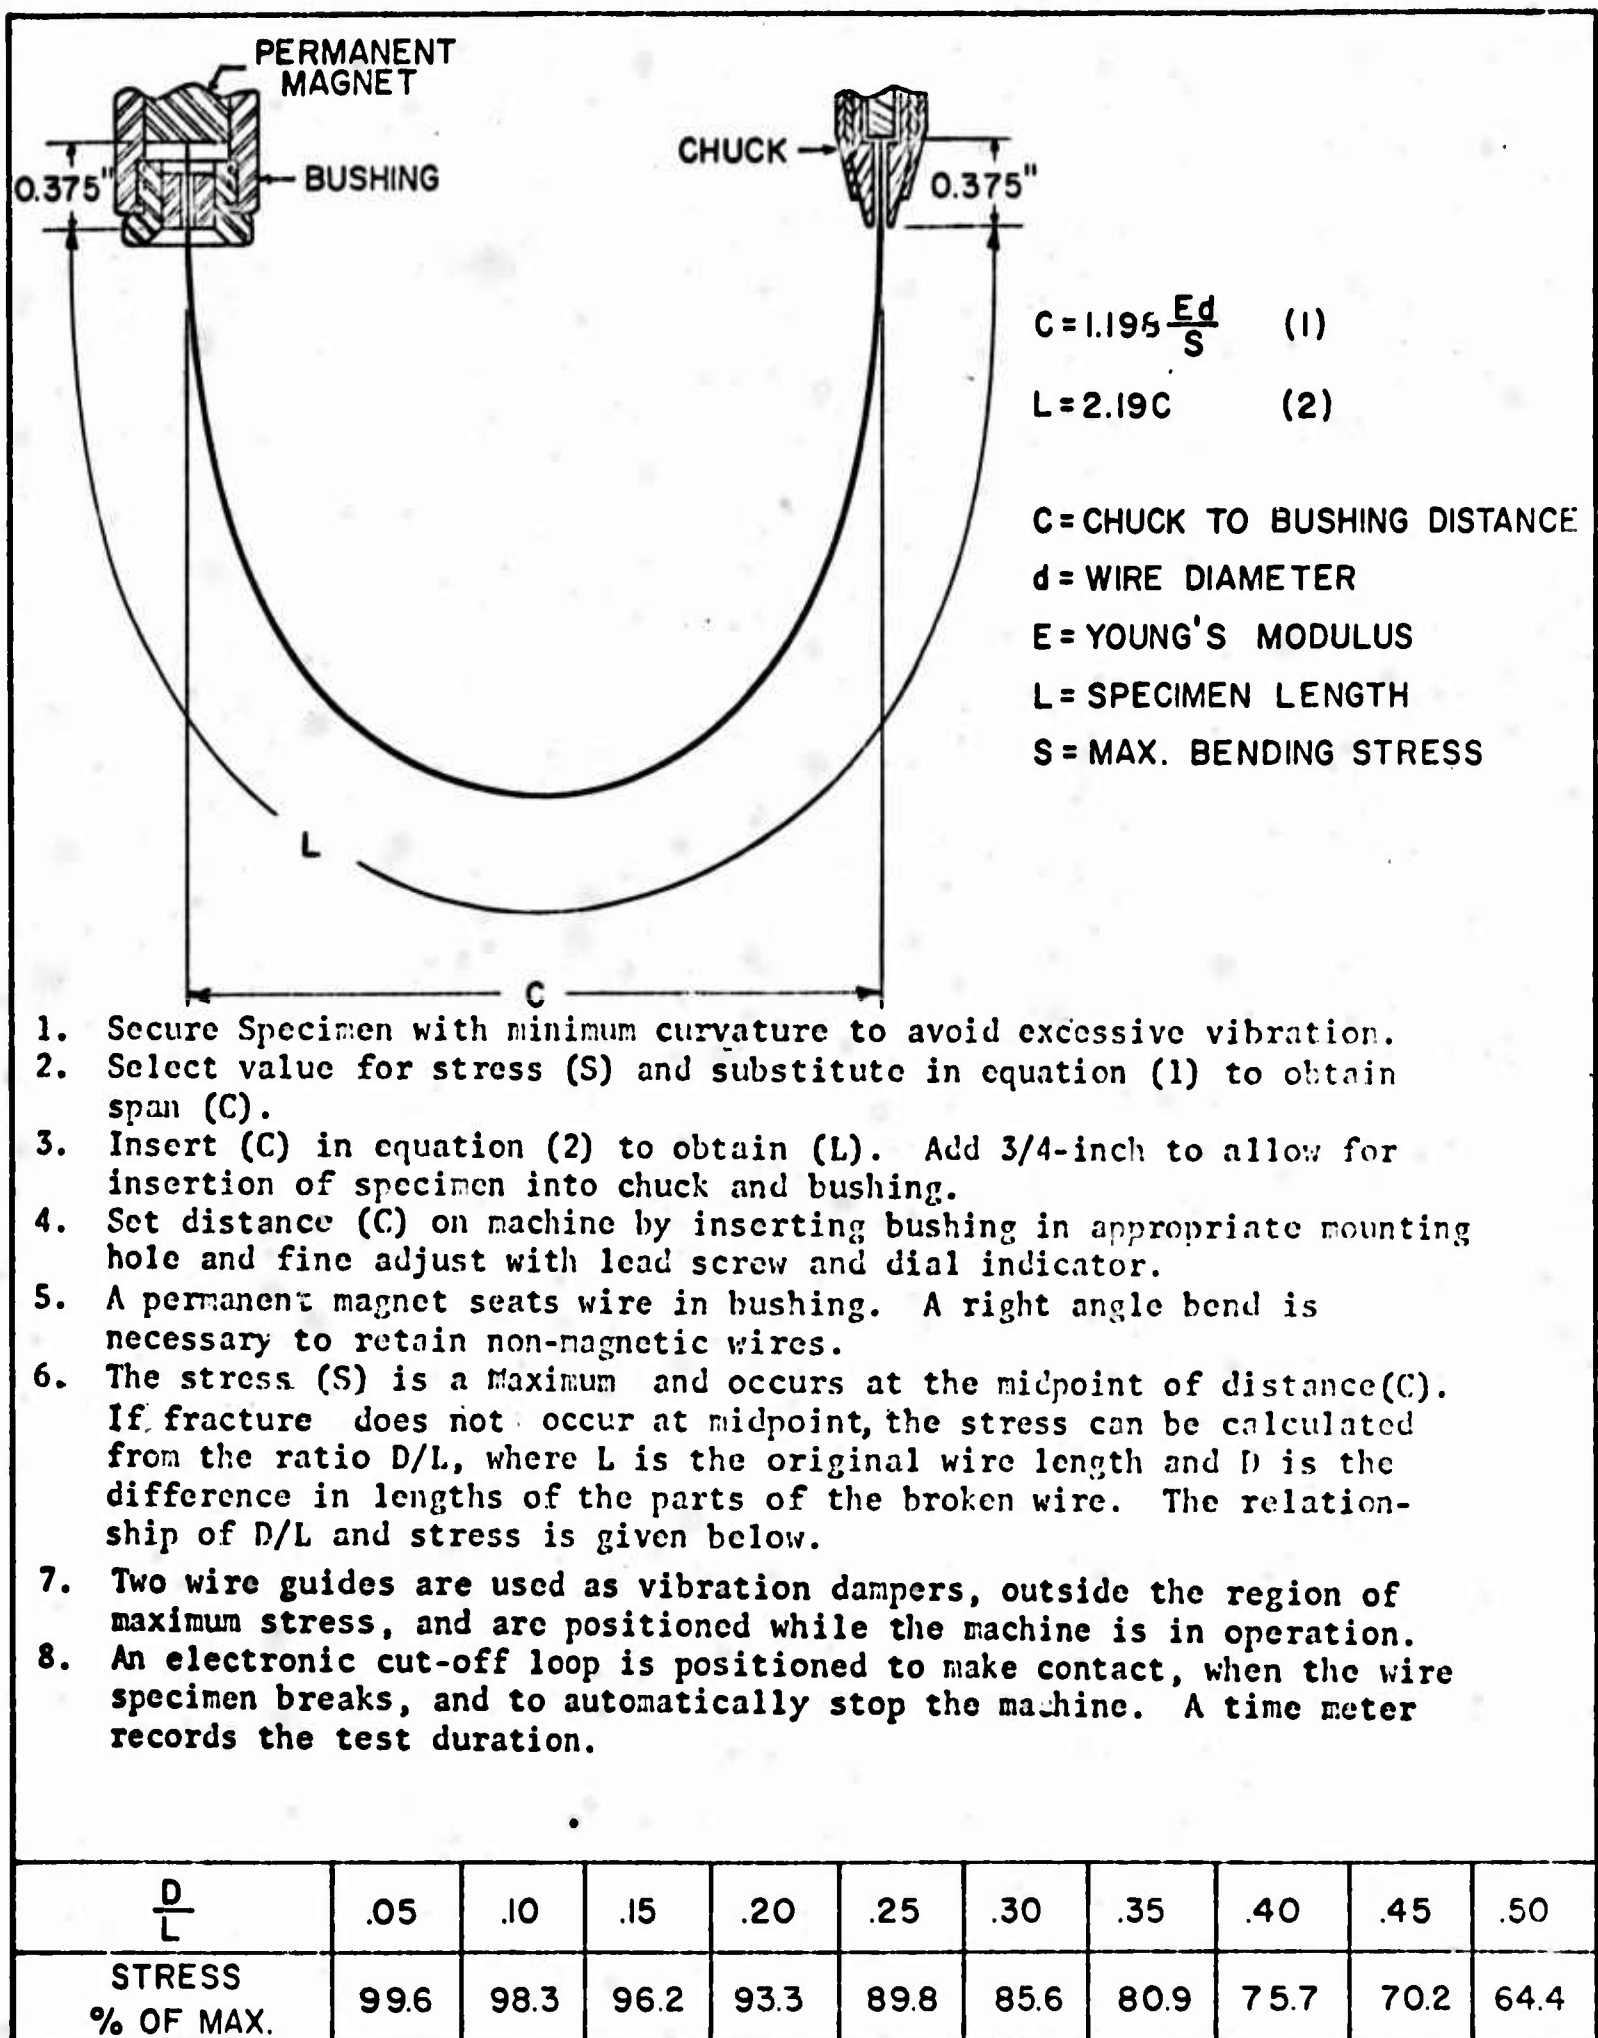
FIGURE 2 - PROCEDURE FOR SETTING UP WIRE SPECIMEN  
IN MODEL 802 ROTATING BEAM WIRE FATIGUE TESTER

2. A Model 802, Hunter Spring, rotating beam wire fatigue tester, shown on Figure (1), was used for the evaluations. The tester consists essentially of a motor-driven chuck and a magnetic bushing that is mounted in anyone of nine equally spaced holes in a bushing-bar. A micrometer screw is provided on the bushing-bar for accurately adjusting the distance between the chuck and bushing. Details of the procedures for setting-up and testing wire specimens in the fatigue tester are given on Figure (2). Formulas for determining the specimen length and chuck to bushing distance, appropriate to the testing stress desired, are also given on Figure (2). When set-up in the tester, the wire specimen assumes the shape of an arch in which the length is 2.19 times the base, the height is 0.835 times the base and the radius of curvature at the apex is 0.417 times the base.

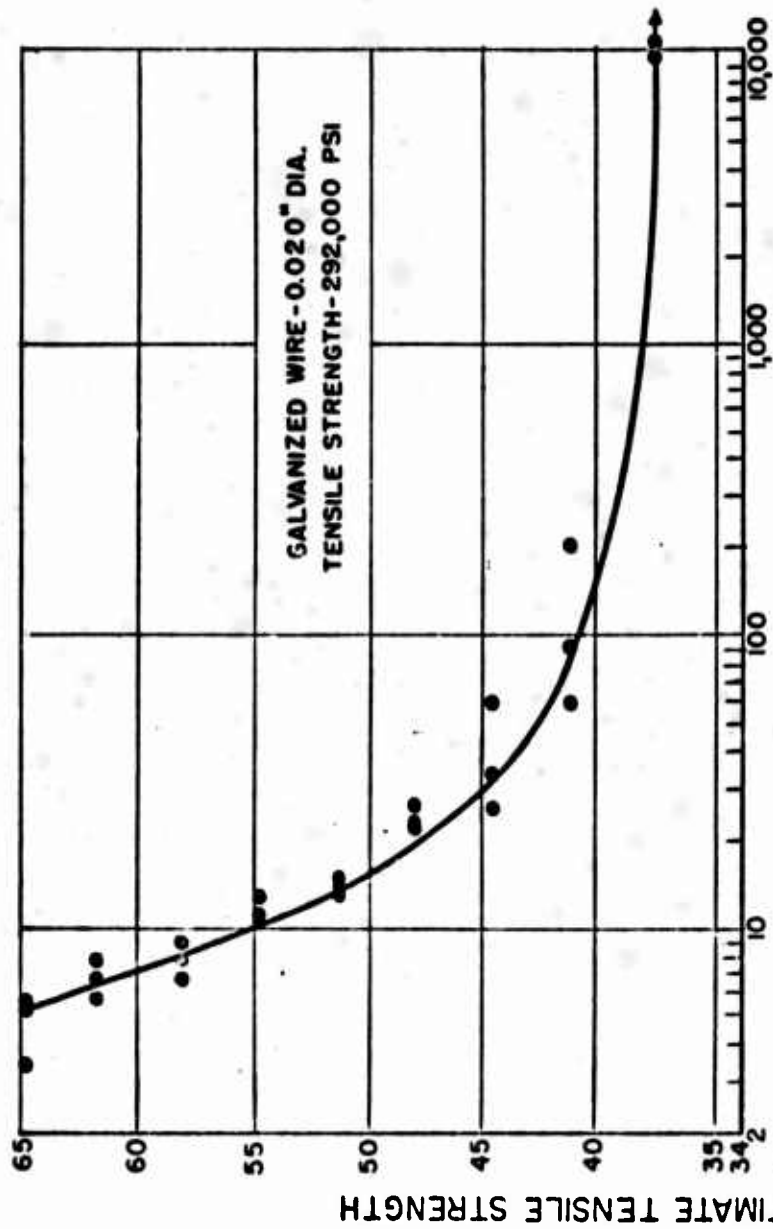
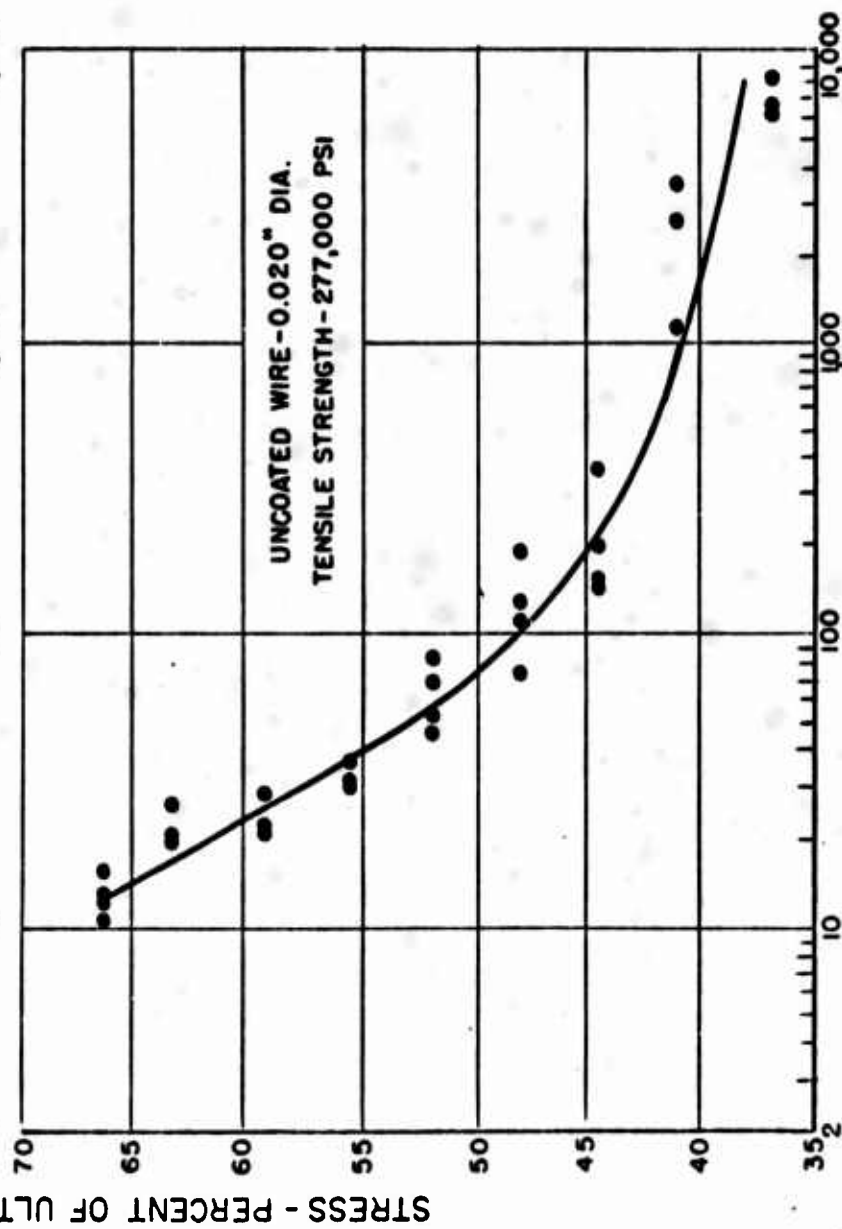
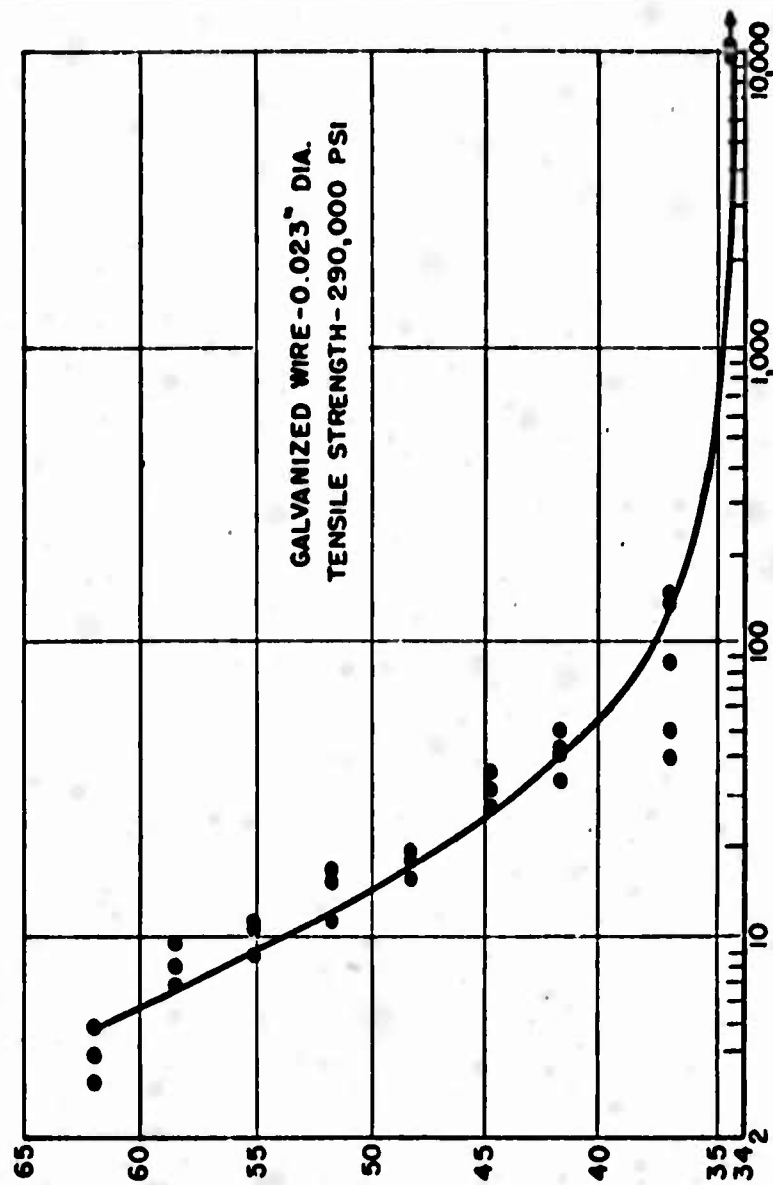
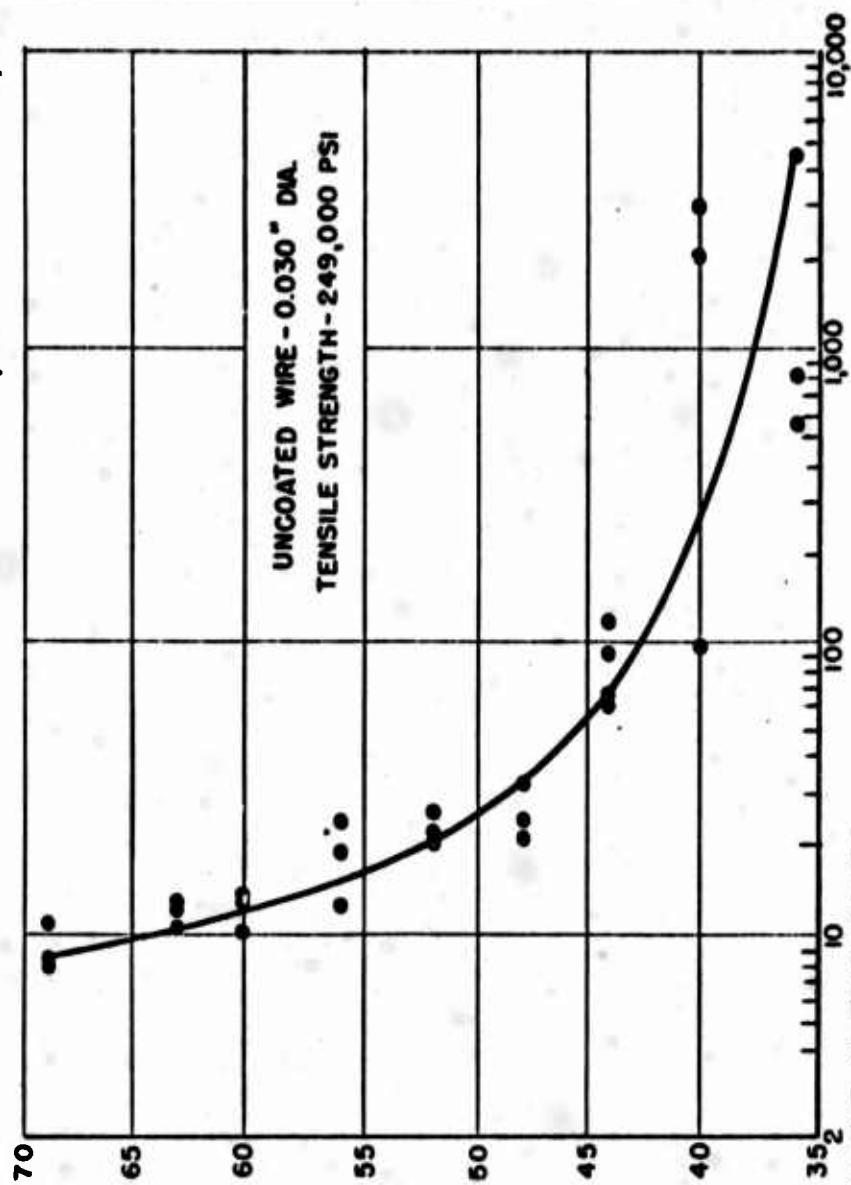
FIGURE 3 - RESULTS OF FATIGUE TESTS ON VARIOUS WIRE SPECIMENS

3. Fatigue evaluations were conducted on 0.020 and 0.030 inch diameter uncoated I.P.S. wires and on 0.020 and 0.023 inch diameter drawn galvanized I.P.S. wires, which were obtained from a single source. At least three specimens, for each type and size of wire, were tested to failure at each of nine different stress levels, except where specimens did not fail after 10 million cycles. In these cases, only two specimens were evaluated.

4. Fatigue data obtained on the various wire specimens are shown plotted on Figure 3. A curve, faired in by eye, is fitted through the data points for each type and size of wire. The four S-N curves are redrawn on Figure 4 for purposes of comparison. It may be seen from the figure that for uncoated and galvanized wires of the same diameter, the fatigue life of the uncoated wire is appreciably longer. It may also be seen that, for 0.020 and 0.030 inch diameter uncoated wires, the fatigue life of the smaller diameter wire is appreciably longer. No valid comparison can be made from the S-N curves for the 0.020 and 0.023 inch

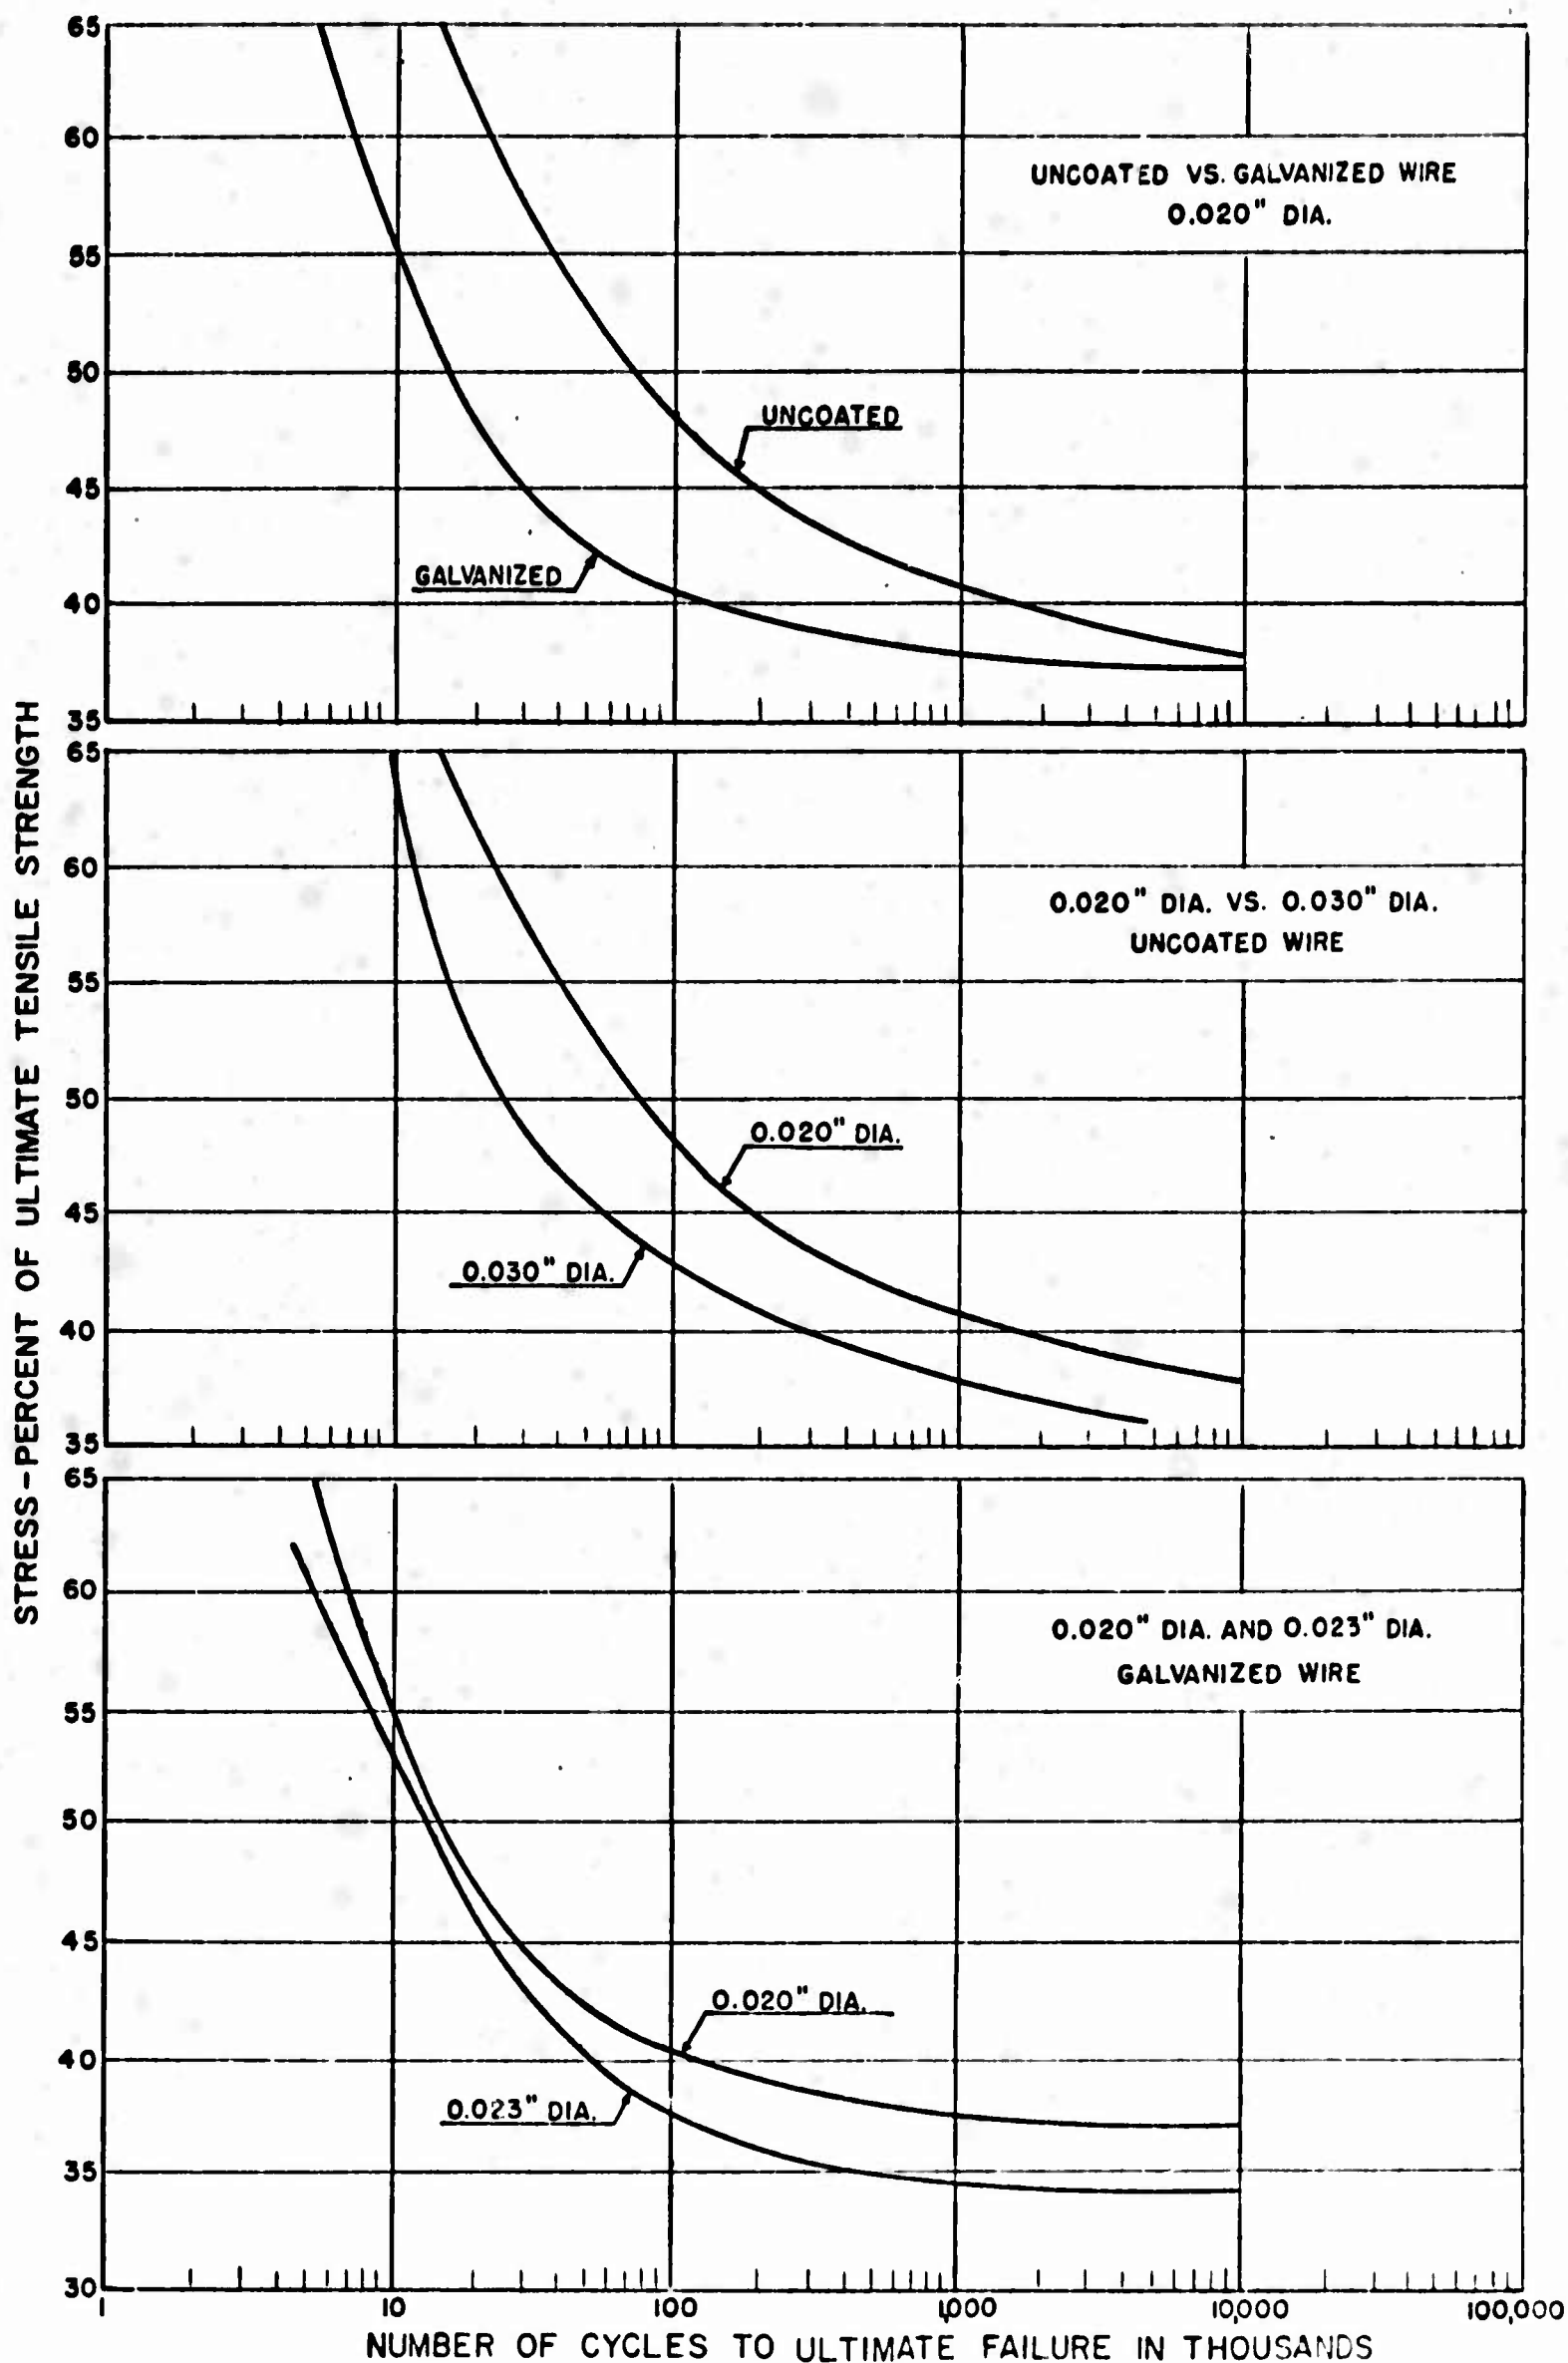
FIGURE 4 - COMPARISON OF S-N CURVES FOR VARIOUS WIRE SPECIMENS  
 U.S. NAVAL APPLIED SCIENCE LABORATORY

diameter galvanized wires due to the small difference in wire size. However, these curves do substantiate, to some extent, the trend observed for the uncoated wires, in that the smaller diameter wires appear to have a longer fatigue life than the larger diameter wires.
