TECHNIQUES FOR FABRICATING SCANNABLE COLD CATHODES

Research and Development Technical Report  
ECOM-2948

Dietrich Dobischek  
Nelson Dent

March 1968

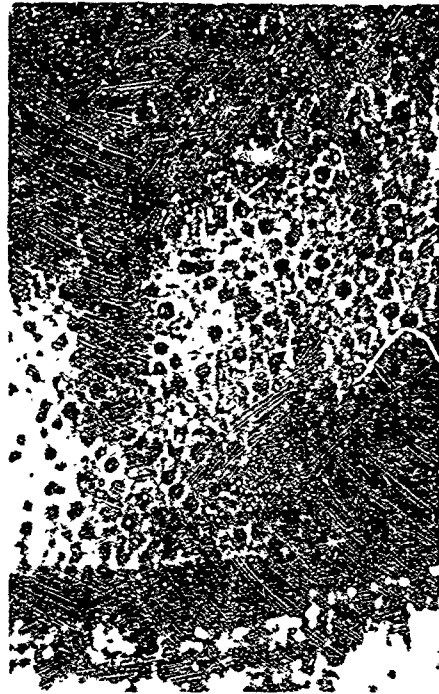
FIGURE 2. ASPERITIES FORMED ON PLAIN MOLYBDENUM SURFACES

The samples were examined under the microscope in reflected light. Of the six samples prepared, four samples showed the expected formation of asperities in the aluminum treated area. Photographs taken of these samples are displayed in Figure 2 a through d. Differences in the size and density of the asperities will be noticed. The small number of experiments does not permit an explanation of these differences. A more systematic investigation of the numerous factors which may have caused the variations would be necessary.
