THE DEVELOPMENT OF
GUN LAUNCHED ROCKETS

F.M. Groundwater

SRI-H-R-6

FEBRUARY 1968

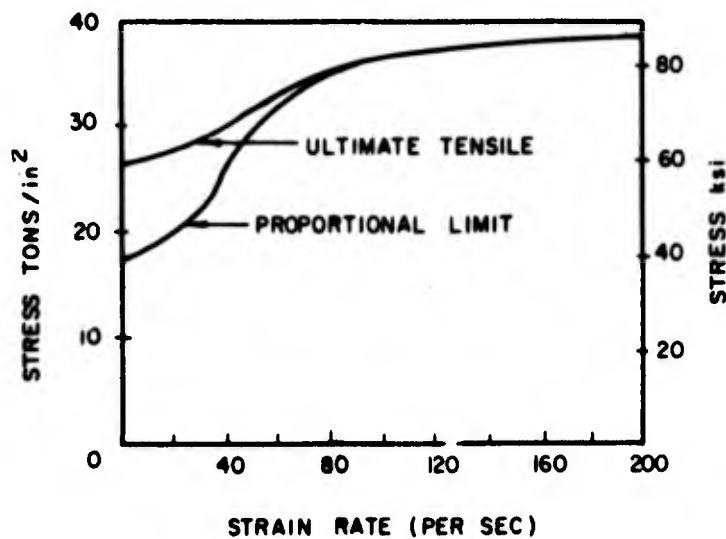
FIGURE 2

STRAIN RATE vs ULTIMATE TENSILE STRESS
AND PROPORTIONAL LIMIT OF MILD STEEL
(.22%)

mechanical properties is evidenced in these materials at high rates of strain. Some qualitative data is shown in Figs. 2, 3 *. In designing the first generation of Martlet III vehicles, it was hoped that both of these phenomena could be utilized in order to achieve substantial increases in performance.

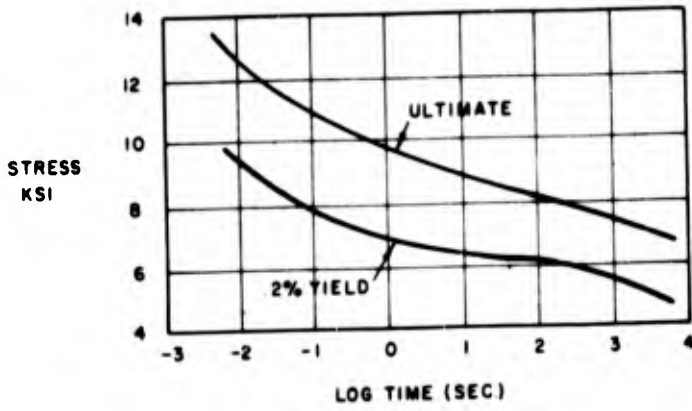
FIGURE 3

STRESS vs TIME TO STRESS OF METHYL-METHOCRYLATE PLASTIC SHEET. STRESS APPLIED AS RAMP FUNCTION

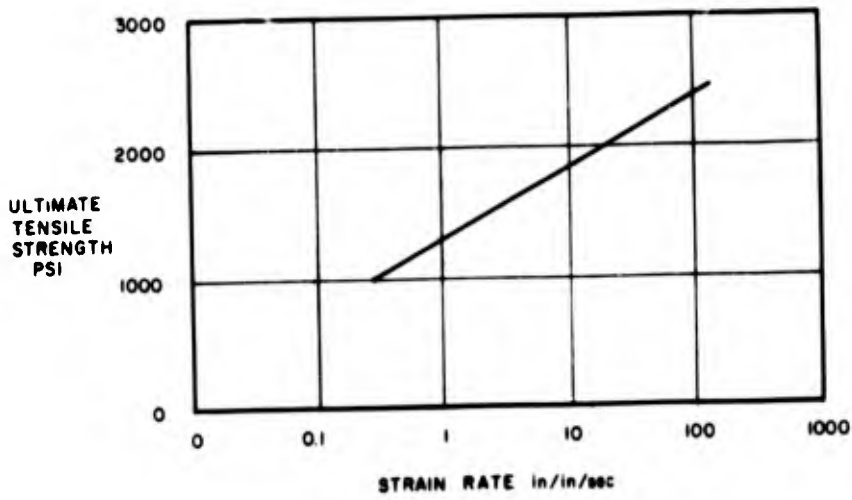
FIGURE 4

TYPICAL ULTIMATE STRESS vs STRAIN RATE FOR DOUBLE BASE PROPELLANT

The mechanical strength of the rocket propellant used in the Martlet III was of the order of 1000 psi in compression. No quantitative data was available to ascertain shear strength values and a value of 60% of the compressive strength was assumed. On the basis of the increased tensile strength at high rates of strain, it was further assumed that shear strength characteristics would improve accordingly. In order to achieve significant performance, the motor would be stressed in the shear mode to the order of 1000 psi. It was felt that this was not overly optimistic in view of the increase of strength depicted in Fig. 4. **

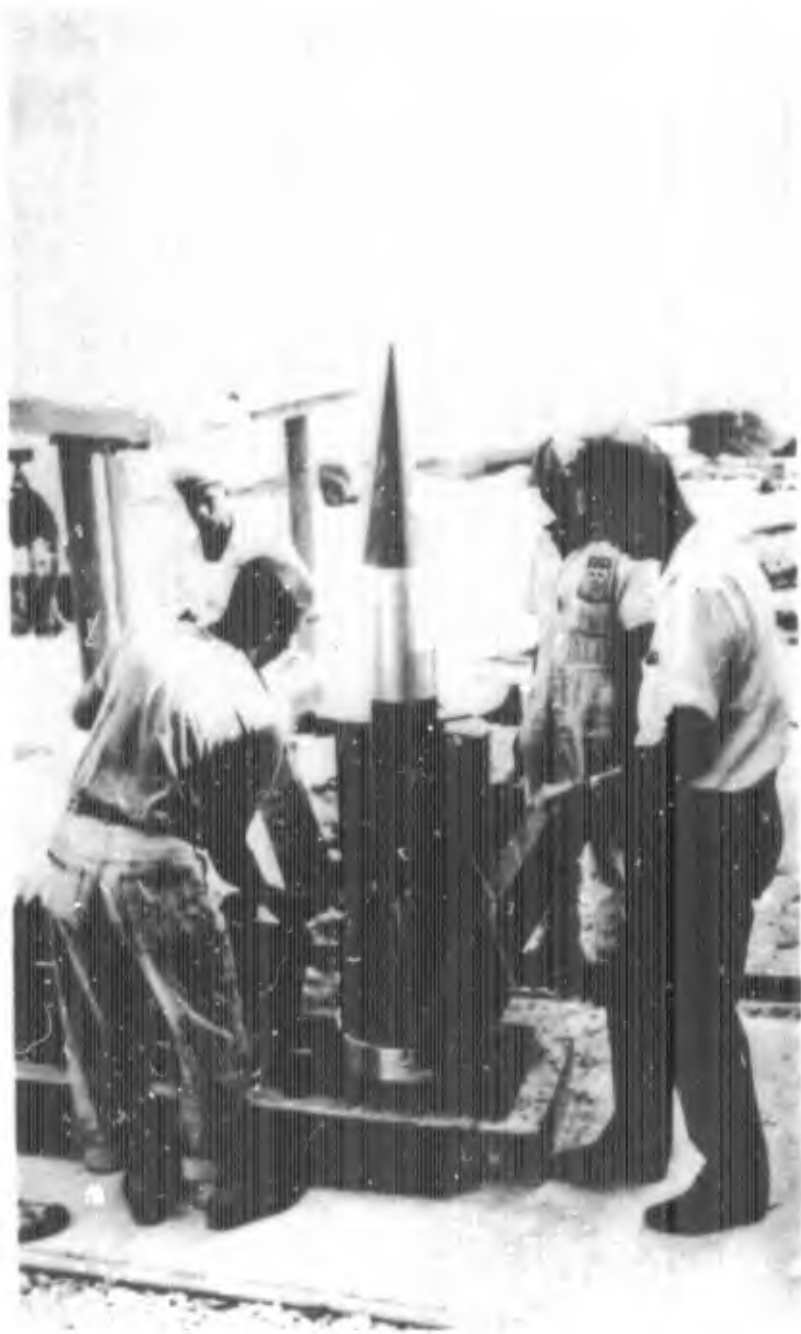
FIGURE 10C

ASSEMBLY OF PROJECTILE PRIOR TO LAUNCH

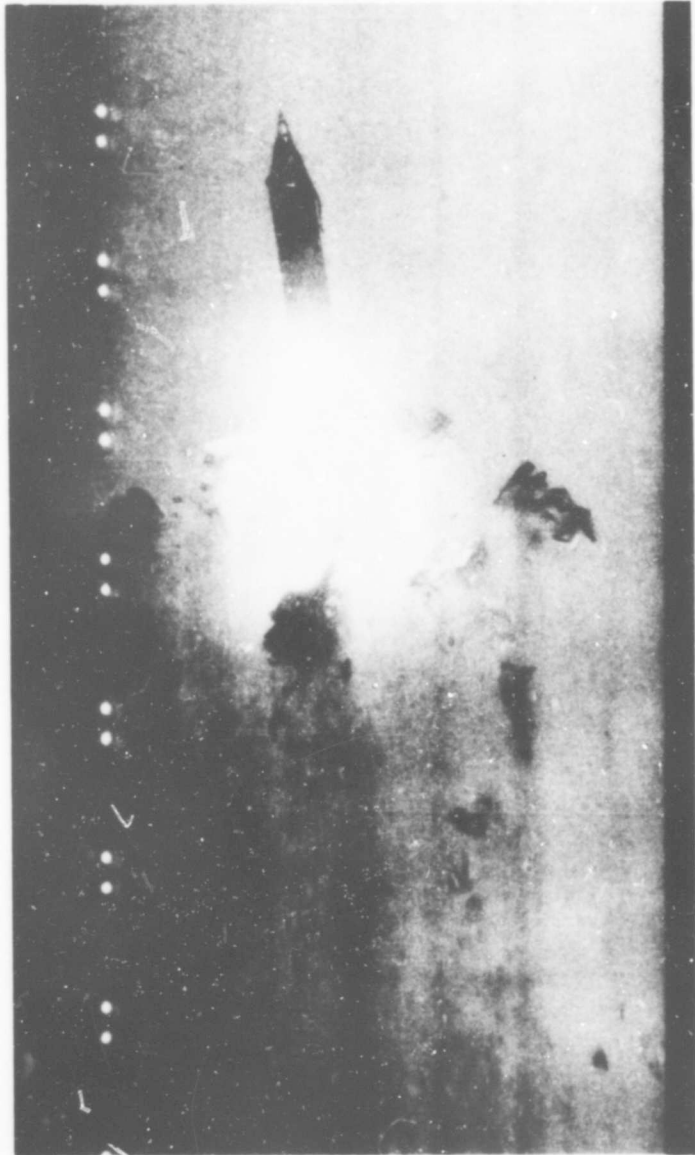
FIGURE 20A

SMEAR PHOTO SHOWING PREIGNITION
AND ANTENNA DAMAGE

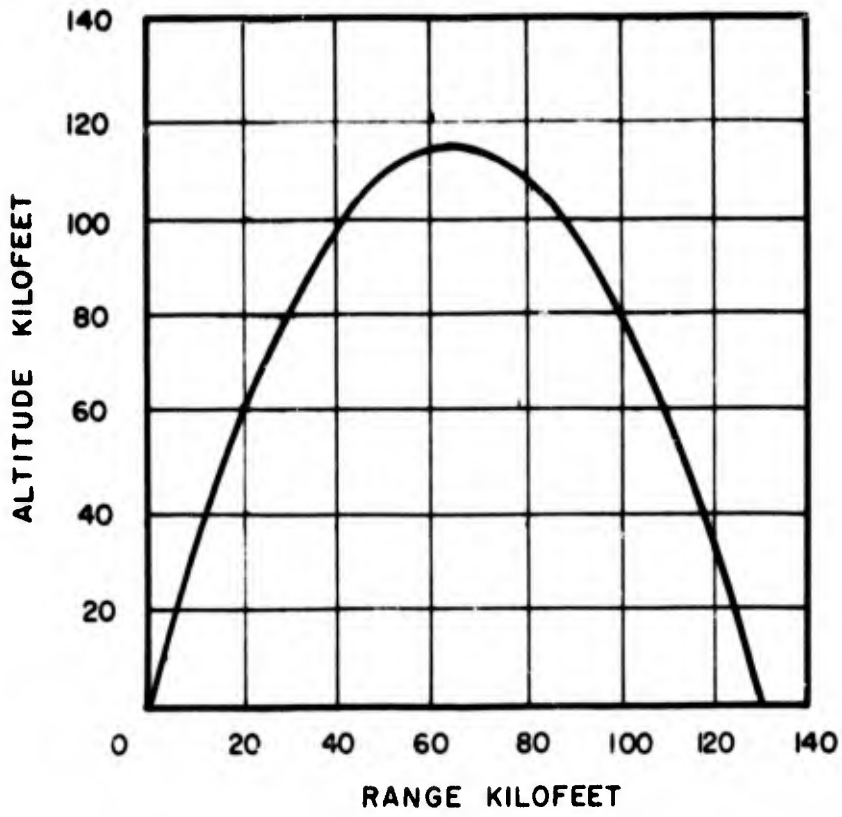
FIGURE 22

RADAR TRACK FOR VEHICLE
CHICOUTIMI

*See Figure 22

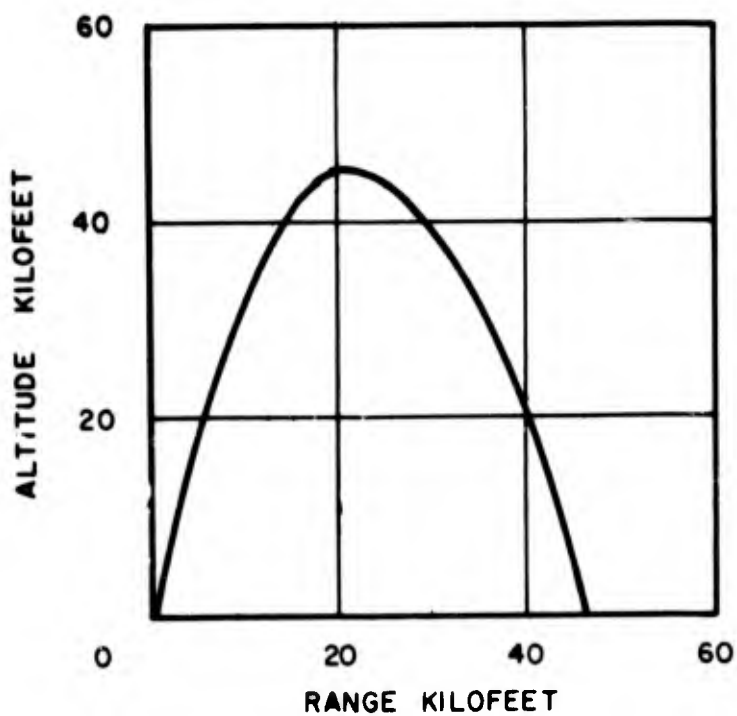
FIGURE 23

RADAR TRACK FOR MOTOR
TEST VEHICLE
NUMBER 5

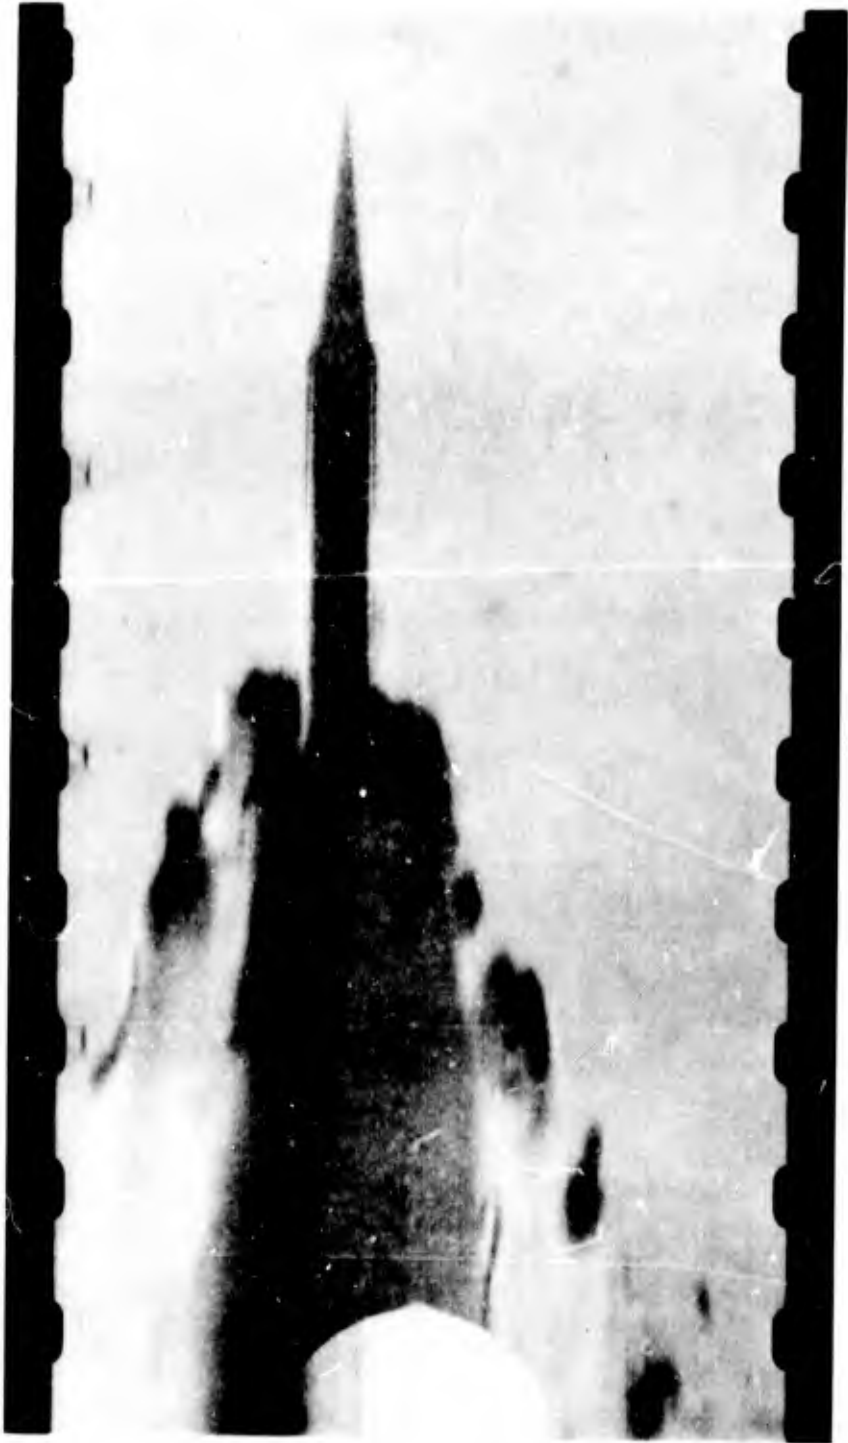
FIGURE 23B

SMEAR PHOTO OF SHOT NO 10

The photographs indicated a clean launch at relatively low velocity. The motor ignited at the proper time and burning was regular. The flight was irregular and visual observations indicated the vehicle far off expected trajectory. This was later confirmed by the recovery of the vehicle fragments which had impacted on the island.

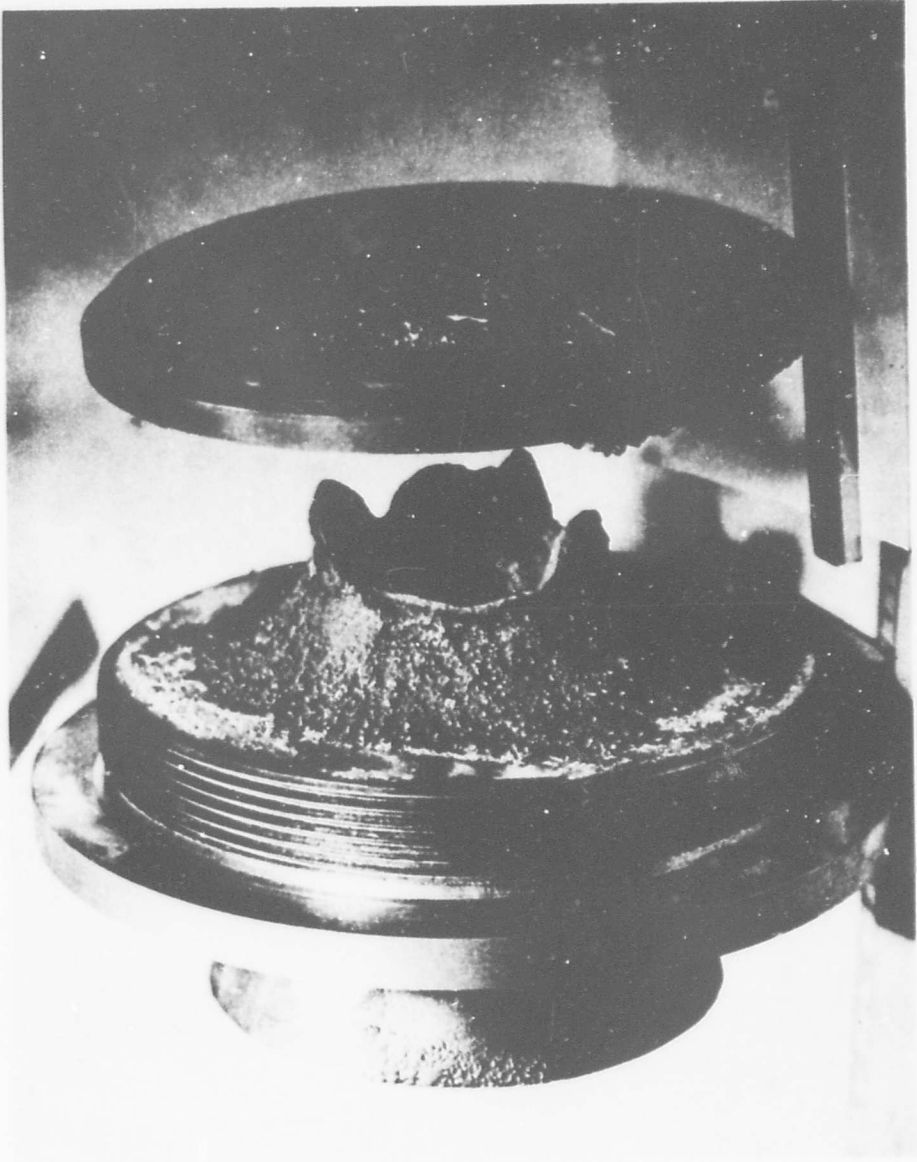
FIGURE 26C

MEEHANITE NOZZLE AFTER FIRING
N5 - ALUMINIZED MOTOR

Remarks: In view of the improved performance of the Meehanite material when heat treated, it was decided to conduct one more test with such a nozzle with all internal surfaces coated with .010" thick layer of Al_2O_3 .

Performance was again poor and the nozzle was separated into two sections as the throat wall (3/4" thickness minimum) was eroded completely away.
