EXPLORATORY ENVIRONMENTAL EVALUATION OF SOLDERLESS WRAPPED CONNECTIONS

REPORT NUMBER TR-1242

Exploratory Environmental Evaluation of Solderless
Wrapped Connections

T&E Task Assignment 67-2-8ER

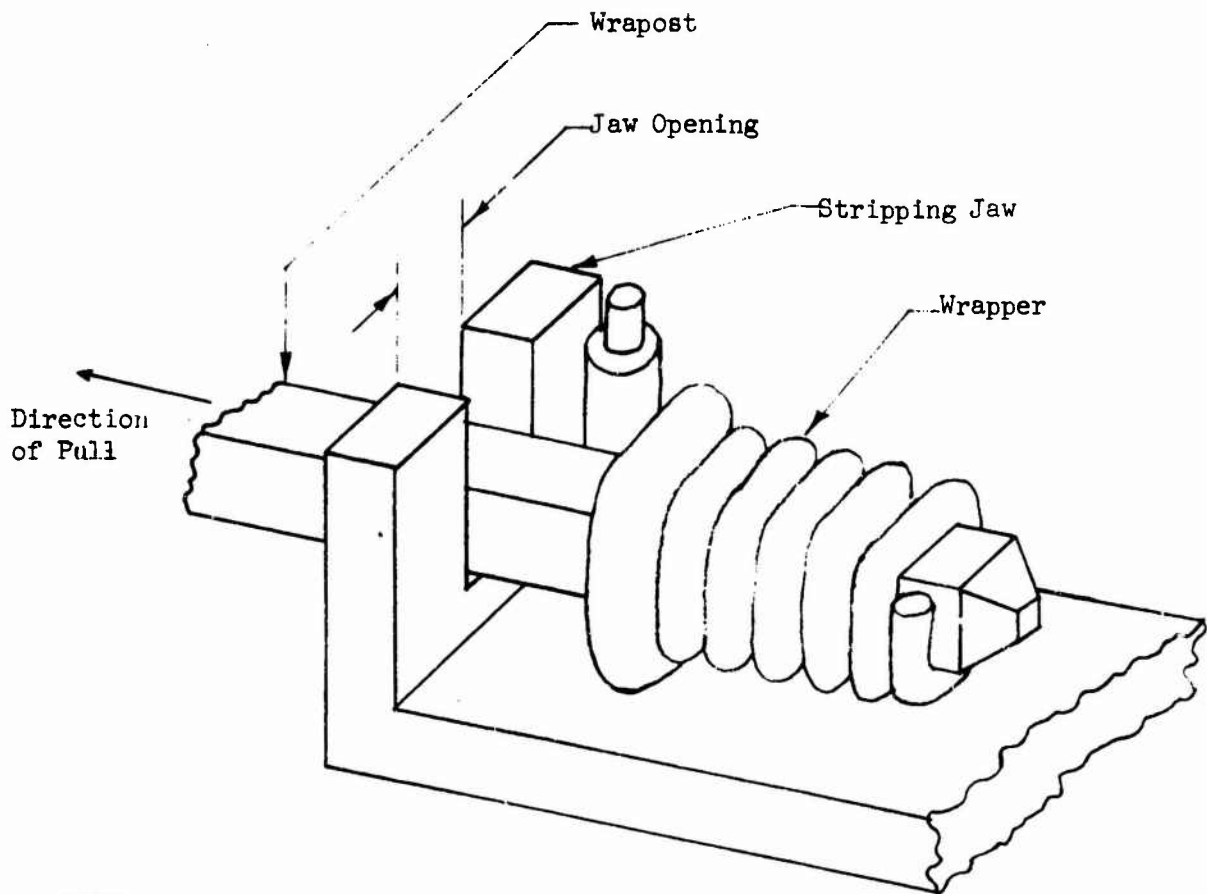
Figure 1

1. The stripping jaw shall engage at right angles to axis of the wrapost.
2. The maximum total clearance between jaw opening and wrapost shall be $0.7 \times$ diameter of wire.
3. When the wrapost and stripping fixture are properly aligned, the clearance shall be such that there is no binding or wedging between jaw and wrapper.
4. Both sides of the stripping jaw shall be in the same plane, creating a flat surface contact with the wire on either side of the wrapost.

Strip Force Test Fixture
