TR 607-2

RESEARCH AND DEVELOPMENT OF  
HIGH QUALITY LASER GLASS  
SEMIANNUAL TECHNICAL REPORT  
NUMBER 2

Period Ending 30 December 1968  
ARPA Order No. 306  
Contract No. N00014-68-C-0192

American Optical Corporation  
Central Research Laboratory  
Southbridge, Massachusetts 01550

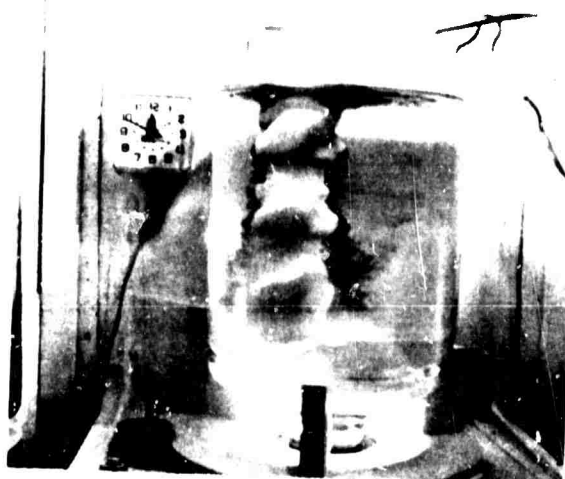
Figure 3. Stirring action with 3-tiered stirrer.

Typical results obtained with the equipment prior to its redesign are shown in Fig. 3. These experiments were carried out at a glycerin viscosity of 15 to 25 poises. The stirring rod is turning in a counterclockwise direction and the coloring solution is added at the top of a clear "melt." In Figs. 3b, 3c, 3d and 3e, one sees that the initial stirring action is one of wrapping a corkscrew of stria around the stirring rod. In Fig. 3e, this is still visible around the stirring rod although coloration in the rest of the melt is starting to obscure the action at the stirring rod. In Fig. 3f, the coloration of the rest of the melt completely masks any stirring action or lack thereof occurring at the stirring rod. For this reason the technique of adding a clearing agent to a "melt" which had previously been uniformly colored was adopted. As indicated by the clock, the first five pictures represent the initial twenty minutes of stirring in this experiment. The final picture was taken about two hours after the stirring experiment had been started.

While an experiment of the type shown in Fig. 3 is very useful in studying the type of stirring action which occurs, it does not show up dead zones which may exist in the stirring

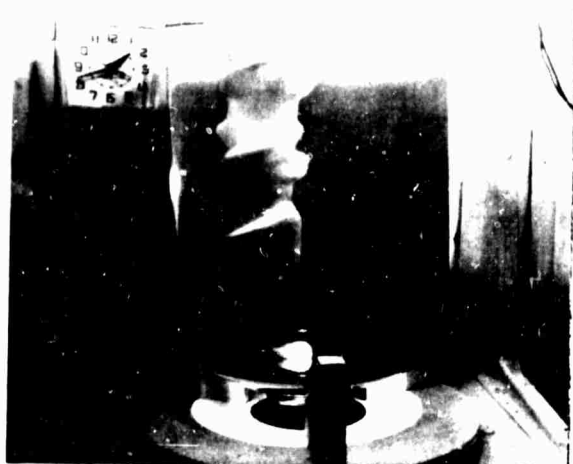
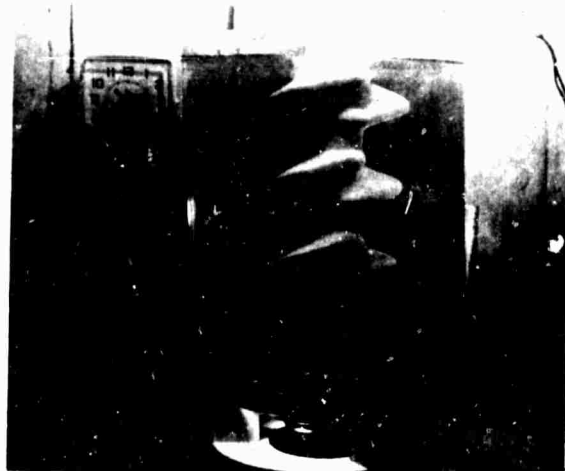
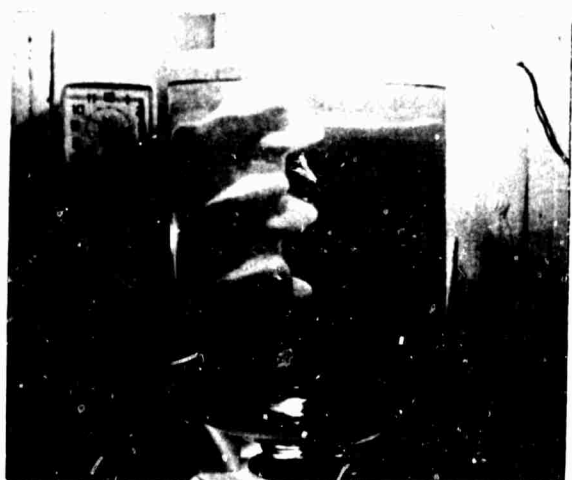
Figure 4. Dead zones with 3-tiered stirrer.

process. In order to show this, one starts with a uniformly colored solution and adds a clearing agent to the top of the "melt." An experiment of this type, shown in Fig. 4, was carried out under the same conditions of viscosity and stirring as were used in Fig. 3. As may be seen in Fig. 4b, stirring action is complete enough after fifty minutes to make the stirring rod visible although some stria is still present in the glycerin. At the end of one hour and twenty minutes of stirring, the main body of the glycerin appears to be fairly free of stria. On the lower portion of the stirring rod, however, there is still a thin layer of uncleared glycerin next to the stirring rod. This is most noticeable near the bottom of the stirring rod at the junction between the straight cylindrical portion and the spherical bottom. This ring at the bottom of the stirrer is still noticeable after three hours of stirring. The final photograph after ten hours of stirring shows the glycerin to be completely clear.
