D6-25219

**STRESS-CORROSION PROPERTIES  
OF  
HIGH-STRENGTH PRECIPITATION-HARDENING STAINLESS STEELS  
IN  
3.5% AQUEOUS SODIUM CHLORIDE SOLUTION**

**Clive S. Carter  
Dana G. Farwick  
Alan M. Ross  
Jack M. Uchida**

**BOEING** COMMERCIAL AIRPLANE GROUP  
SEATTLE, WASHINGTON

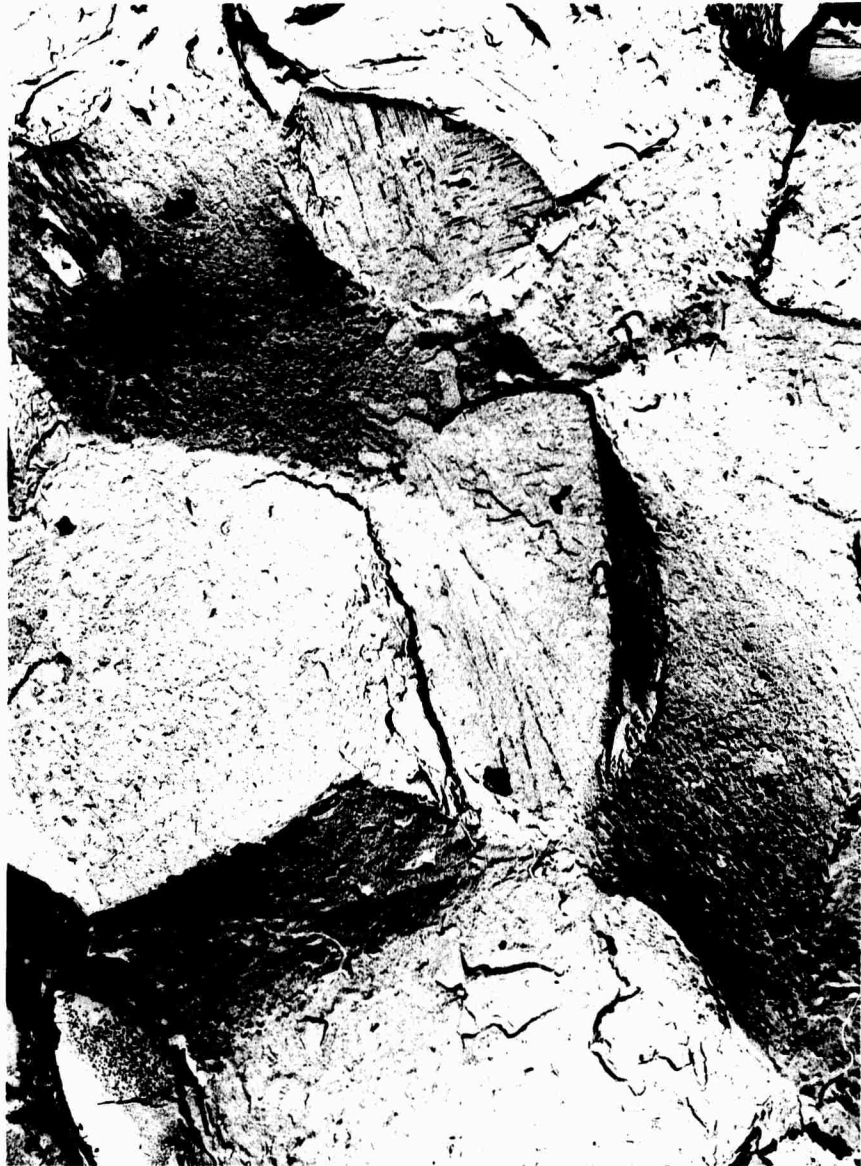
Figure 15      Intergranular stress-corrosion cracking in semiaustenitic stainless steel 17-7 PH (TH 1050) (X4,000).

Fractographic examination revealed that the stress-corrosion cracks in both the semiaustenitic and martensitic steels invariably propagated in an intergranular manner. Typical fractographs are shown in Figs. 15 and 16.

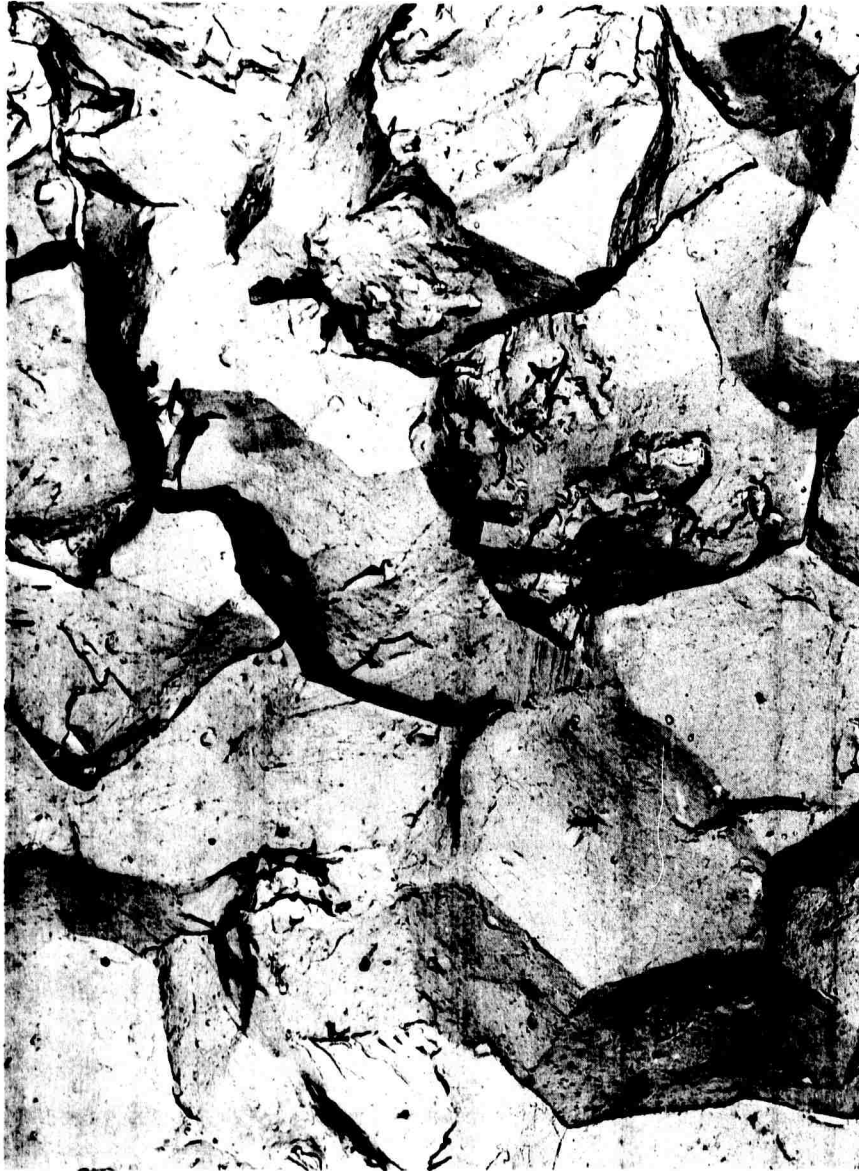
Figure 16      Intergranular stress-corrosion cracking in martensitic stainless steel AM 362 (H 900) (X4,000).
