Technical Note 5-70

## NOISE REDUCTION OF THE XM759 CARGO CARRIER (MARGINAL TERRAIN VEHICLE)

Howard H. Holland, Jr.

July 1970

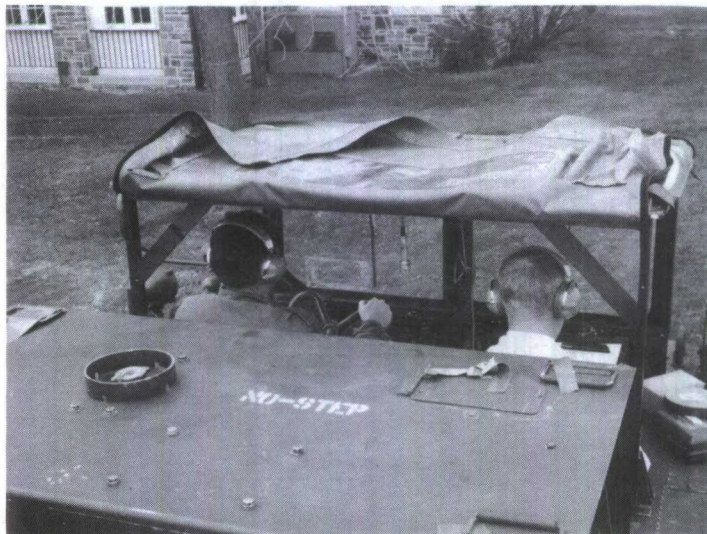
Fig. 4. VIEW OF THE MICROPHONE MIDWAY BETWEEN THE DRIVERS' HEADS WITH CURTAINS UP (OPEN CAB)

All of the cab measurements were made with the microphone located midway between the heads of the driver and the assistant driver (Fig. 4). In most cases, the microphone was suspended from the cab ceiling with the microphone facing down. In a few cases when the cab was completely open and there was nothing over the drivers' heads, the microphone was held by hand, facing up, midway between the drivers' heads.

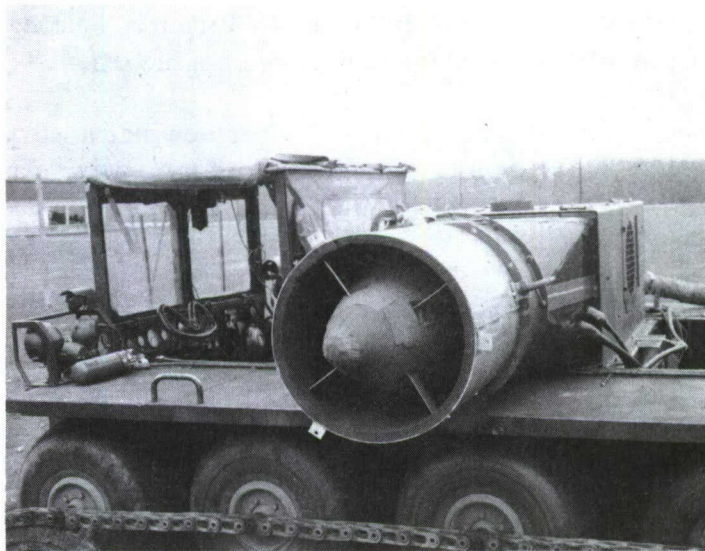
Fig. 11. CARR-KALEN ATTENUATOR ON PILOT VEHICLE NO. 2

The C-K Attenuator was attached to the fan housing and measurements made in the cab (closed and open) at 2000, 3000 and 4000 rpm. Testing was stopped at this time because the fan belts had been burned by the engine exhaust.
