Technical Report

**R 715**

**AMPHIBIOUS ASSAULT LANDING CRAFT PROGRAM—  
LARGE PALLET DEVELOPMENT**

March 1971

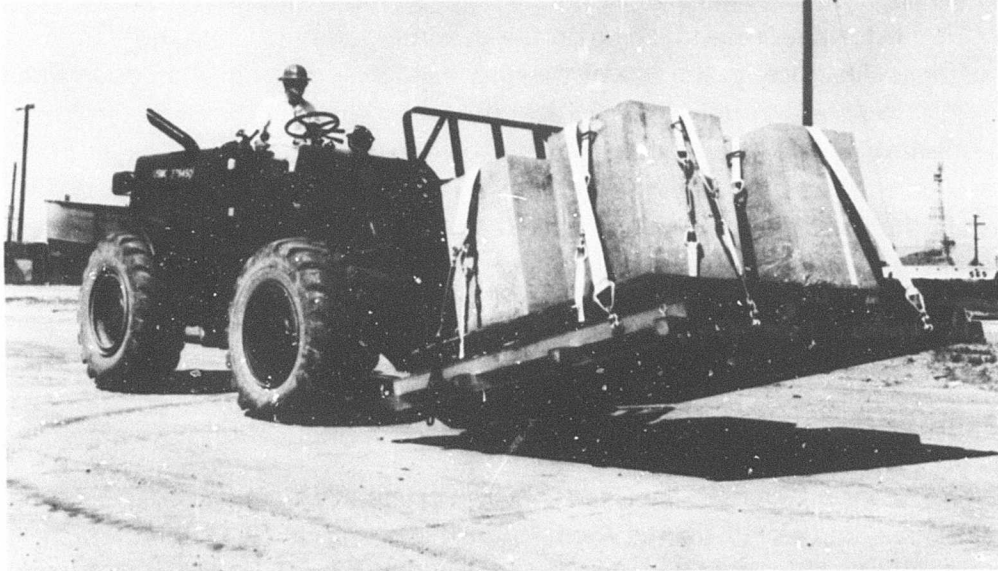
Figure 1. Wooden large pallet during initial forklift operations.

The first, a wooden pallet, was designed to be low in cost and disposable. It was built with construction-grade 4 x 4's and 1/2-inch 32/16 unsanded plywood in accordance with the deck-loading criteria presented in the American Plywood Association booklet on pallet design.\* Figure 1 shows the wooden pallet loaded and ready for testing. The approximate weight of the wooden pallet is 600 pounds, and the prototype cost was \$335. A drawing of details is presented in Figure A-1 of the Appendix.

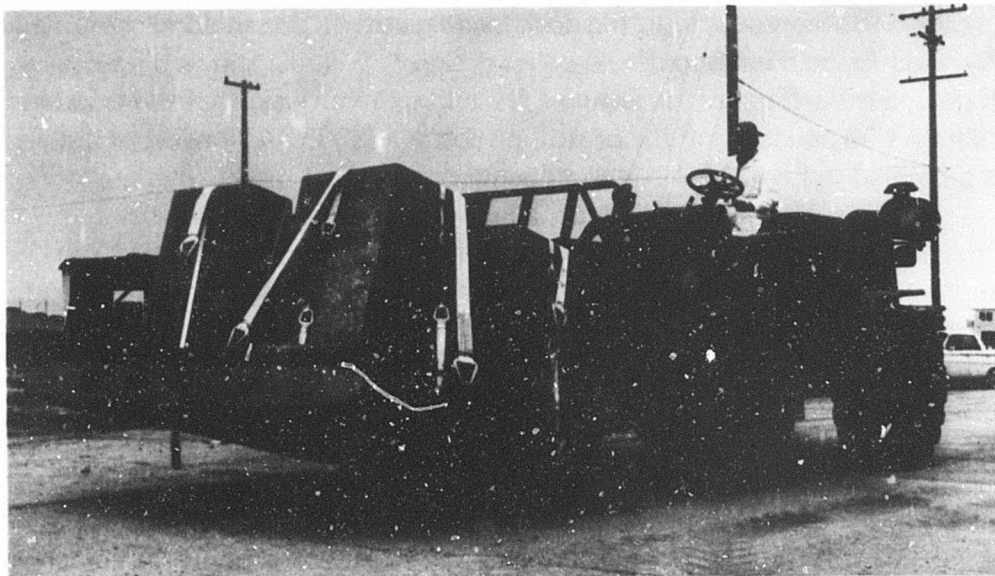
Figure 2. Folded-plate large pallet (steel construction) during initial forklift operations.

this folded-plate pallet in aluminum is anticipated to have low cost, since construction on a production basis is a two-step operation—punching out the tine opening and breaking (folding) the plate. A detail drawing of the folded-plate pallet is presented in Figure A-2 of the Appendix. Figure 2 illustrates the pallet loaded and ready for testing.

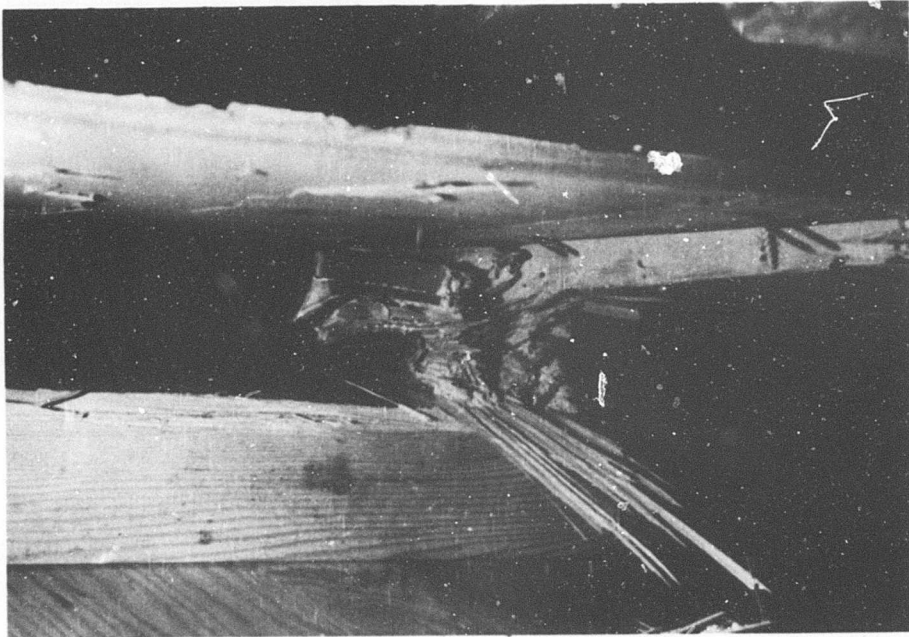
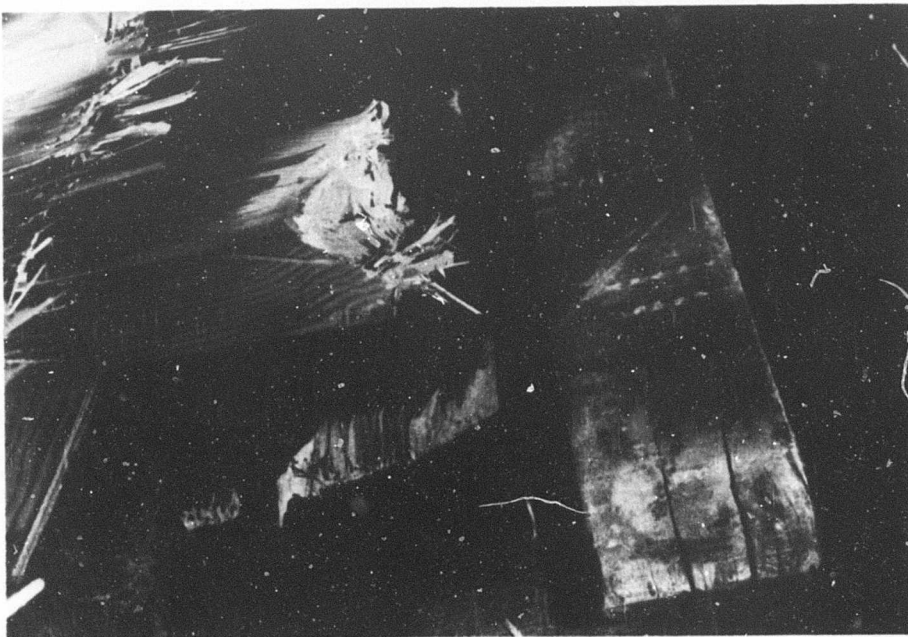
(a) At bolt connections.

(b) At knots.

Figure 8. Wooden large pallet failures from crane drop tests.

The four-point lift test performed on the pallet resulted in excessive deformation in the 4 x 4 beams, although by this time checks were fully visible in the 4 x 4 framework. Lifting the pallet was possible; however, on the first drop the pallet nearly failed in that deflections were excessive. On the second drop failure occurred (see Figure 7). In all cases failure occurred at bolt joints and knots of the 4 x 4's (Figure 8). Several eye bolts failed during the destruction although the lifting eye assembly for the four-point lift performed satisfactorily with only slight indications of shear initiation in the timbers (Figure 9).

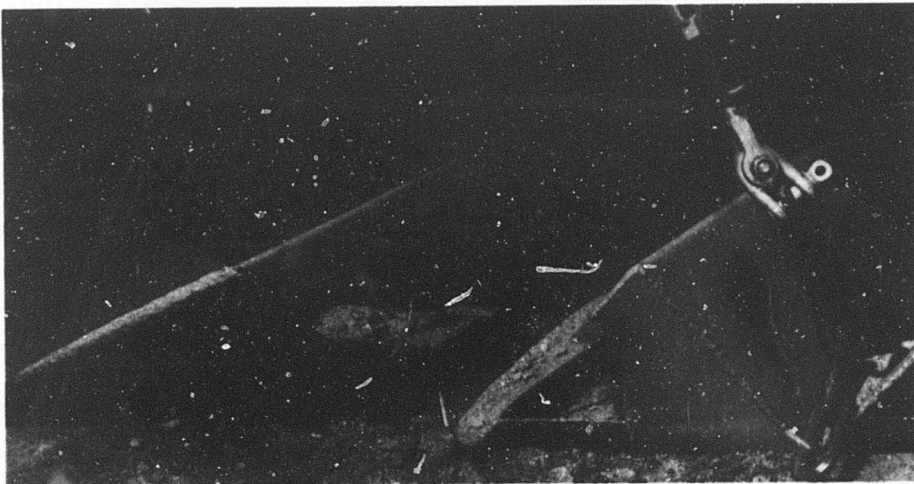
(a) Tine opening after first forklift operation.

(b) Grab-eye damage after crane drop tests.

(c) Gusset tear after crane drop tests.

Figure 11. Typical damage to folded-plate pallet.

During the drop test its extreme flexibility proved an asset to its life expectancy, but the standard wooden pallets were destroyed (Figure 10a). Failure of the wooden standard pallets was primarily a bearing failure due to stress concentrations developed on the wooden pallet at the breaks (folds) of the folded plate. The extreme flexibility, however, required rigging the pallet several times in the performance of a test program, especially after the standard pallets failed, since the strapping would loosen excessively. Little damage occurred to the large pallet itself during any portion of the forklift operation, although the side gusset plates had buckled.

Crane operation with the folded-plate pallet was difficult because of its flexibility. Although it functioned satisfactorily through the series of free falls, damage to the standard pallets was again extensive. The grab-eye lifting points worked exceedingly well in this portion of the test; none failed (Figure 11).

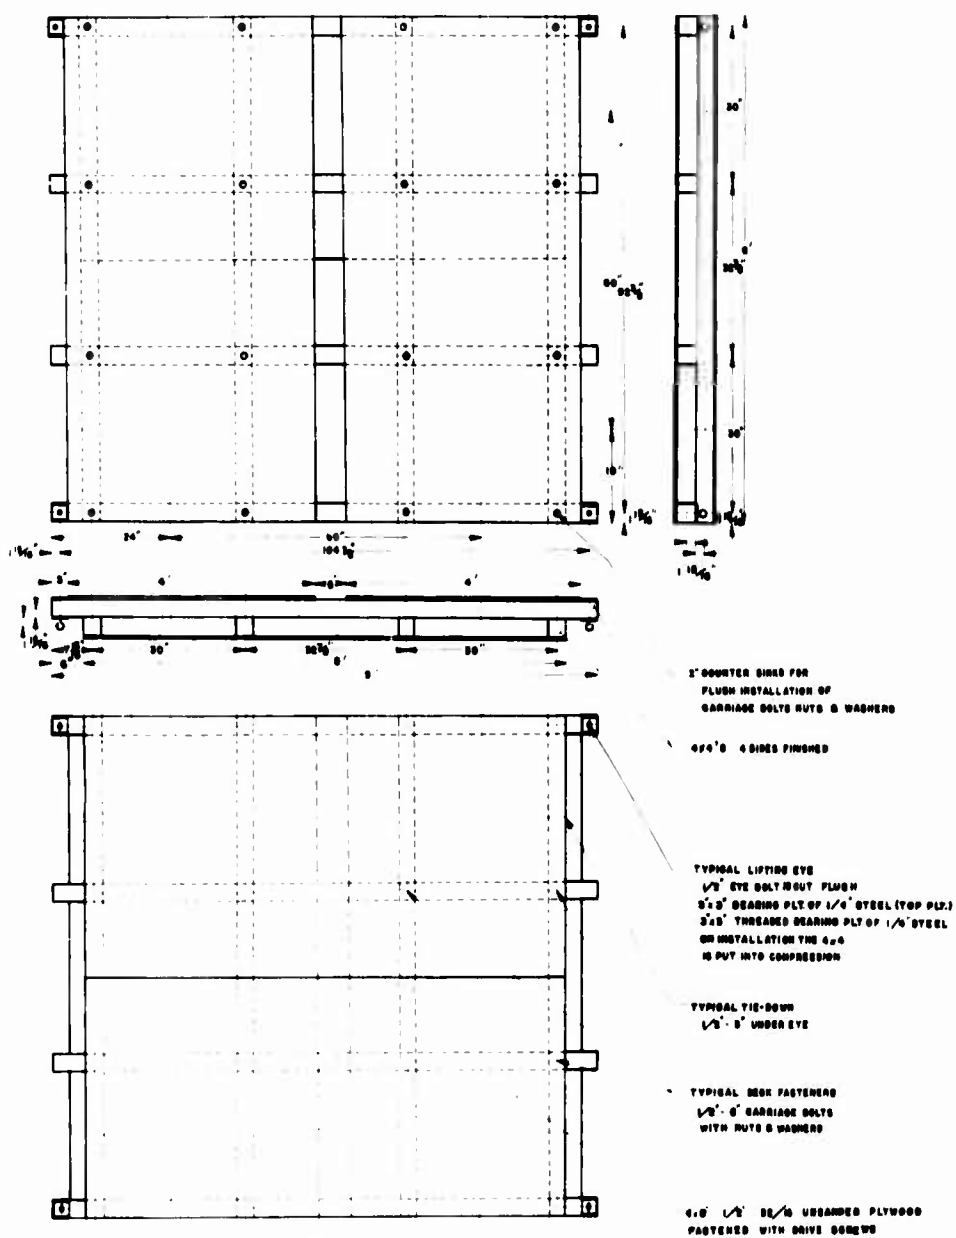
Figure A-1. Wooden large pallet.

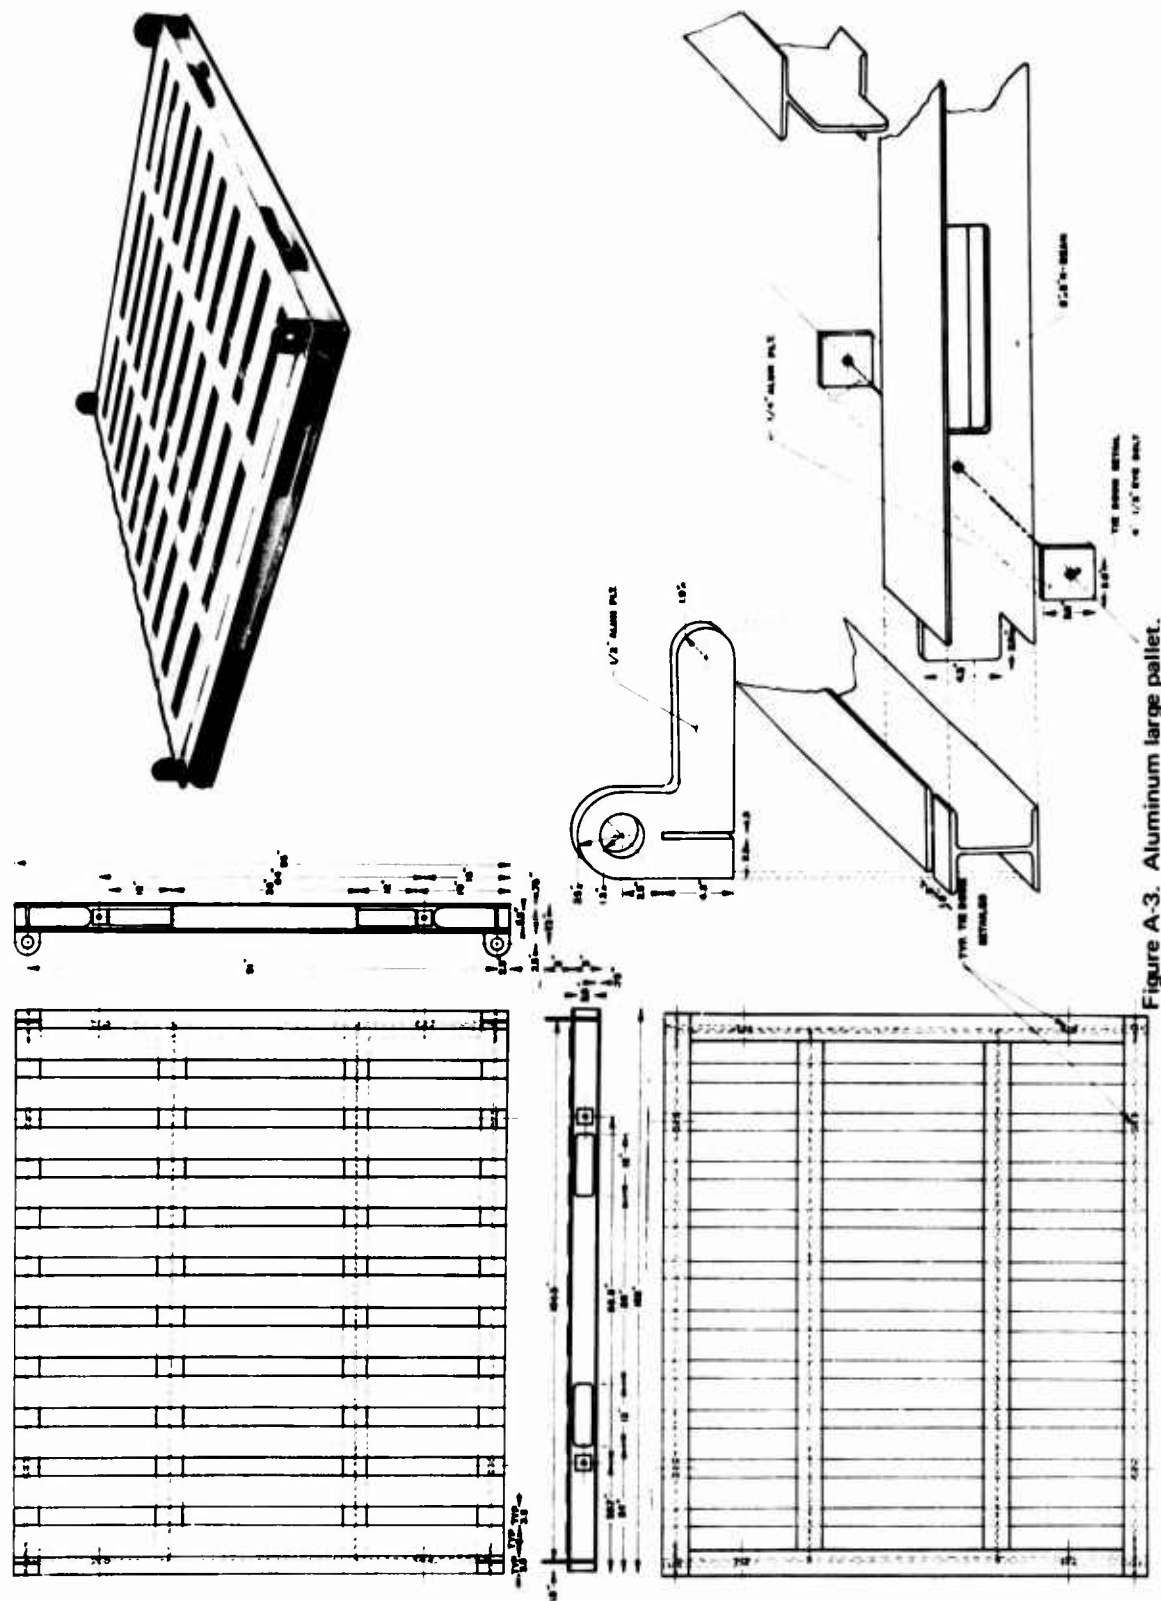
Figure A-3. Aluminum large pallet.

The third, an aluminum pallet, is of the conventional design to provide some comparison with known performance capabilities. The pallet was first designed for steel construction, but the weight requirement necessitated an alternative aluminum design. This pallet served a secondary function as a spreader for lifting the more pliable wooden and folded-plate pallets. Prototype cost for this 600-pound pallet was \$2,000. Figure 3 shows the loaded pallet positioned for testing. Details of the design are presented in Figure A-3 of the Appendix.
