TECHNICAL REPORT NO. 2-580

**SAVANNAH HARBOR INVESTIGATION AND MODEL STUDY**

**RESULTS OF MODEL INVESTIGATIONS**

**RESULTS OF TESTS OF BANK  
EROSION IN NORTH CHANNEL**

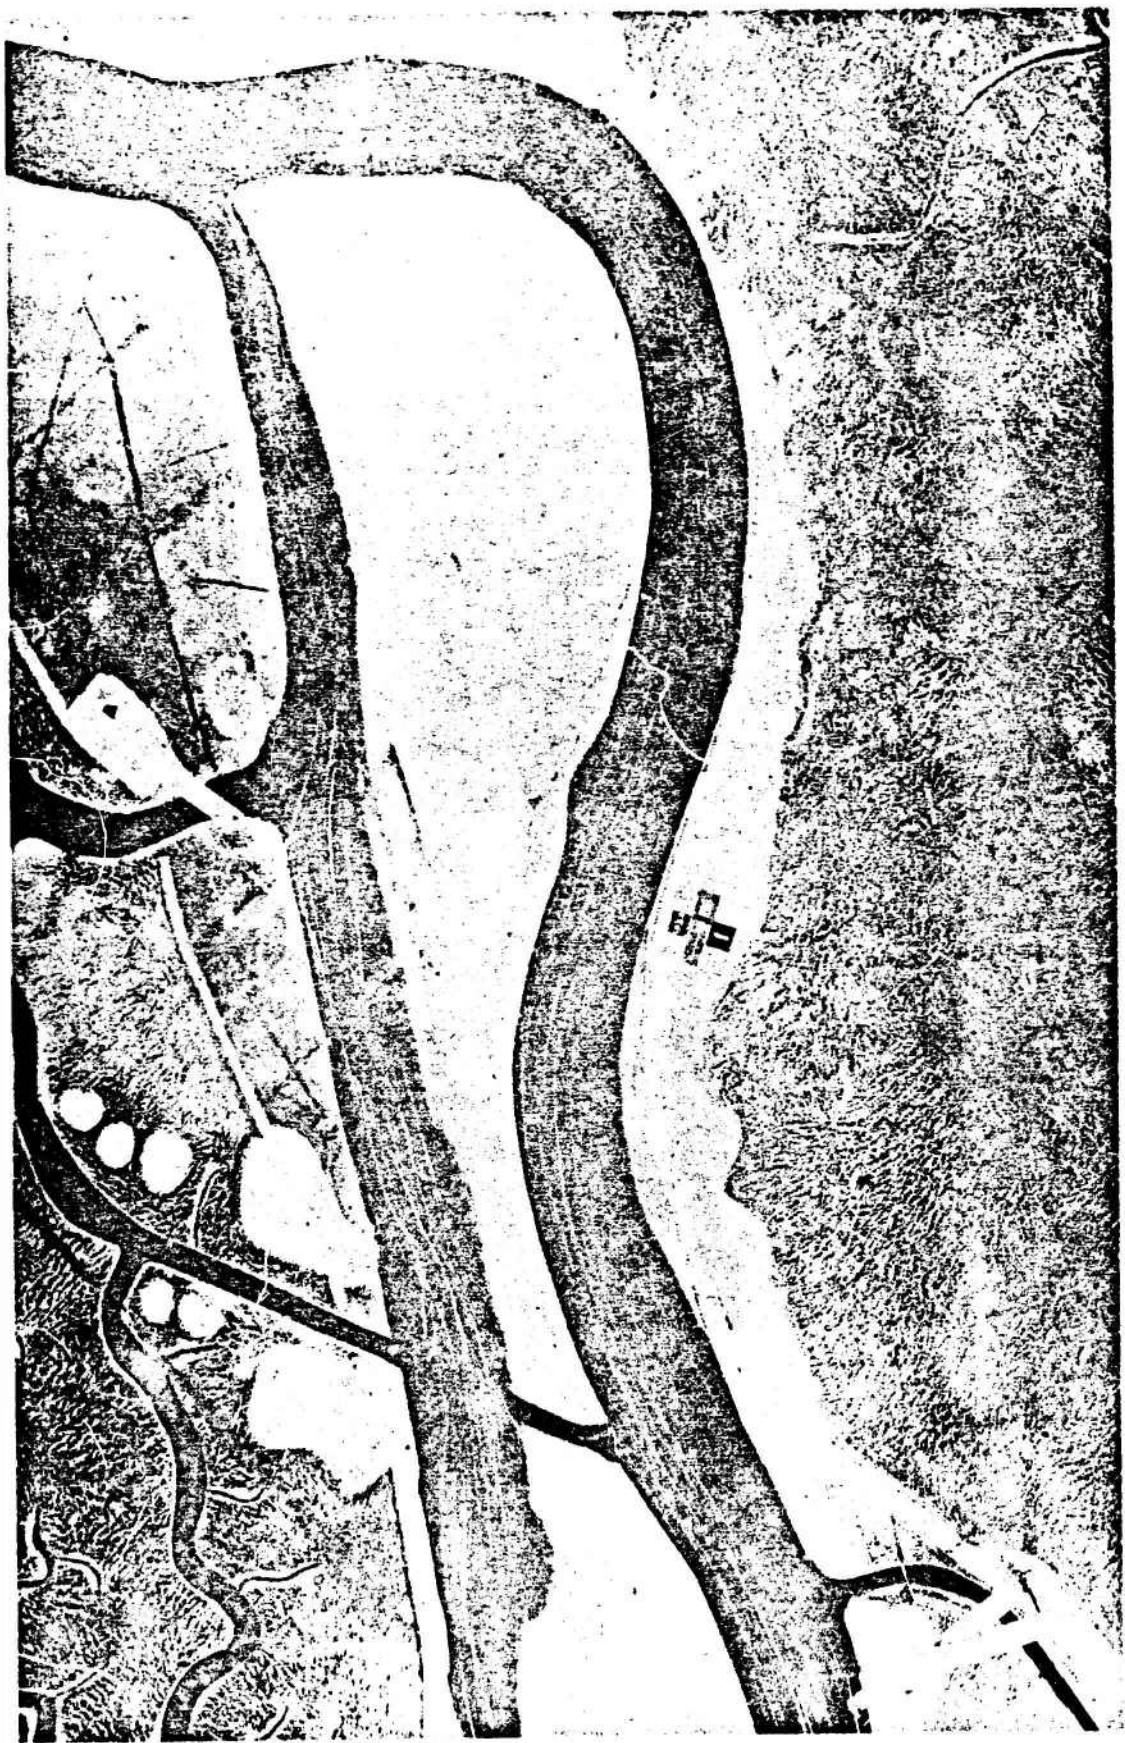
Photograph 2. Surface current directions and velocities for 1964 channel conditions. Hour 1, ebb tide

8. Comparison of photographs 1-13, which show surface current directions and velocities for the 1964 channel conditions at hourly intervals throughout a complete tidal cycle, with photographs 14-26, which show similar information for the recommended channel enlargement, indicates that the enlarged channel would cause no significant changes in surface flow patterns and velocities. In these photographs, the velocity of the surface current in feet per second prototype in any area of the channel can be determined by measuring the length of a confetti streak in inches and multiplying by 2.64. This factor takes into consideration the scale of the photographs and the model-to-prototype scale relations for distance, time, and velocity.

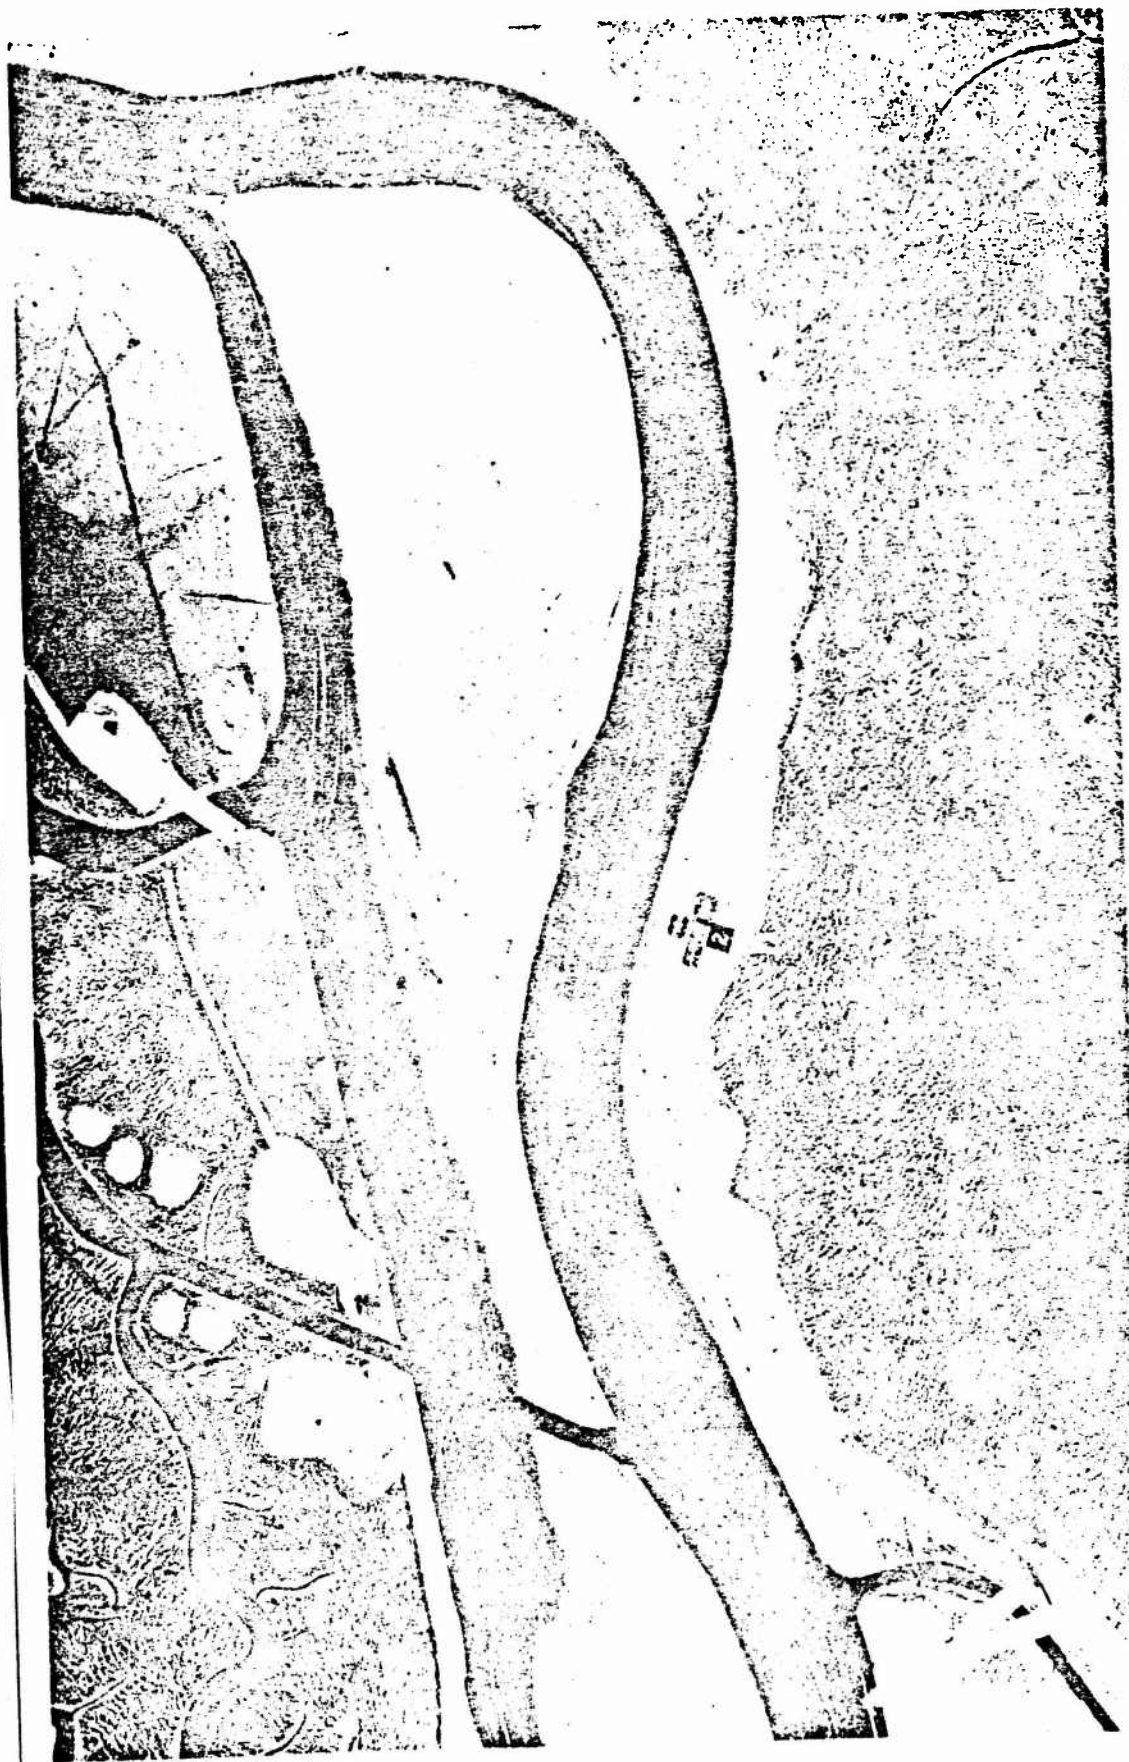
Photograph 3. Surface current directions and velocities for 1964 channel conditions. Hour 2, ebb tide

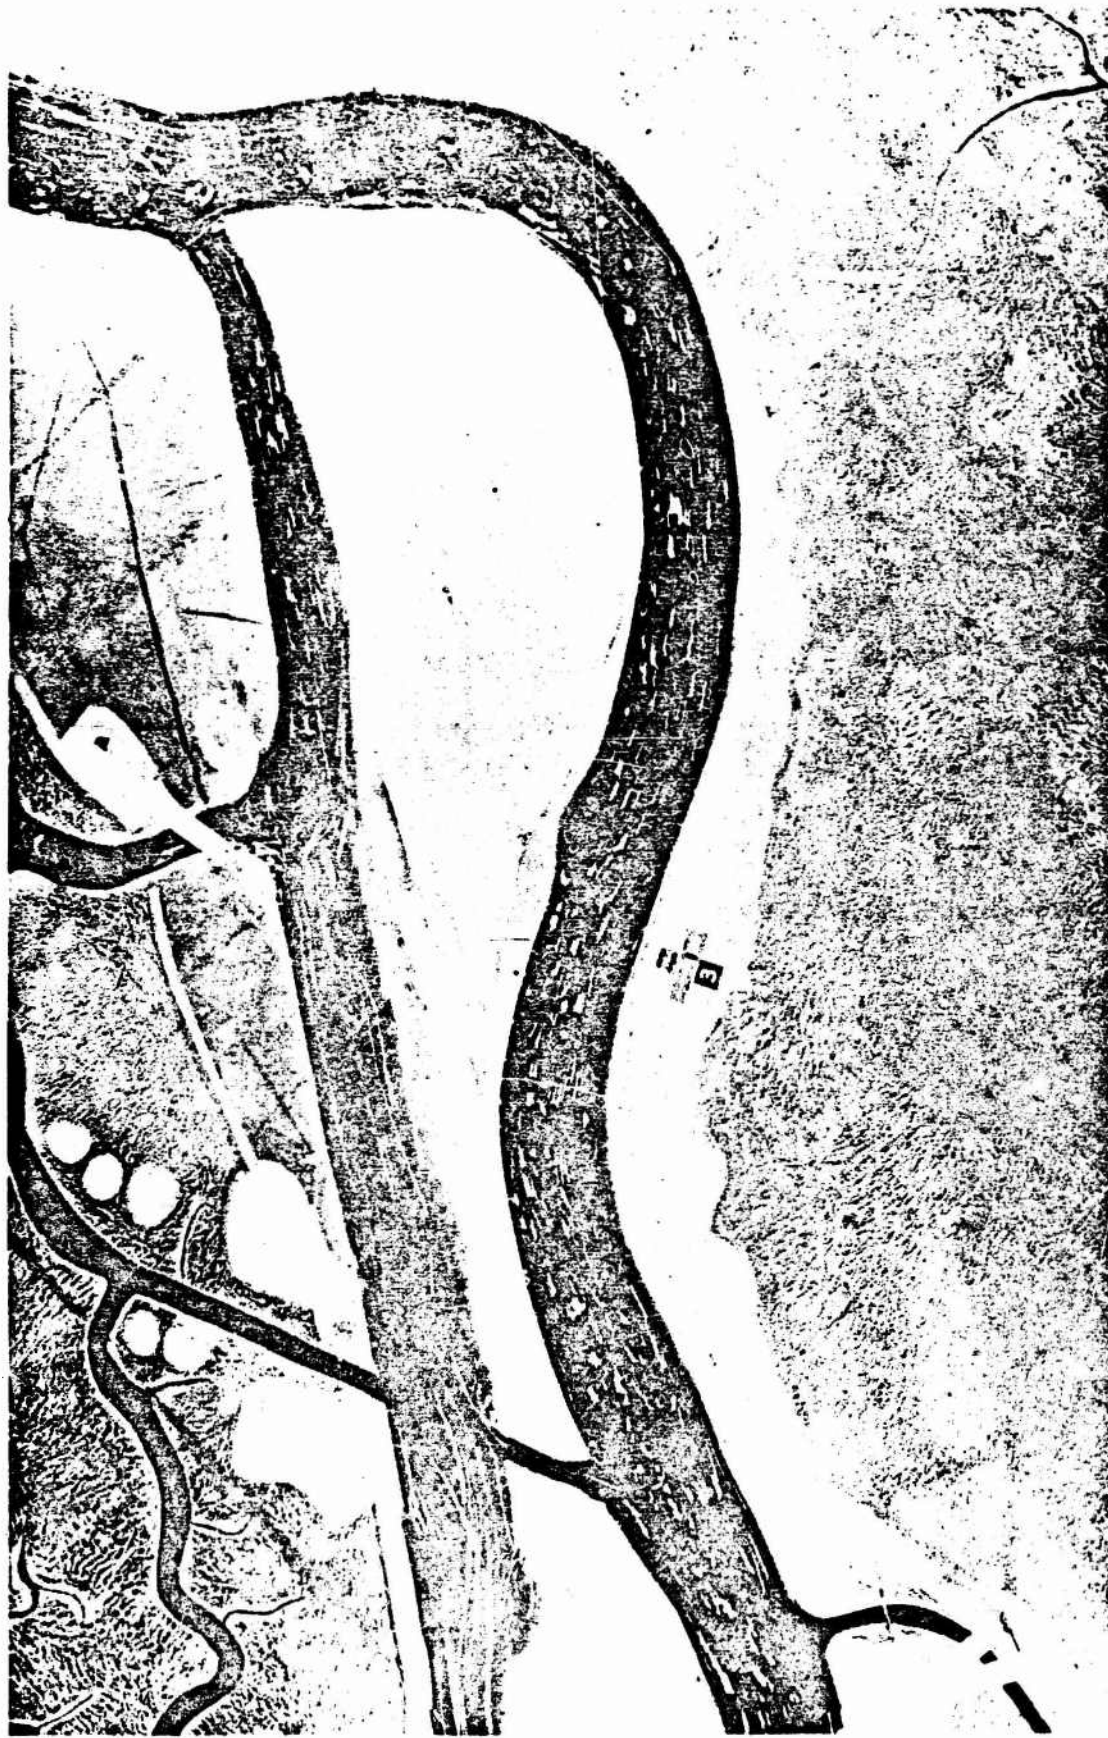
Photograph 4. Surface current directions and velocities for 1964 channel conditions. Hour 3, ebb tide

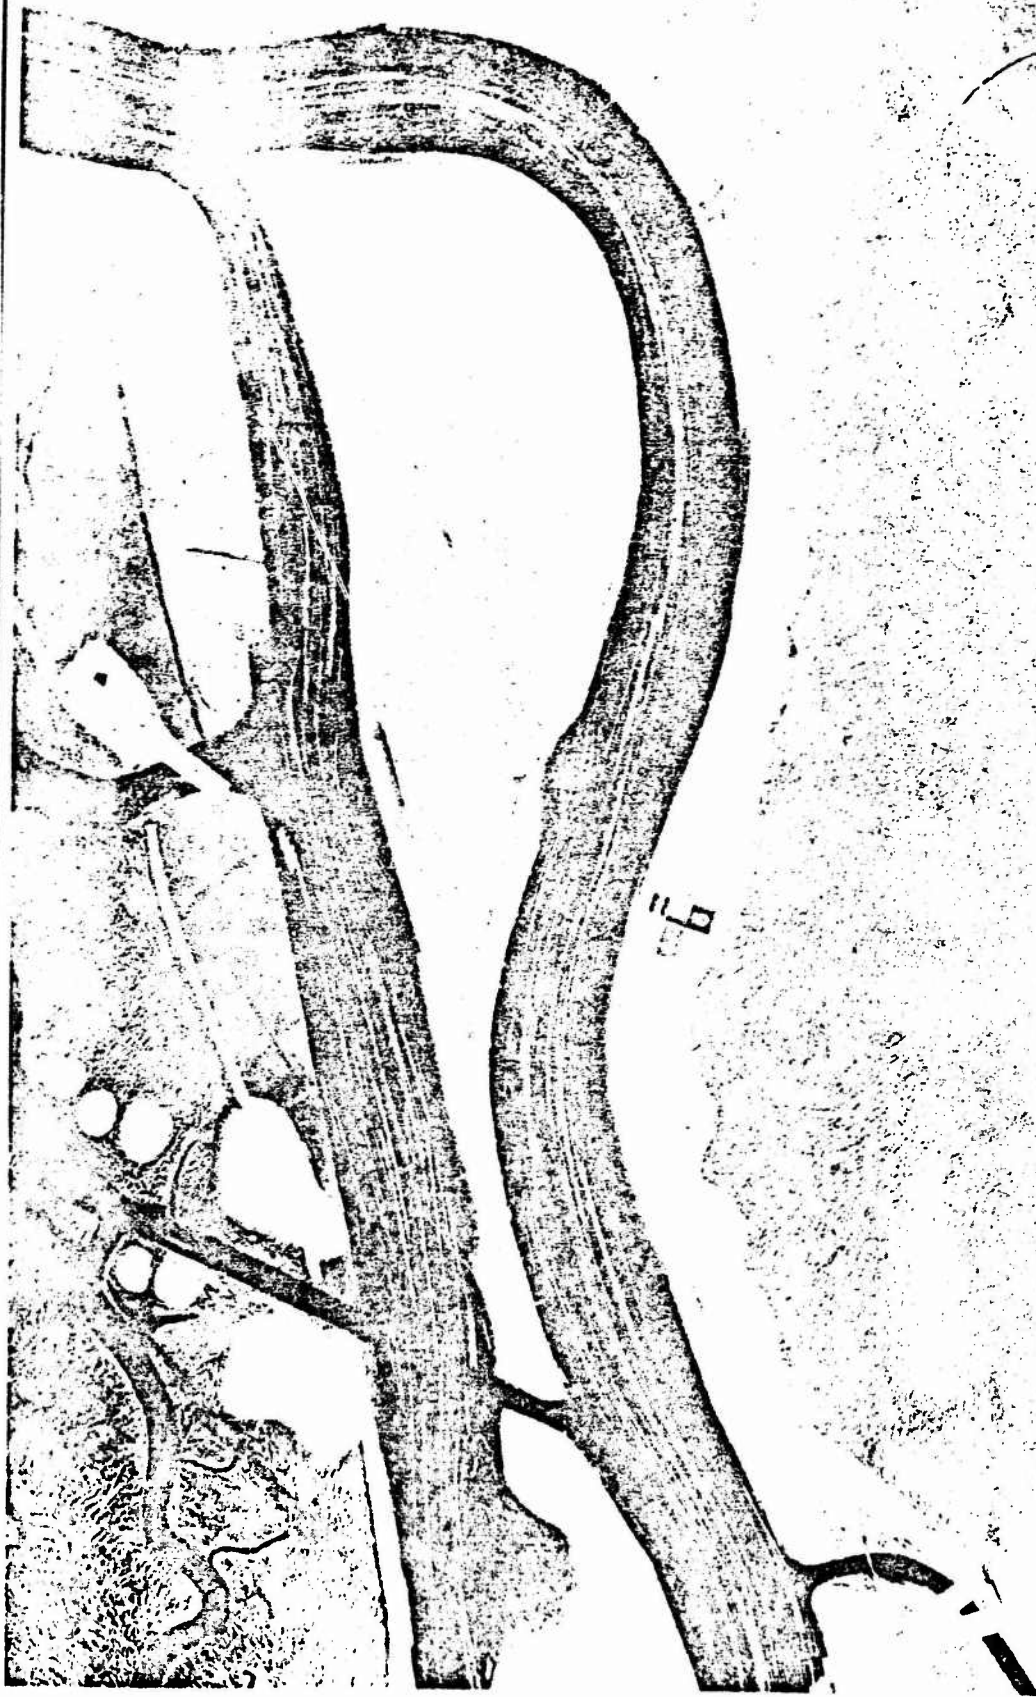
Photograph 7. Surface current directions and velocities for 1964 channel conditions. Hour 6, flood tide

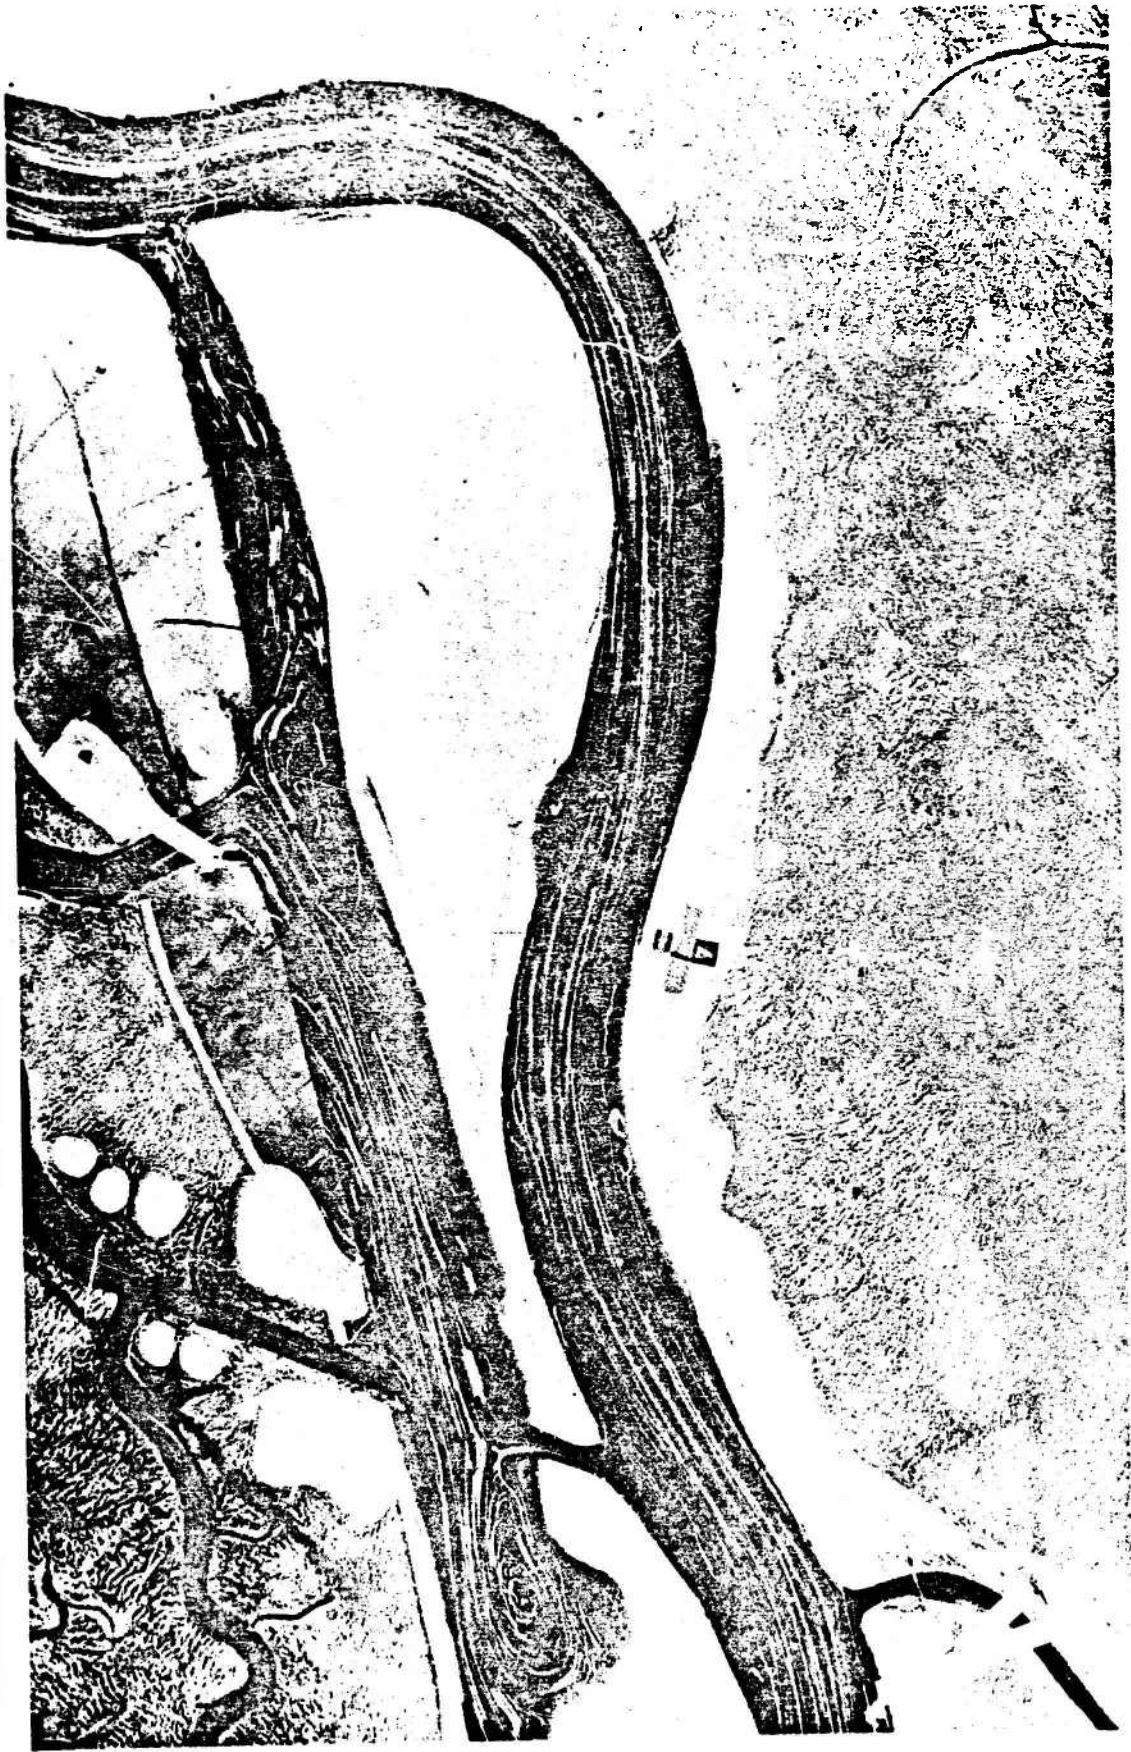
Photograph 8. Surface current directions and velocities for 1964 channel conditions. Hour 7, flood tide

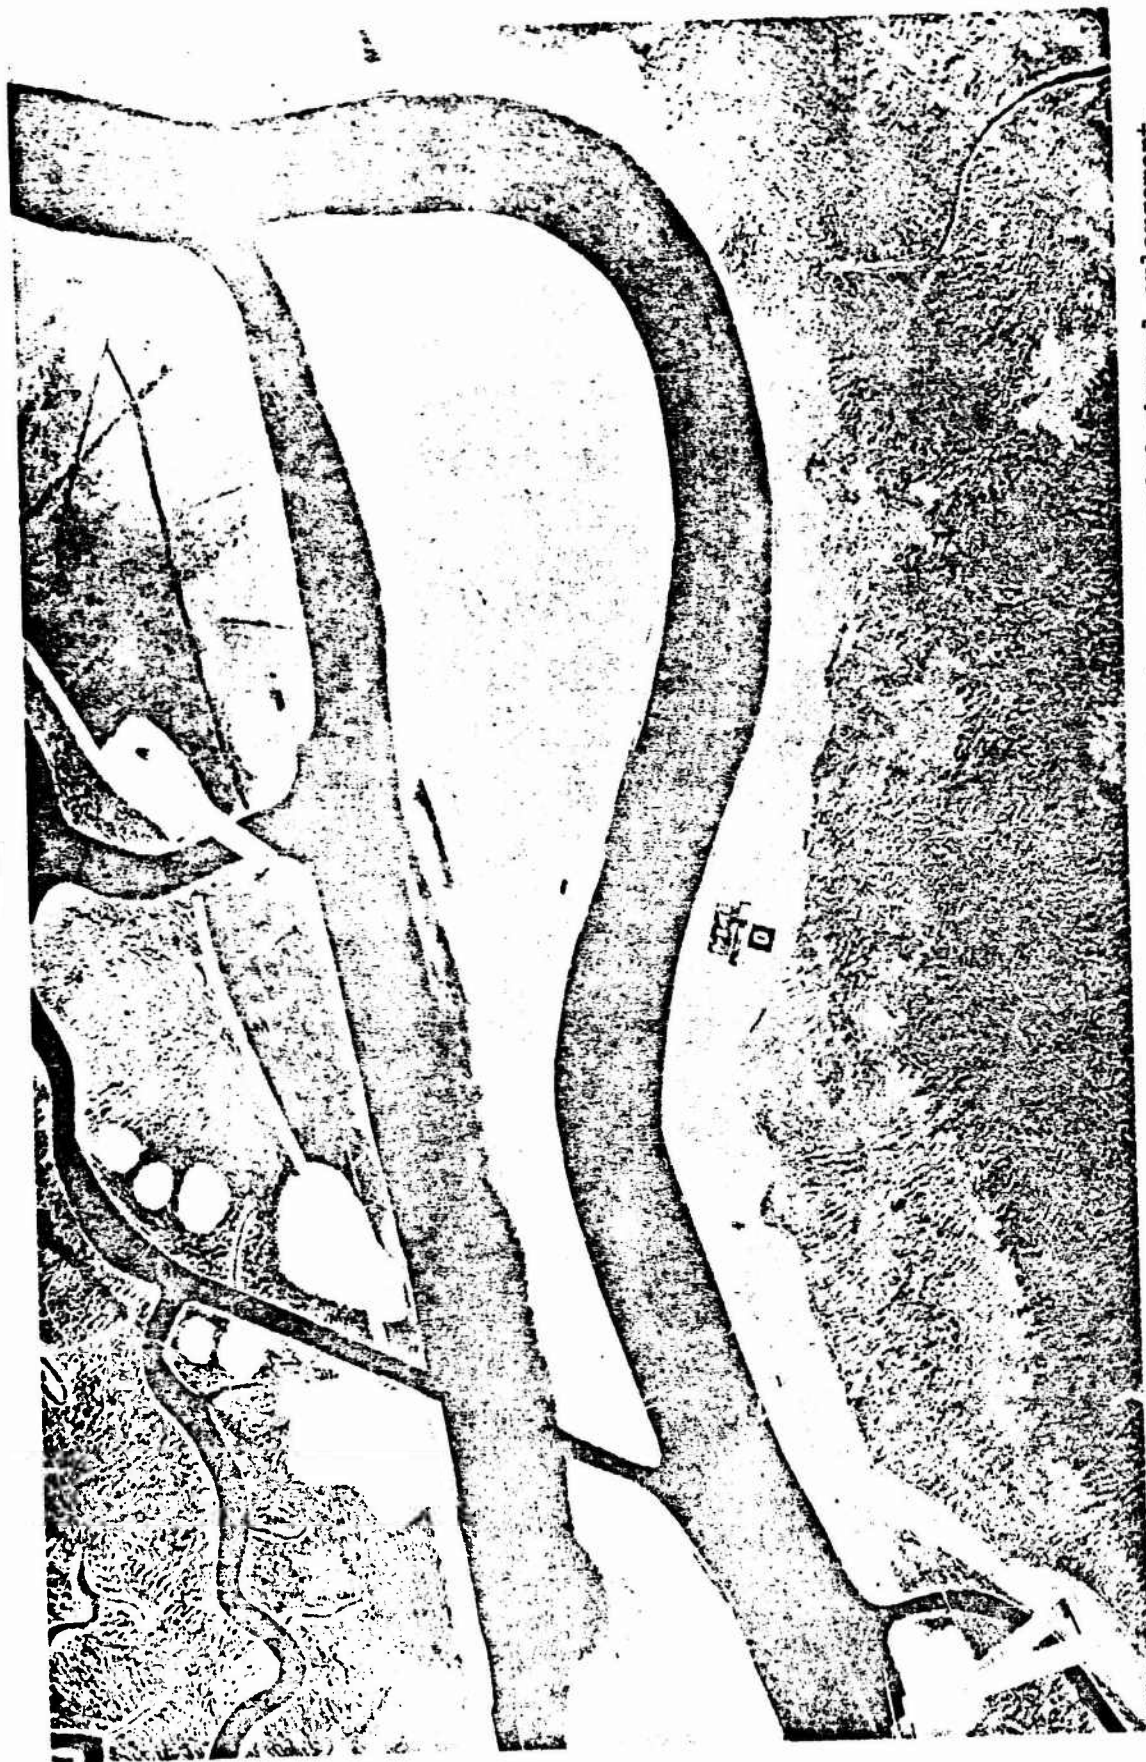
Photograph 11. Surface current directions and velocities for recommended channel enlargement.  
Hour 0, ebb tide

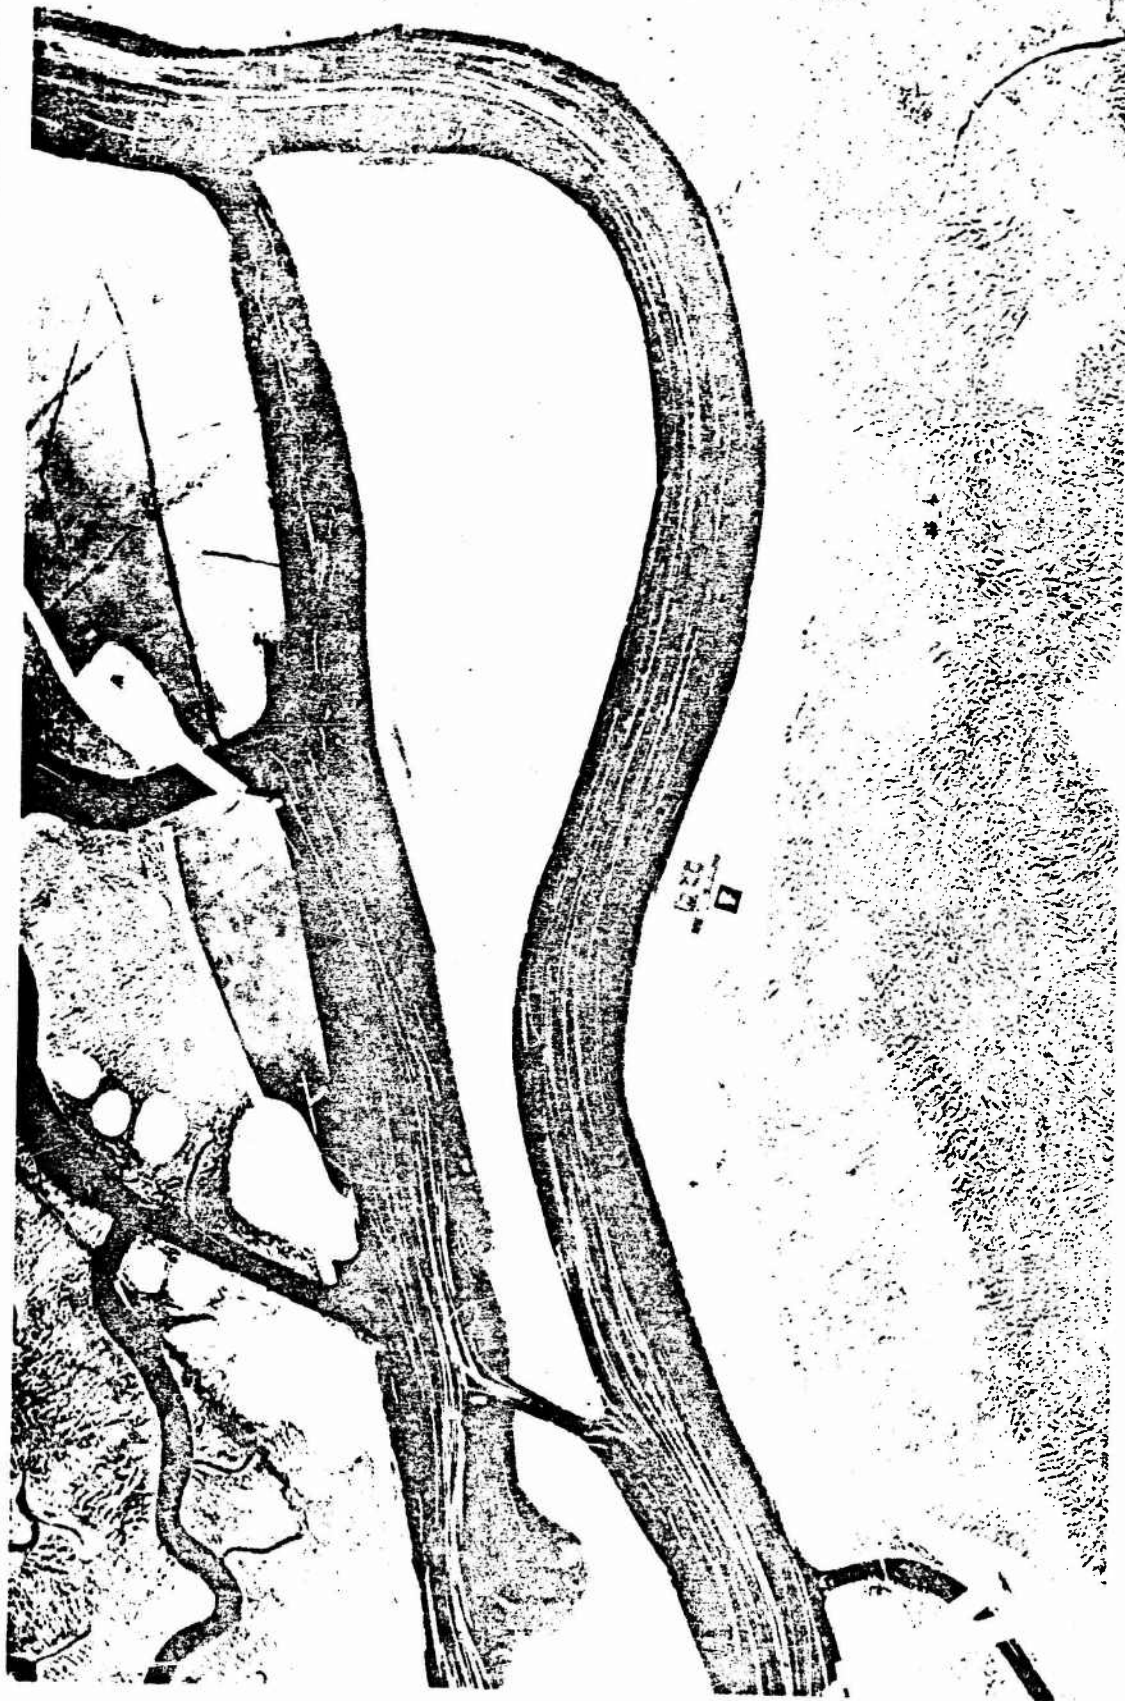
Photograph 21. Surface current directions and velocities for recommended channel enlargement.  
Hour 7, flood tide

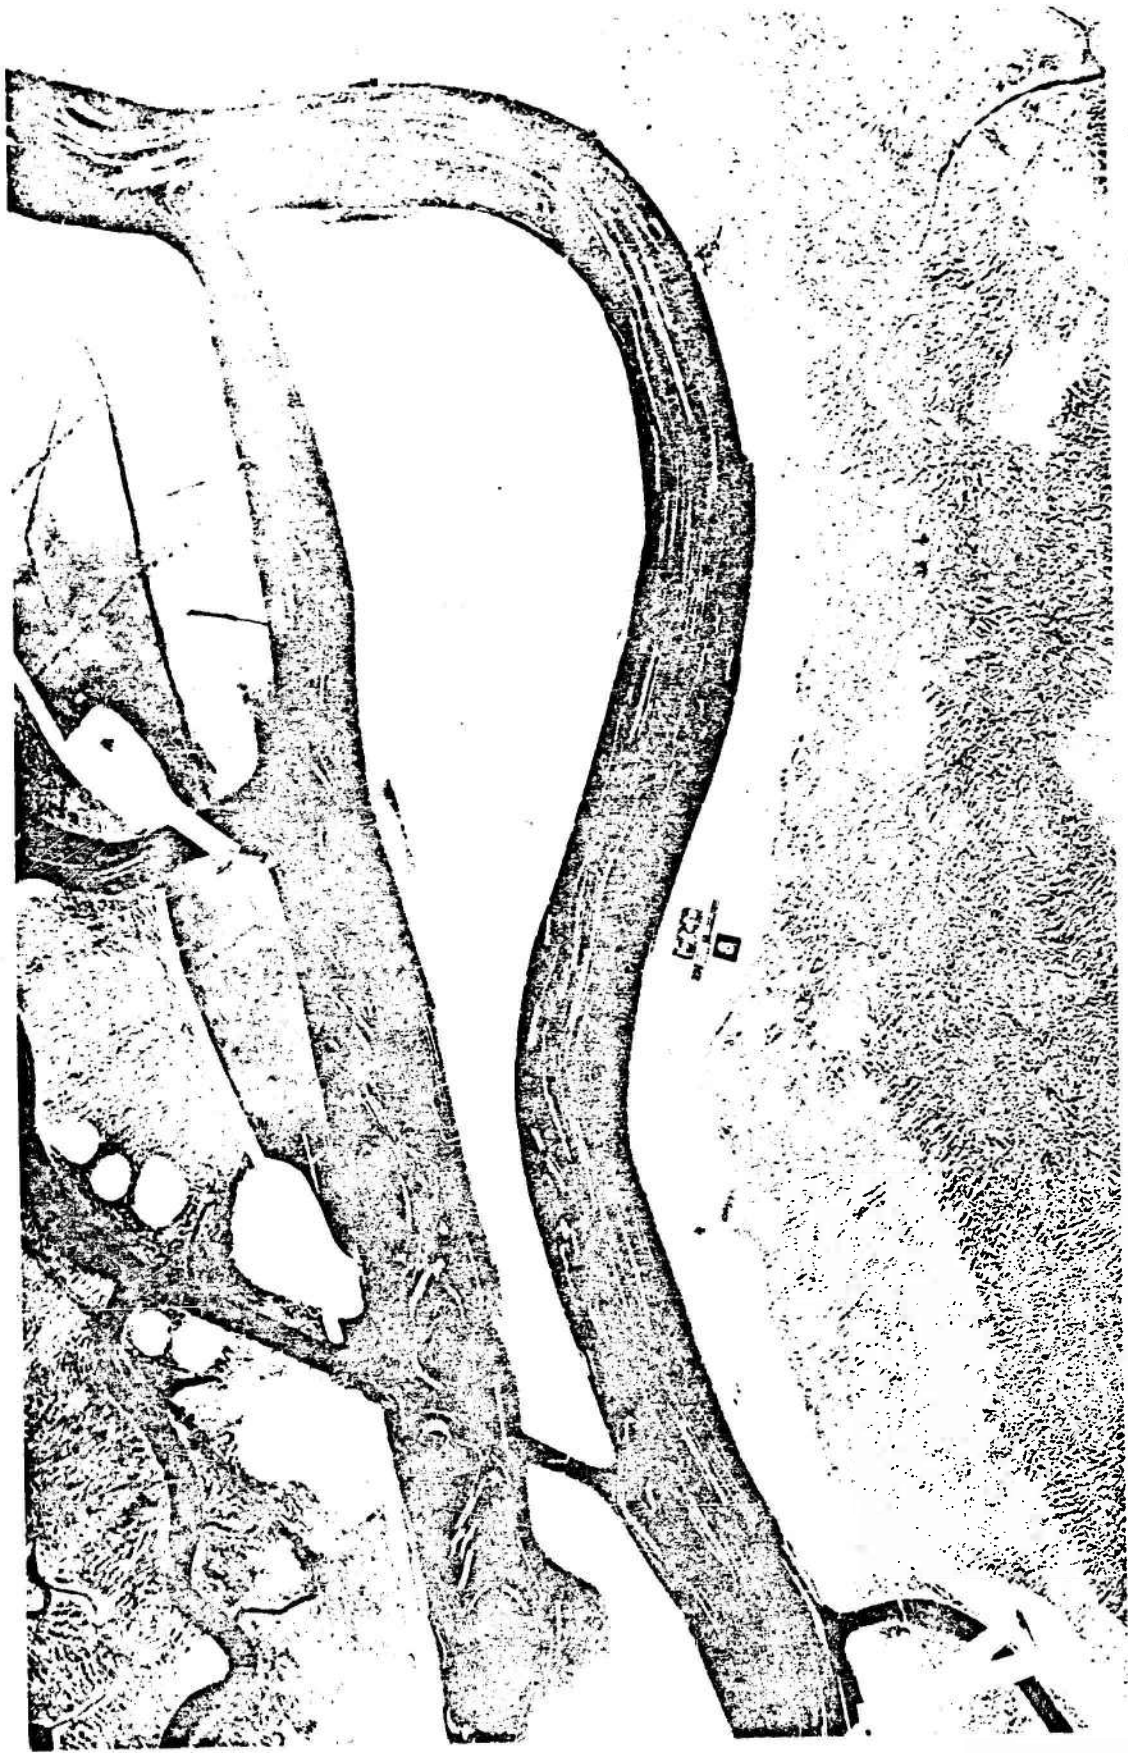
Photograph 22. Surface current directions and velocities for recommended channel enlargement.  
Hour 8, flood tide

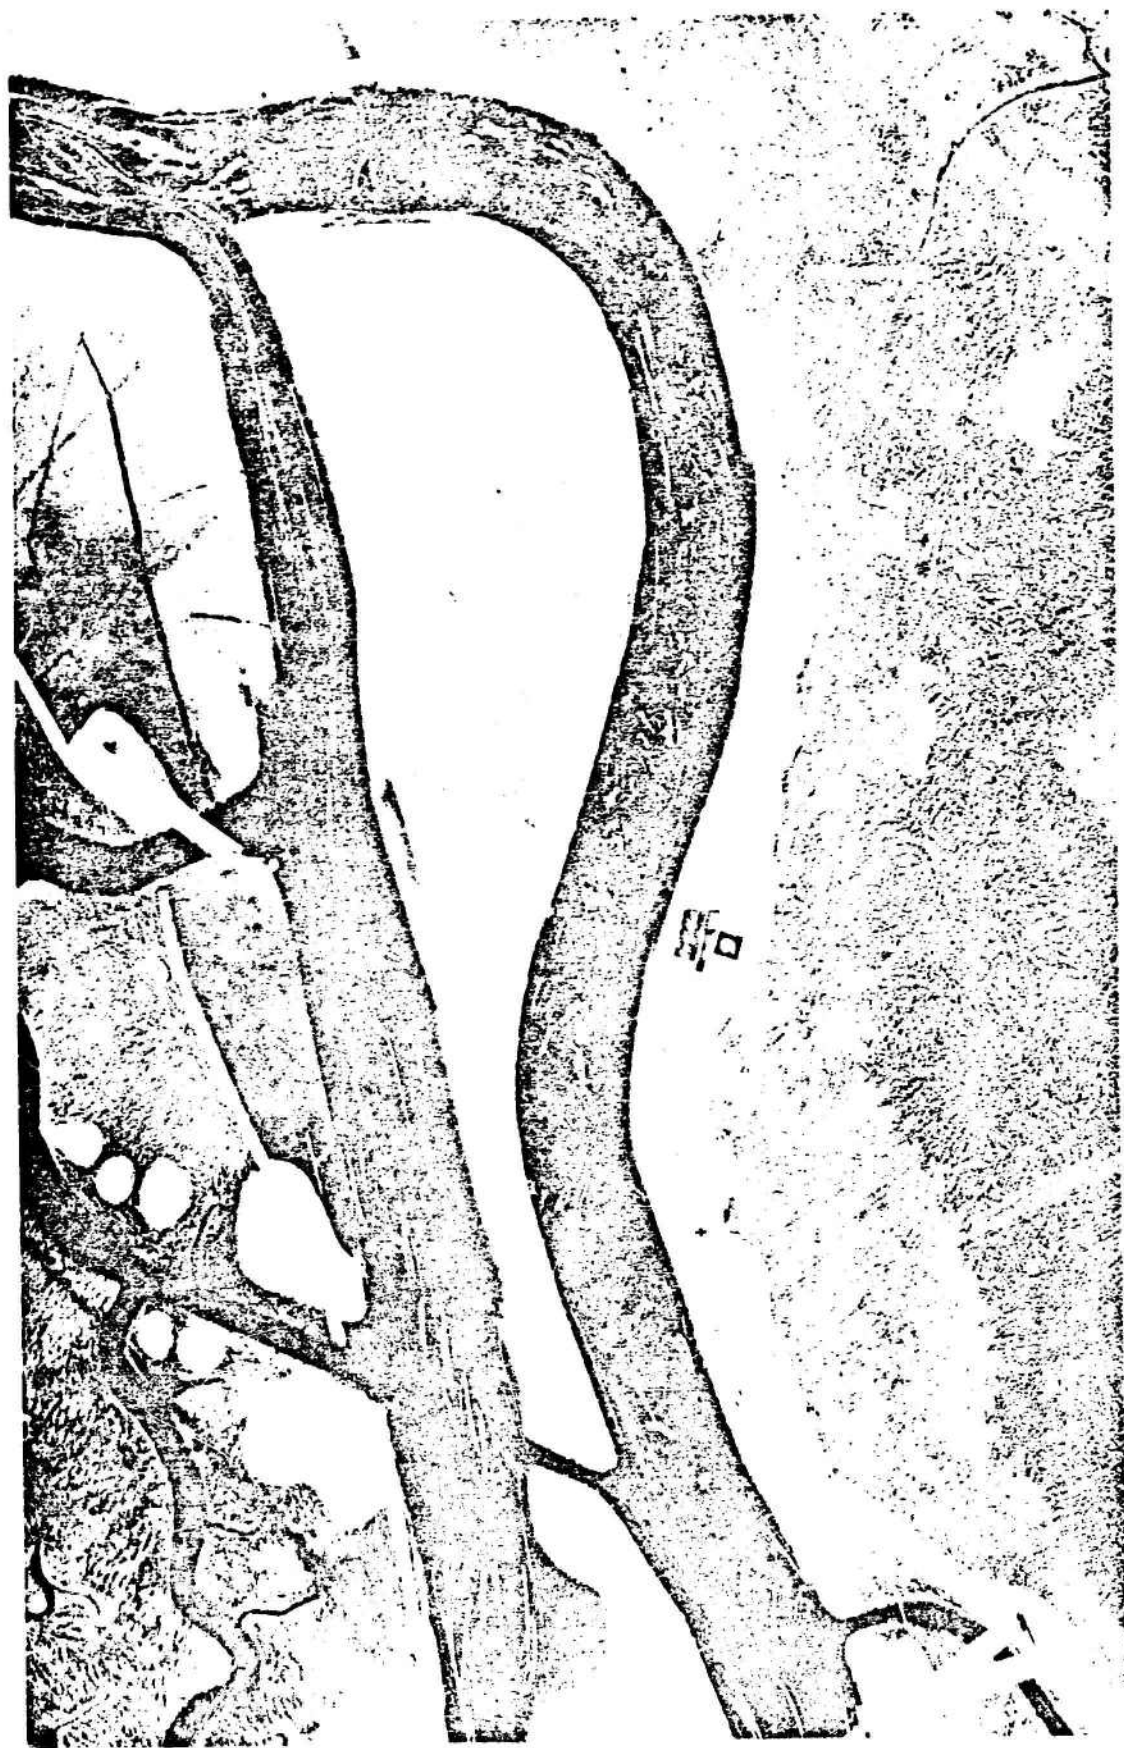
Photograph 23. Surface current directions and velocities for recommended channel enlargement.  
Hour 9, ebb tide

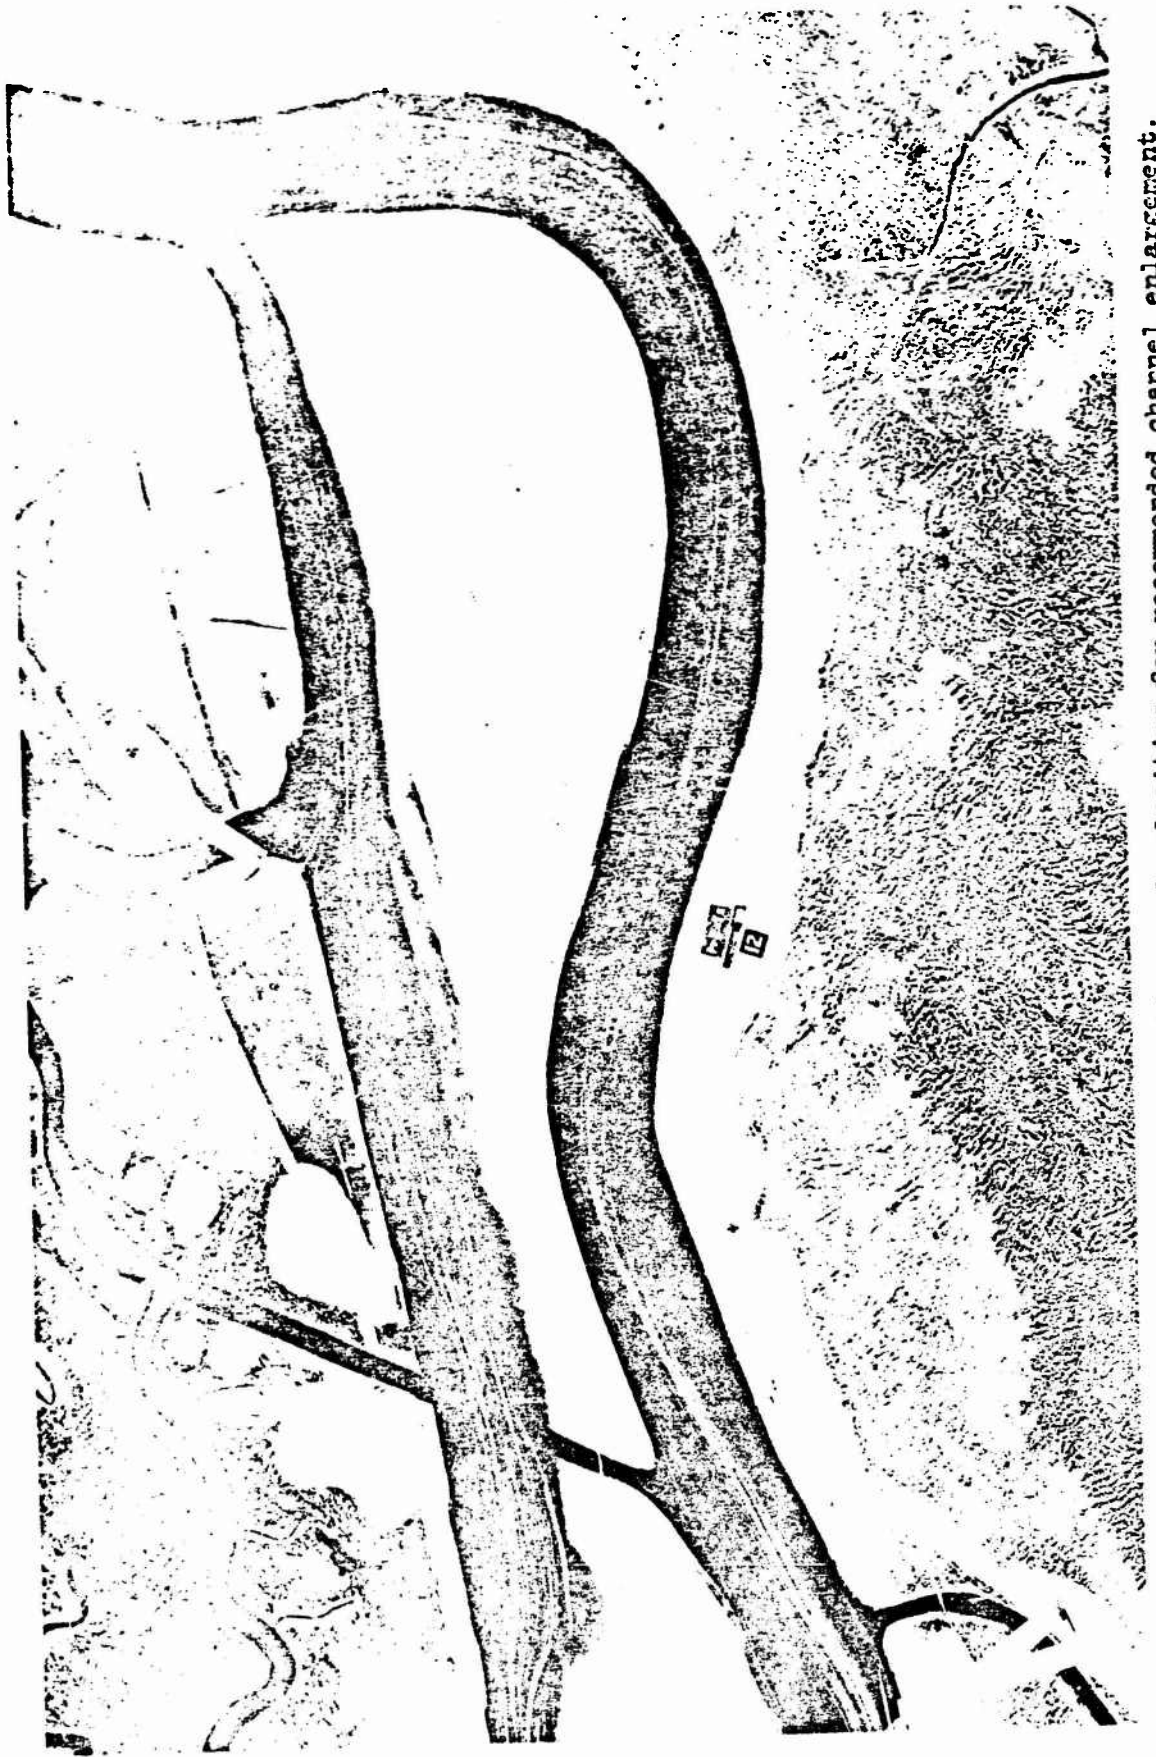
Photograph 26. Surface current directions and velocities for recommended channel enlargement.  
Hour 12, ebb tide
