**RESEARCH, DESIGN, FABRICATION, AND
FIELD TESTING OF A NINETY (90) FOOT
SPAN, TWO (2) ARCH EVALUATION SEGMENT.
AIRCRAFT MAINTENANCE HANGAR**

TECHNICAL REPORT ASD-TR-71-2

FEBRUARY 1971

**AIR MOBILITY PROGRAM OFFICE
AERONAUTICAL SYSTEMS DIVISION
AIR FORCE SYSTEMS COMMAND
WRIGHT-PATTERSON AIR FORCE BASE, OHIO**

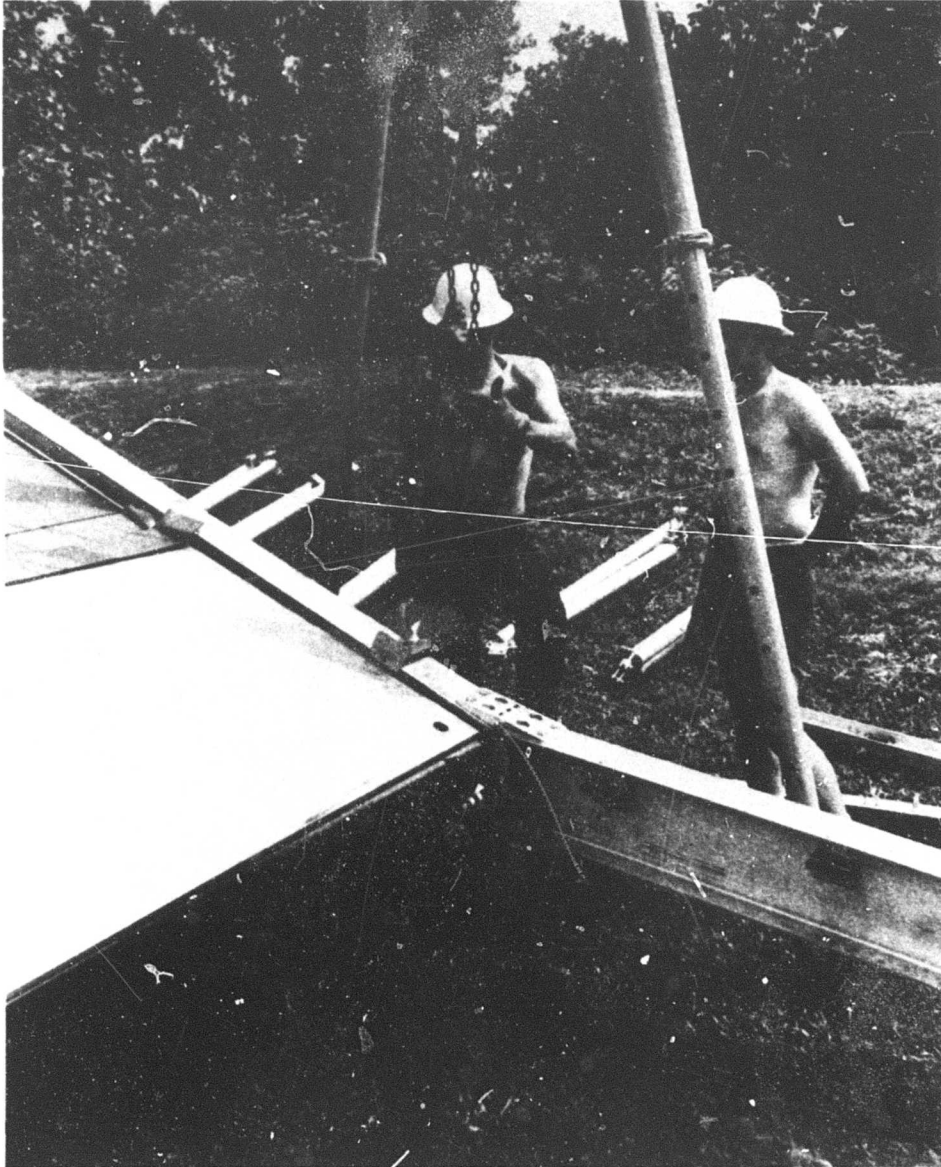
Figure 37. Lifting the Arch

When the arch becomes too heavy to lift by hand (depending on manpower available) use the erection gantry, chain hoists and clamps to lift the arch assembly. (Fig. 37)

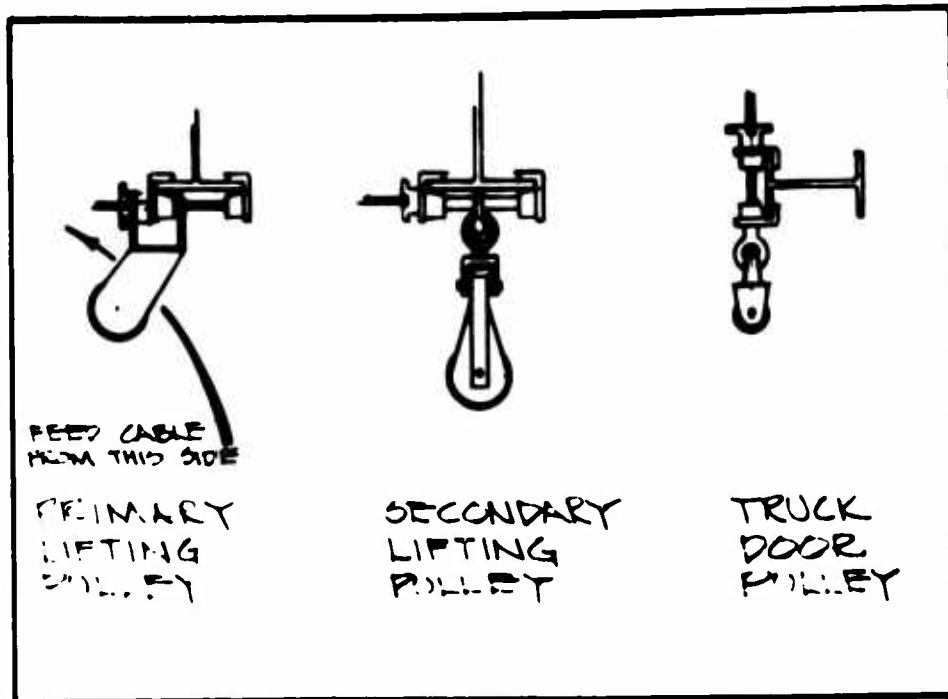
Figure 46. Lifting Pulleys

In addition to adding more lower arch beams and trusses, the lifting pulleys are also located. There are six primary lifting pulleys (Fig. 46) which are attached at fixed positions on the front arch of the openable end wall arch. (Fig. 47)

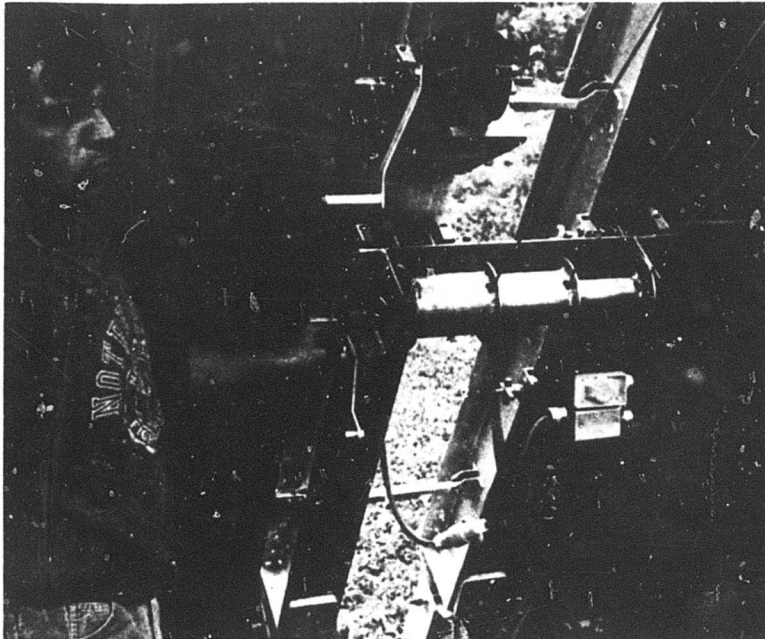
Figure 68. Three-Barrel Winch Assembly

To perform this action, two three-barrel winch assemblies are located on the main arch beams, one on each side of the structure approximately 3.5' from the ground (Fig. 68). The cables from the secondary pulleys are fed onto the winches, the shortest cables are attached to the smallest barrels, the longest cables are attached to the largest barrels, and the intermediate length cables are attached to the center barrels. An important principle used in the design of the winch was to limit the wrappings on the winch barrels to one thickness to efficiently control the amount of cable taken up, thus raising the end wall at a predetermined rate. (Fig. 69)
