THE EFFECT OF RESIDUAL STRESS ON CRACK PROPAGATION IN HY-80 STEELS

INTERIM REPORT
Contract Number N00014-70-C-0265
SwRI Project 03-2801

for
Office of Naval Research
Department of the Navy
Washington, D. C. 20360

October 22, 1971

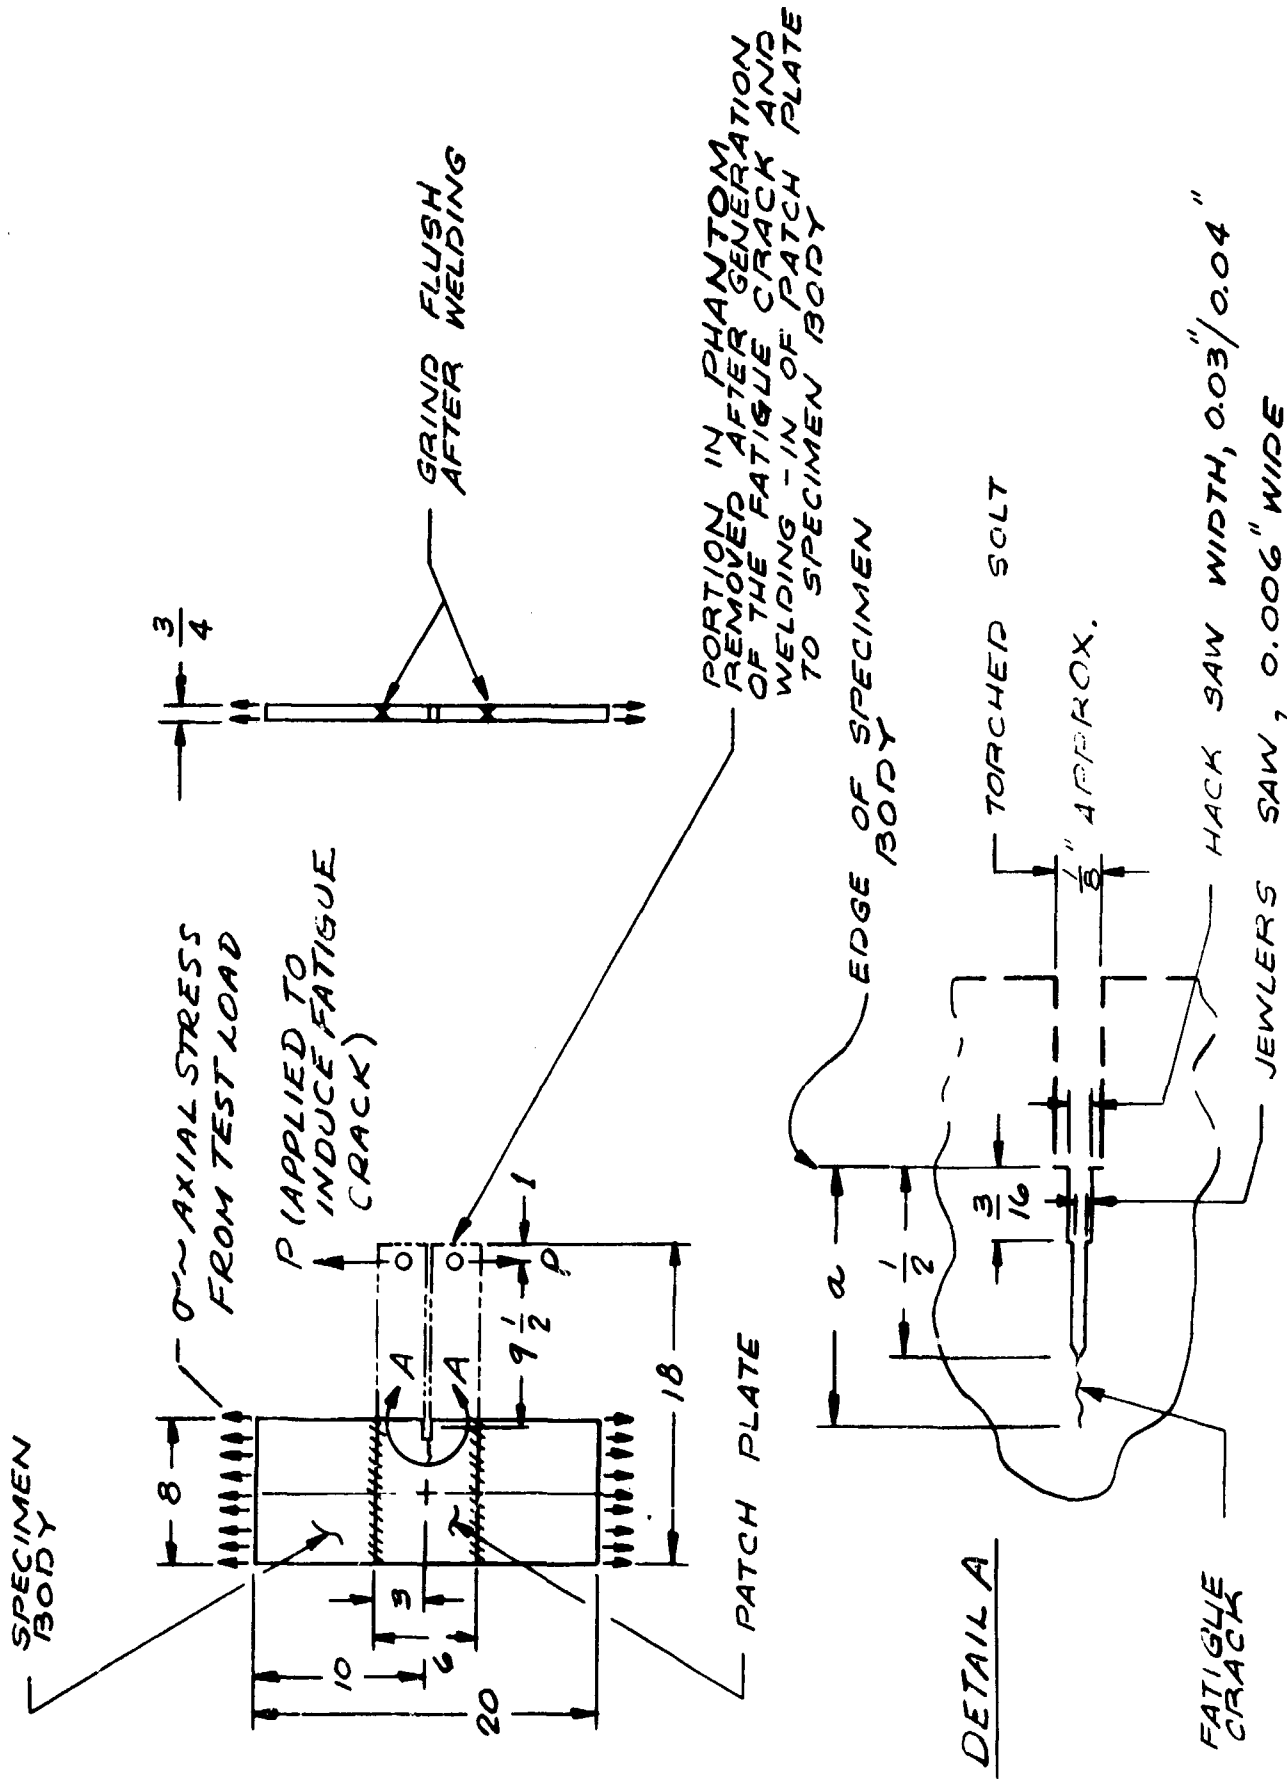
FIGURE 3. SPECIMEN CONFIGURATION "A"

The specimen was fabricated by introducing, into a patch plate, a fatigue crack at the tip of a torched plus saw-sharpened slot; the patch plate was then welded into the specimen body. This is shown in Figures 3 and 4. Therein, it will be noted that in the "A" configuration patch, a stress near the crack tip will not be induced as a result of cooling - and accompanying shrinkage - of the weld because no restraint is offered by the specimen geometry; in the "B" configuration, however, restraint is offered by the specimen body and, as cooling progresses, tensile stresses are induced across the patch, normal to the fatigue crack.

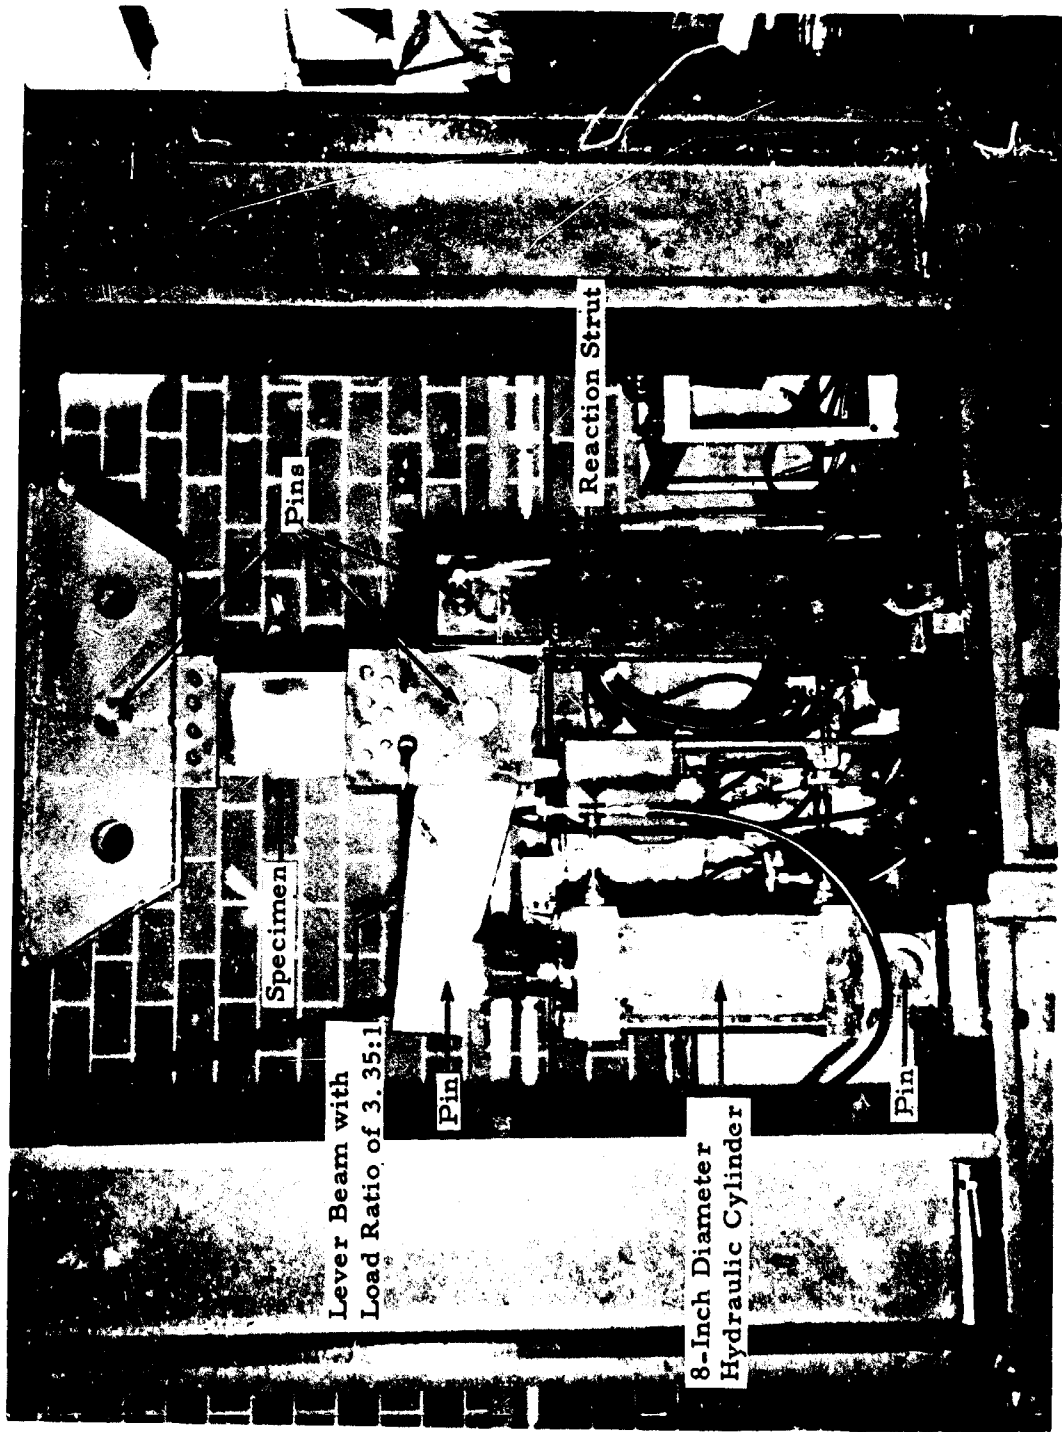
FIGURE 5. THE LOADING FRAME WITH SPECIMEN INSTALLED

After initiation and propagation of the fatigue crack into the patch plate for a distance of 1/2-inch approximately, strain gages with axes parallel to the specimen axis were affixed on both sides of the specimen, adjacent to the crack tip. These gages served a dual purpose in that they were used to monitor strains induced by welding and, also, to detect any tendency for transverse bending due to side-to-side eccentricity of the later applied load. Because of the proximity of the gages to the weld area, Micro-Measurements, Inc. high temperature type gages were used. The instrumented specimen was then mounted in the loading frame shown in the photograph, Figure 5. This loading fixture incorporated an 8-inch diameter hydraulic cylinder attached to a lever beam which had a mechanical advantage of 3.35:1. As all joints were pinned, (see Figure 5), the

specimen was loaded as a two force member even though the lever beam and pin traveled in a circular arc.

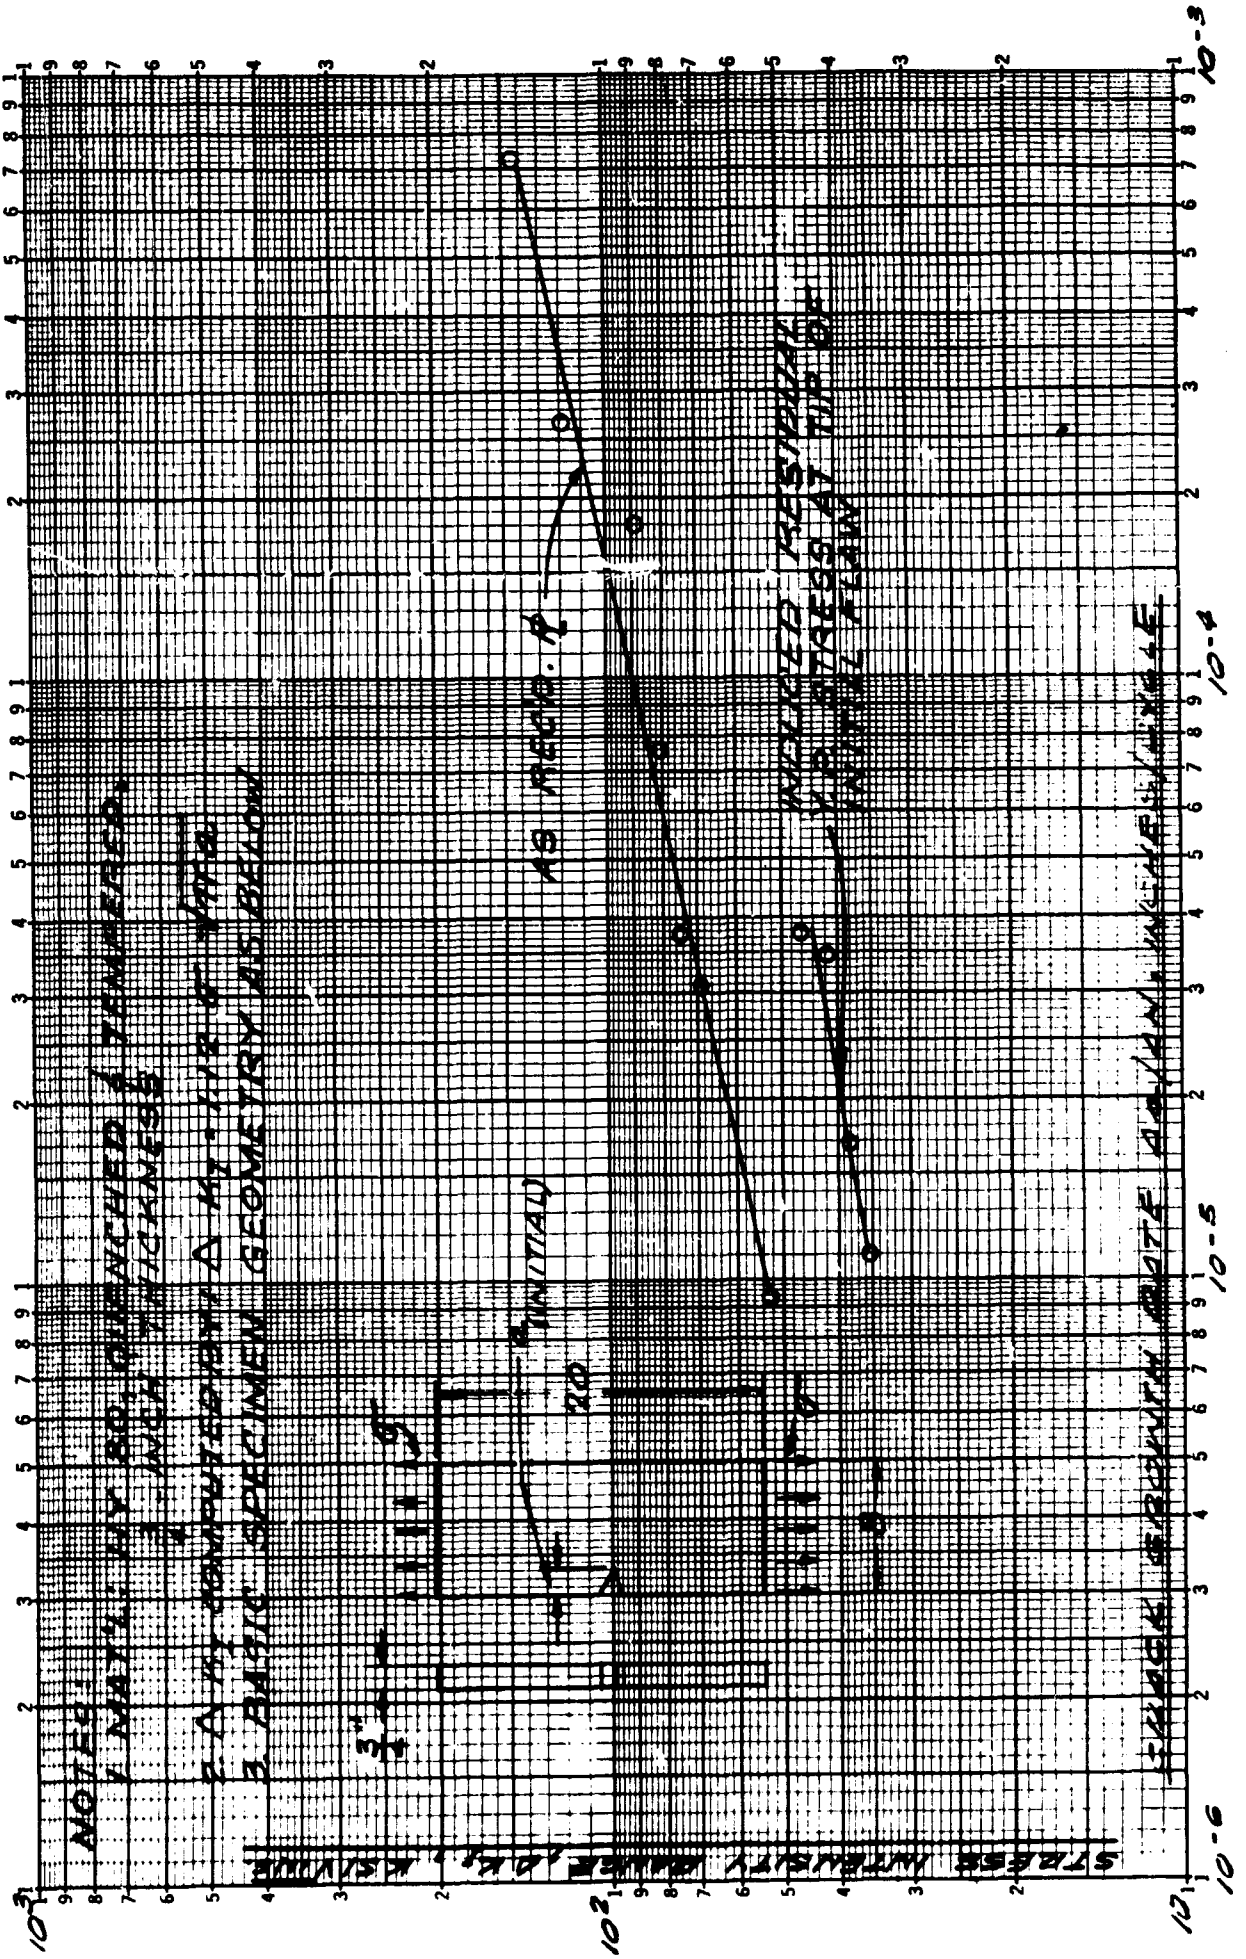
FIGURE 6. CRACK GROWTH RATE VS STRESS INTENSITY RANGE - HY-80 STEEL

The results of the tests conducted in this investigation indicate that, as might be expected for a given stress intensity range, crack growth rate is accelerated by the presence of high residual stresses normal to the tip of a fatigue crack. The equation for the rate of growth may be determined from the data of Figure 6. Therein:

$$M = \text{slope of the log-log curve, viz., } 0.225$$

$$M = 0.174 \text{ and,}$$

The latter, by inspection, results in the faster growth rate for any significant value of ΔK .
