**NORSAR PHASE 2**

**INSTALLATIONS 1969 AND 1970**

NORSAR (NORWEGIAN SEISMIC ARRAY)  
PHASE 2

NORWEGIAN DEFENCE  
RESEARCH ESTABLISHMENT  
N-2007 KJELLER - NORWAY  
INTERN RAPPORT S-51

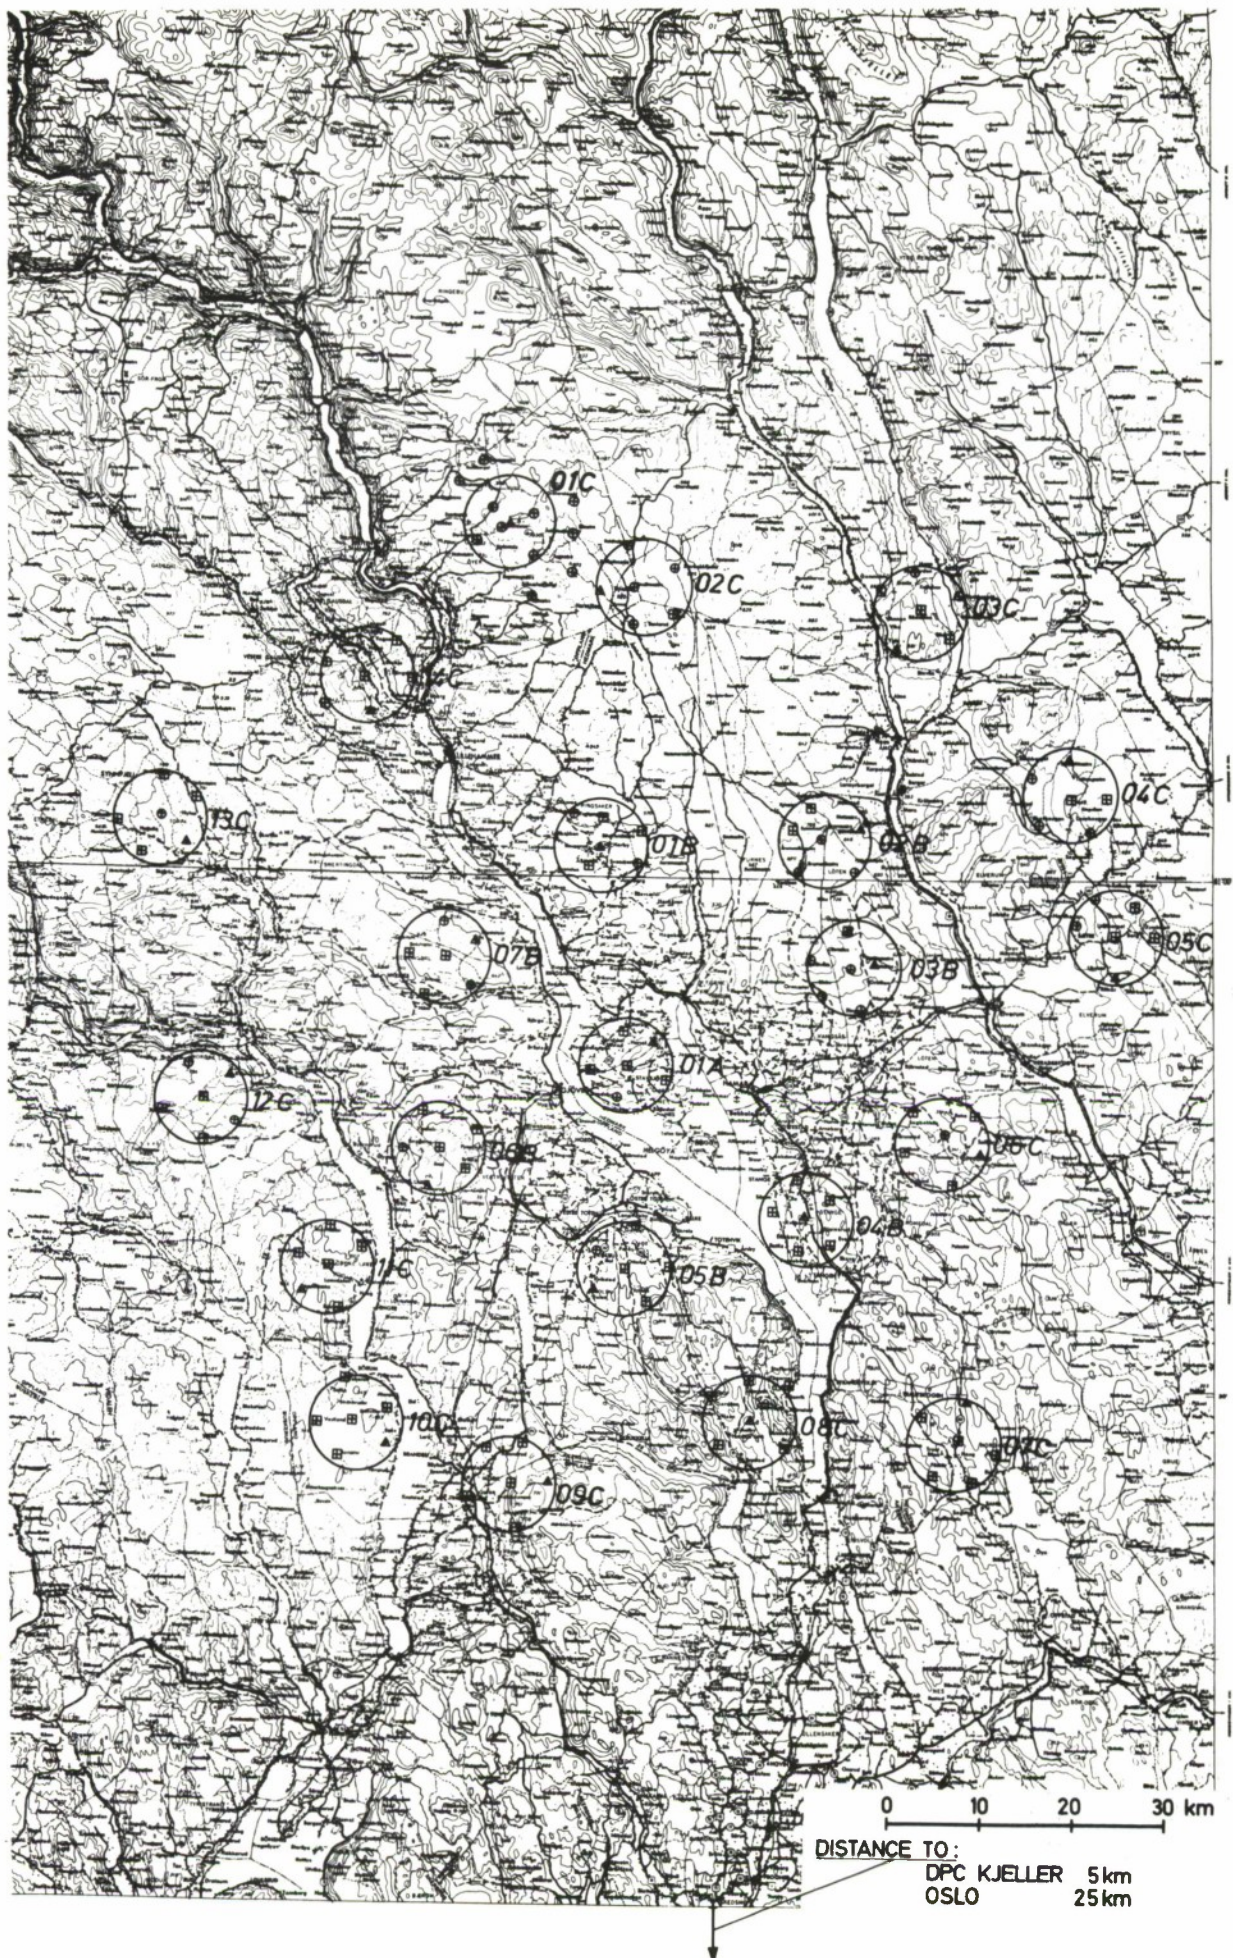
Figure 2.1 NORSAR large seismic array

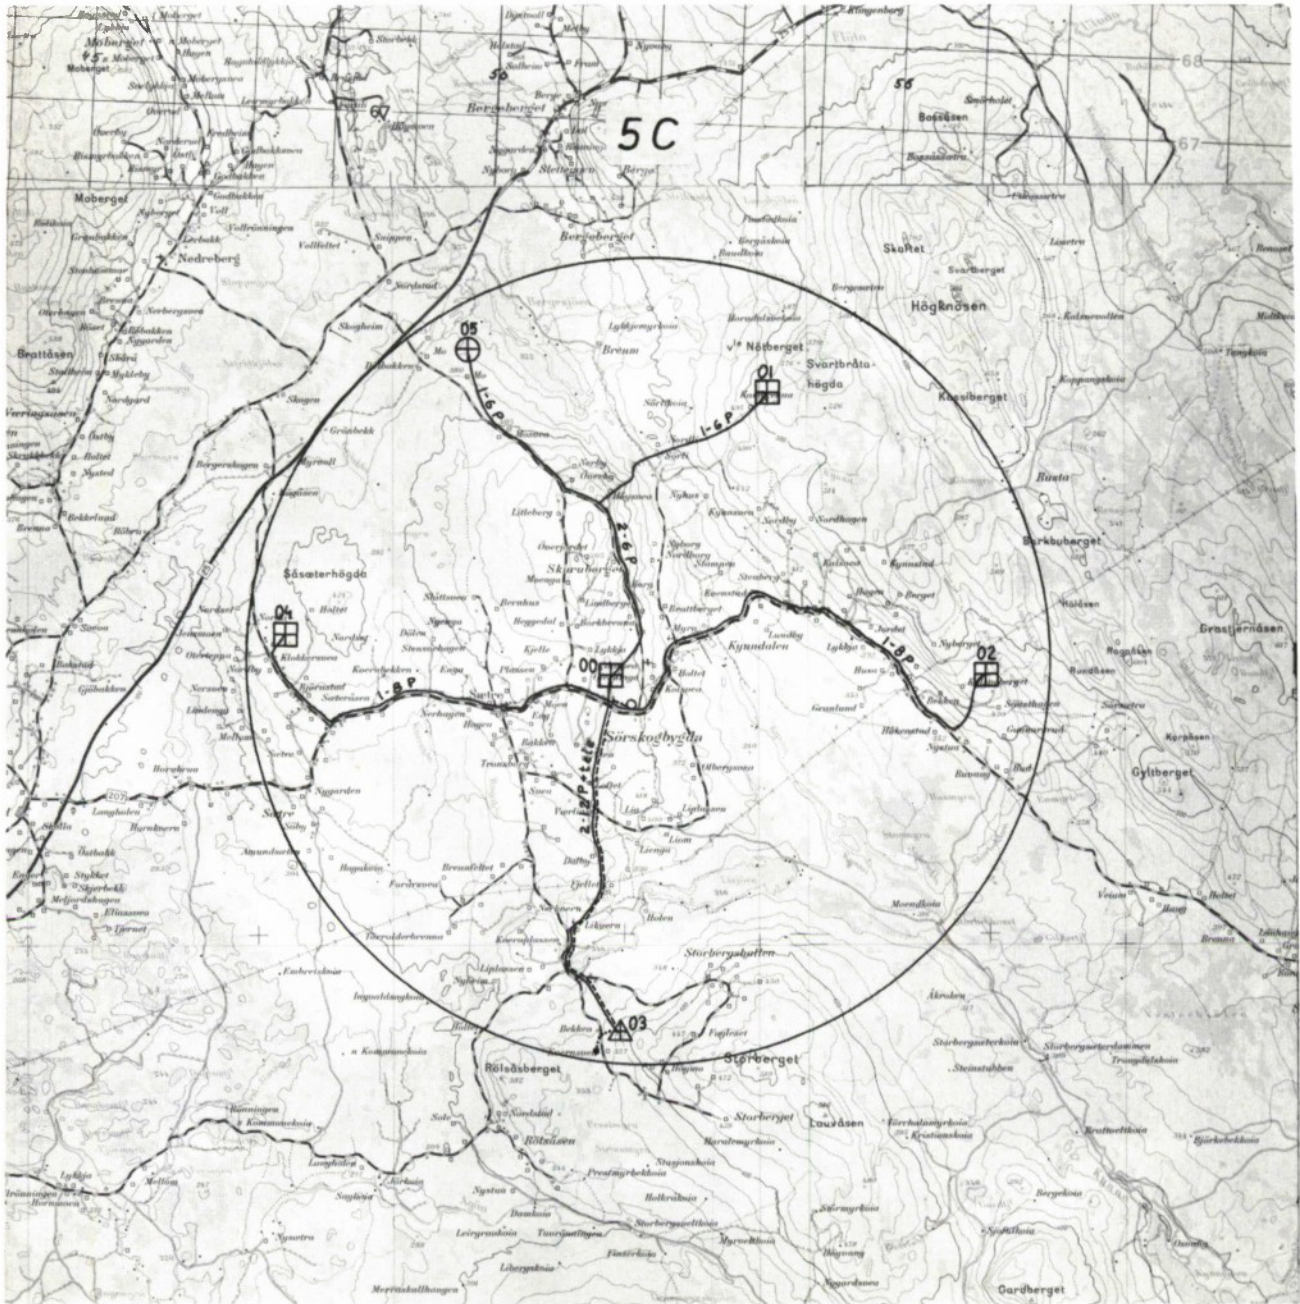
Figure 2.5 Subarray 05C, final configuration

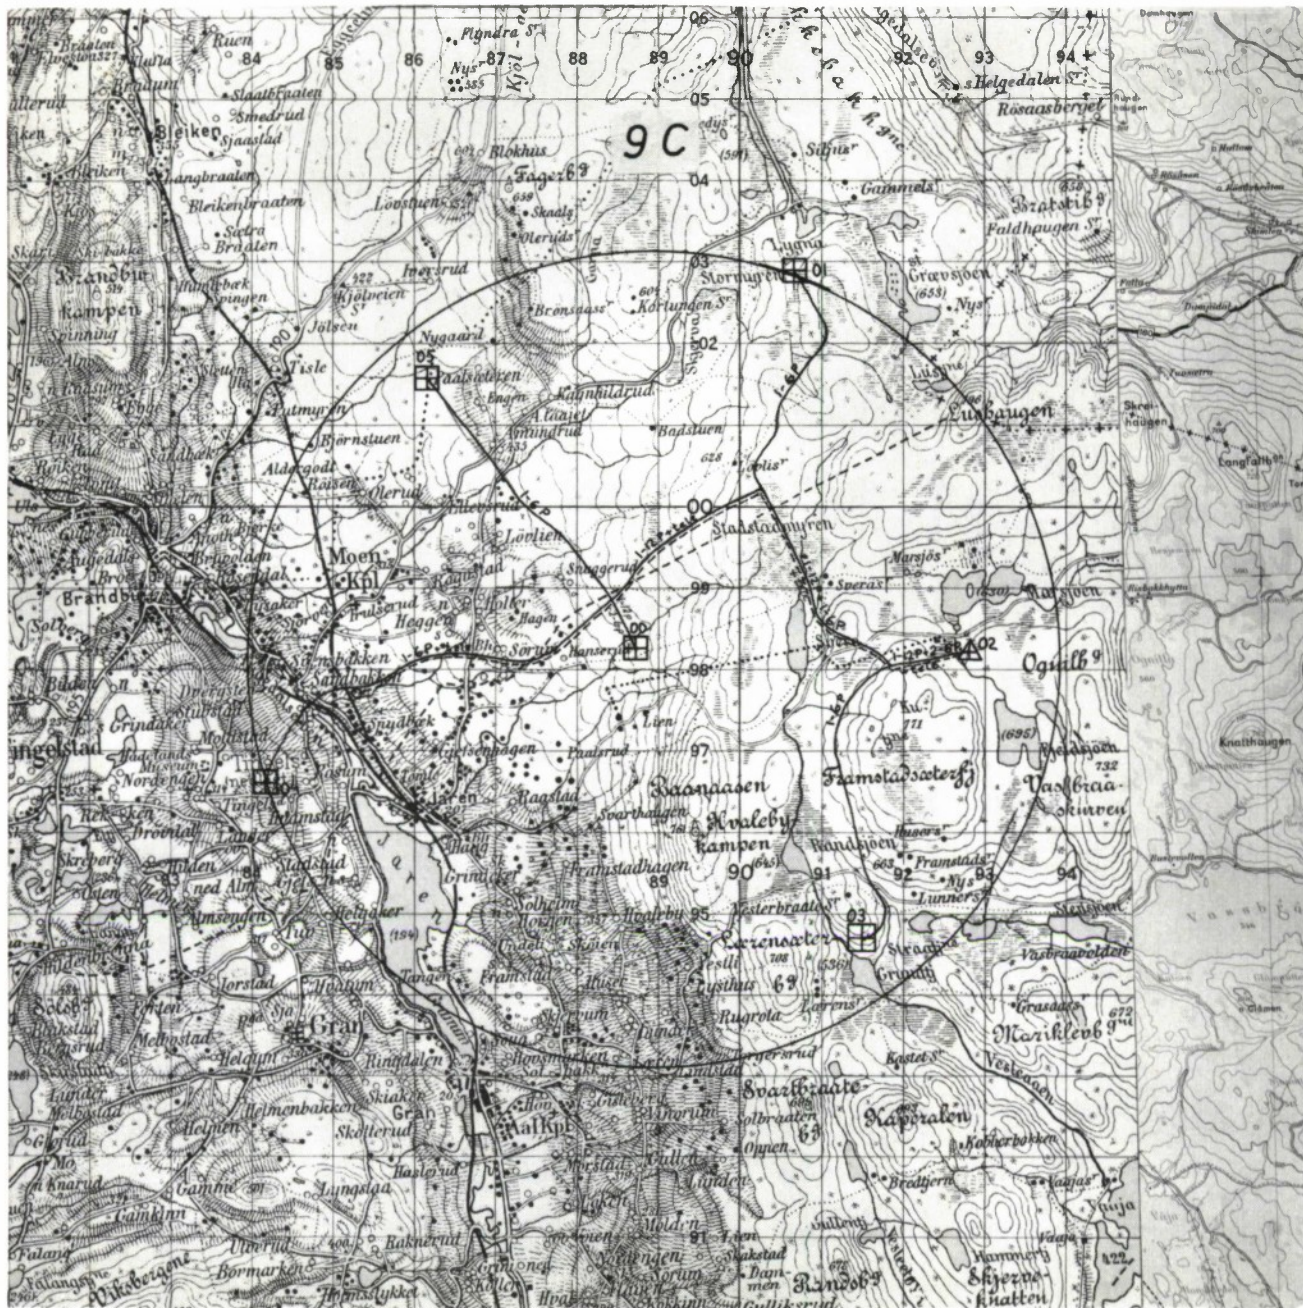
Figure 2.9 Subarray 09C, final configuration

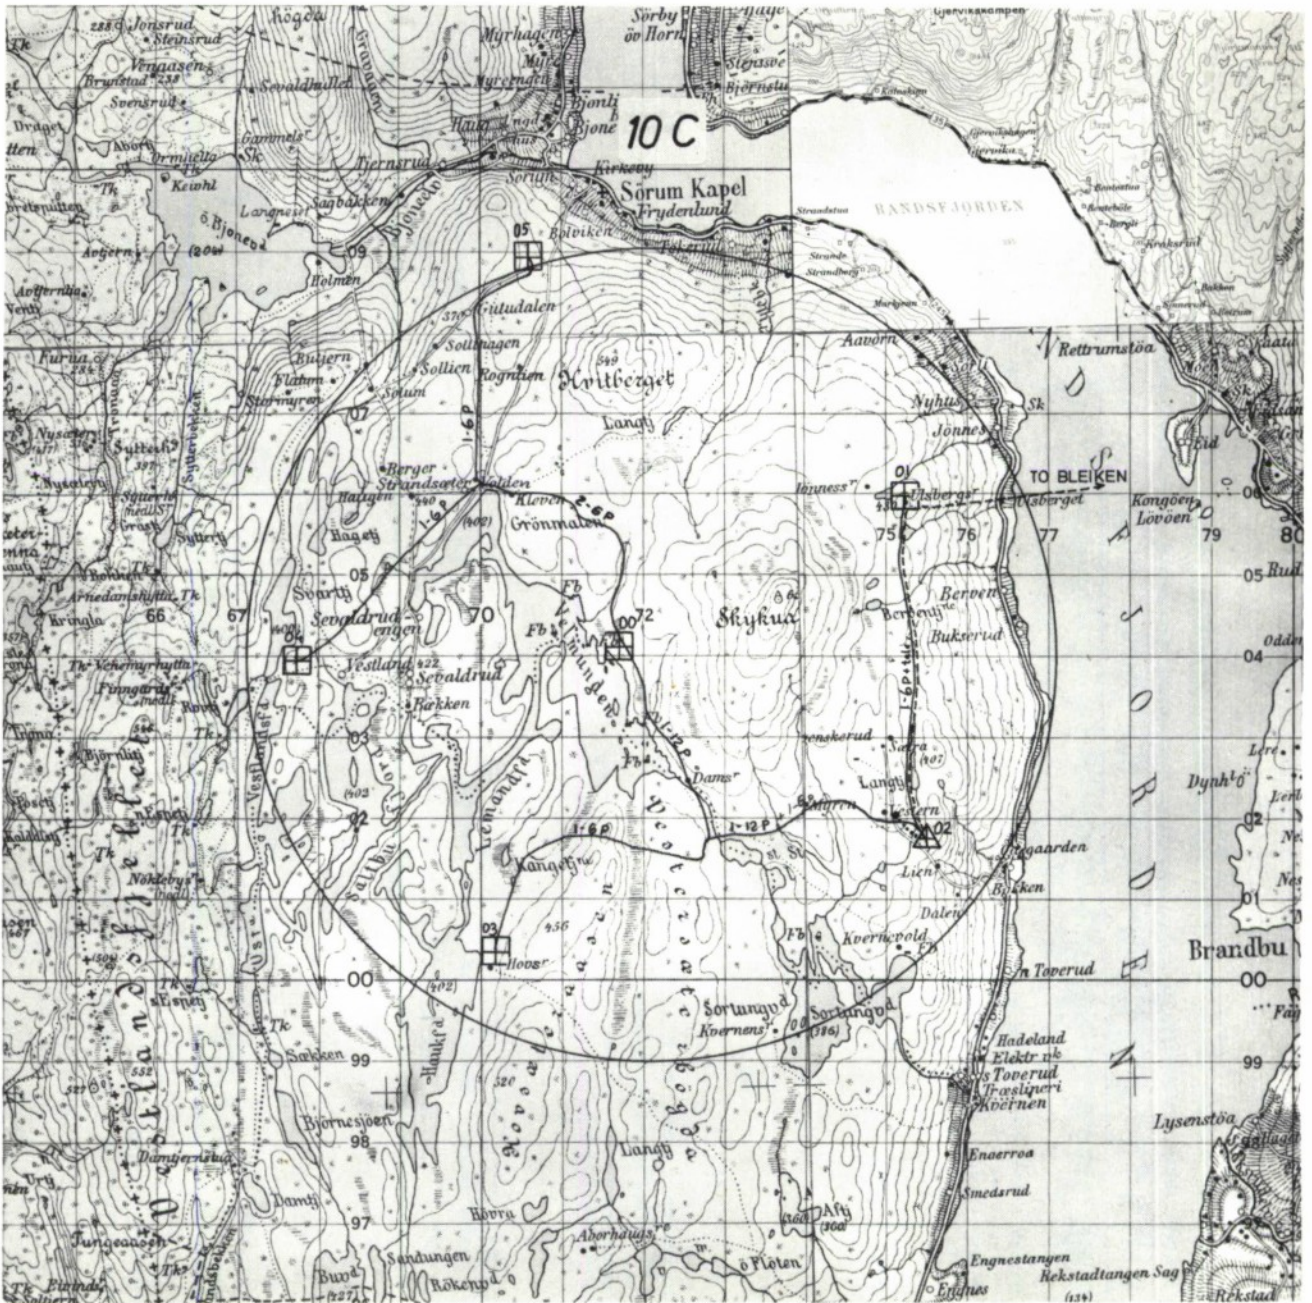
Figure 2.10 Subarray 10C, final configuration

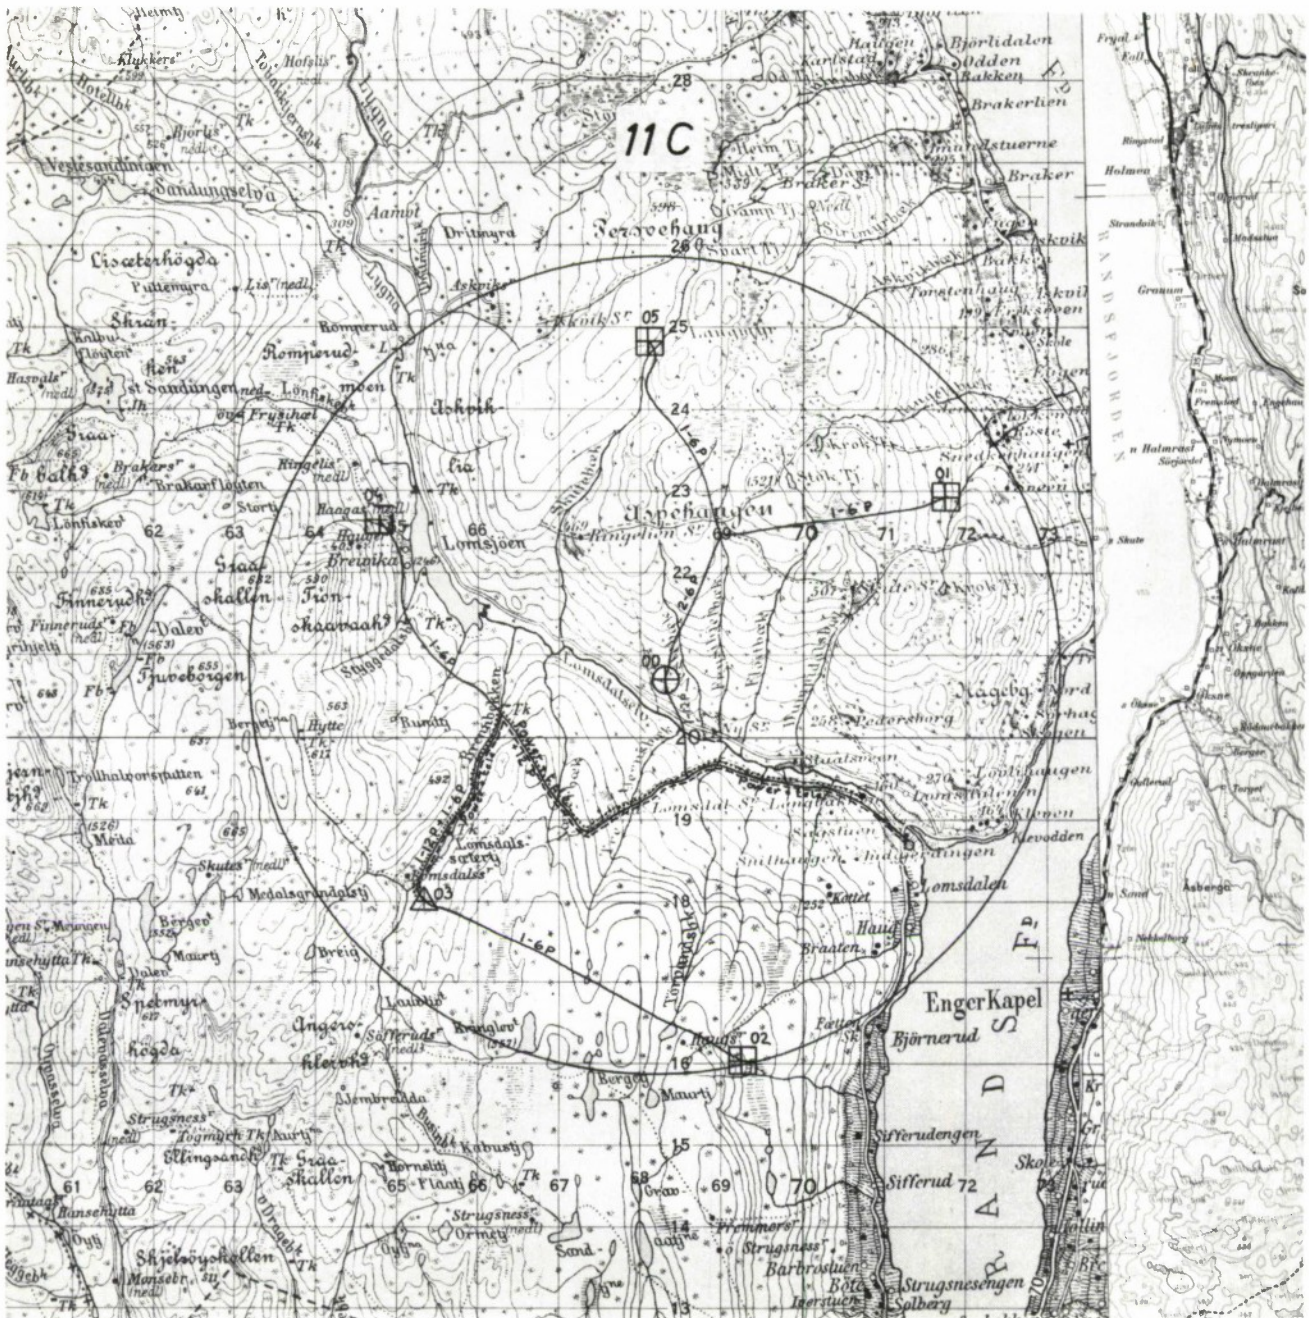
Figure 2.11 Subarray 11C, final configuration

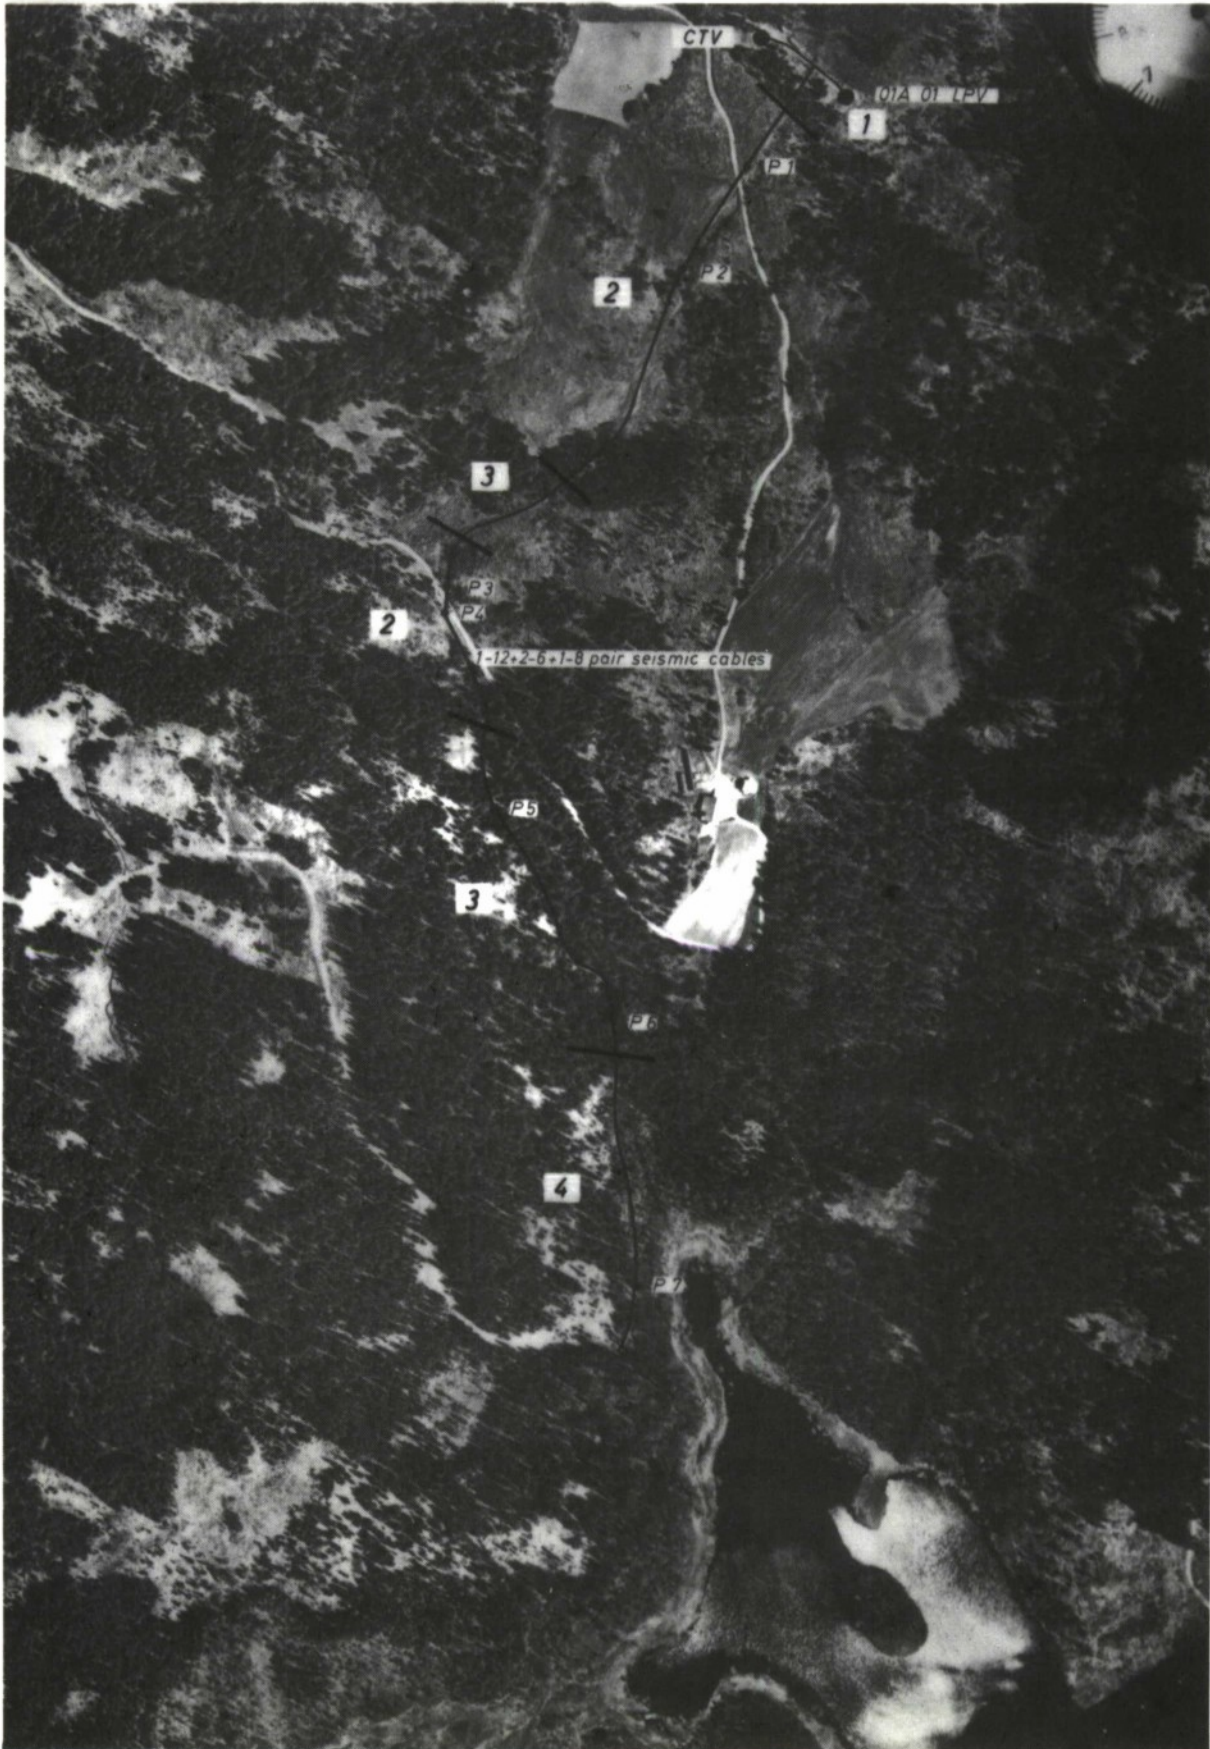
Figure 4.3 Example of airphoto 1:5000 with trenches and markers, vaults, land-owner boundaries and identification numbers

the air photographs, field personnel from the consultant had to plot on the maps the correct positions of SP-holes, vaults and trenches. The results were returned to Widerøe who then delivered complete maps on a scale of 1:5000 showing trenches, holes, vaults and markers. Based on log-books and information obtained locally, landowner names and boundaries were added, and the resulting material is contained in DOC II. Examples of the information found in this document are presented in Figures 4.1, 4.2 and 4.3.

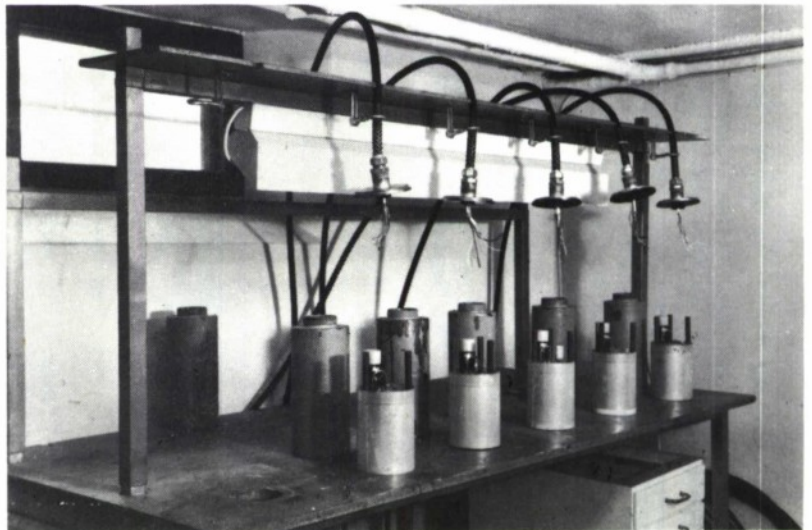
Figure 9.5

Bench used for potting of SP  
seismometers (Noratom  
workshop)

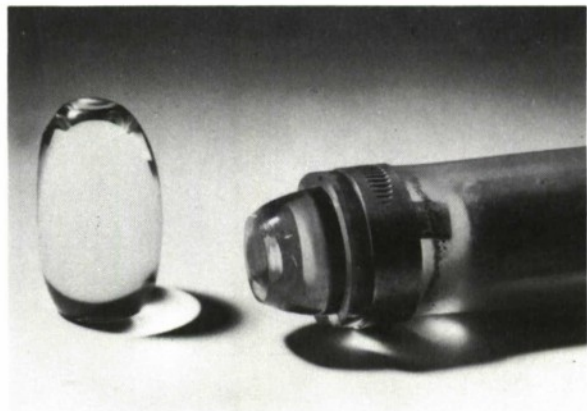
Figure 10.4 Insulation of the SP seismometer supporting rod

During the SP check-out performed by Teleplan A/S, the instrumentation consultant, it was discovered that rather strong 50 Hz noise penetrated into some of the analog signal channels; up to 6 V p-p was measured at the RA-5 amplifier output in some cases. The noisy channels were always found at sites where high-tension overhead power lines passed the area, and there was also a pronounced diurnal variation

which obviously could be correlated with variation in the public power load. There was thus little doubt about the origin of the noise.

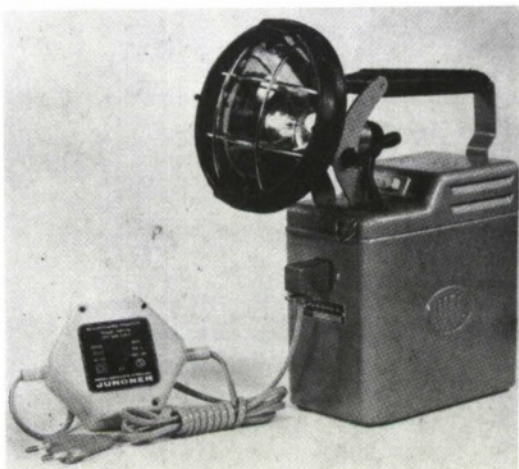
An automatically recharging torch lamp with Ni-Cd battery is installed inside and near the entrance of each CTV. Since the CTVs are not manned, mains failure does not turn on the emergency light. However, a small charging unit sees that the battery is always fully charged.

Figure A5.1 Emergency lamp unit for CTV use
