A SURVEY OF  
NAVAL AIRCRAFT CRASH ENVIRONMENTS  
WITH EMPHASIS ON STRUCTURAL RESPONSE

Dynamic Science 1500-71-43

Dynamic Science  
A Division of Marshall Industries  
Phoenix, Arizona

DEPARTMENT OF THE NAVY  
OFFICE OF NAVAL RESEARCH  
ARLINGTON, VIRGINIA

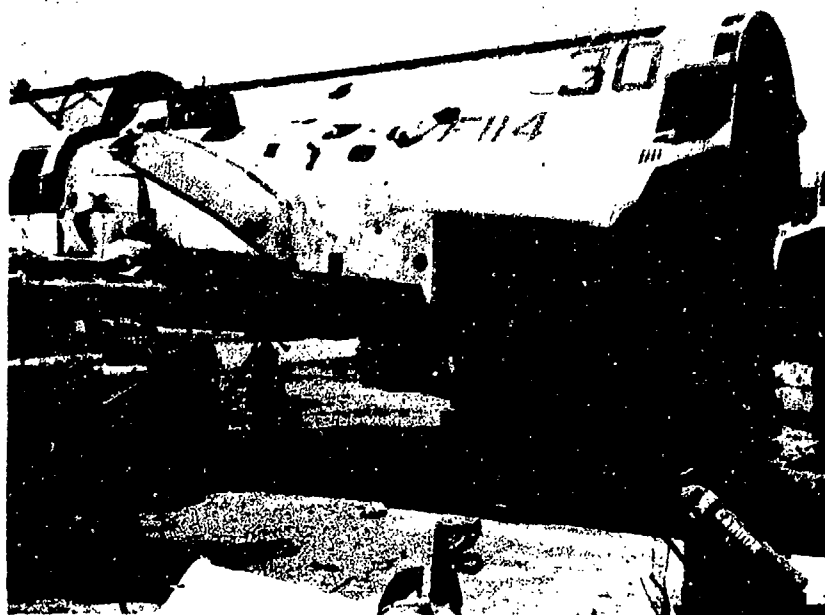
Figure 20. Fire Damaged F-4 Fighter Aircraft.

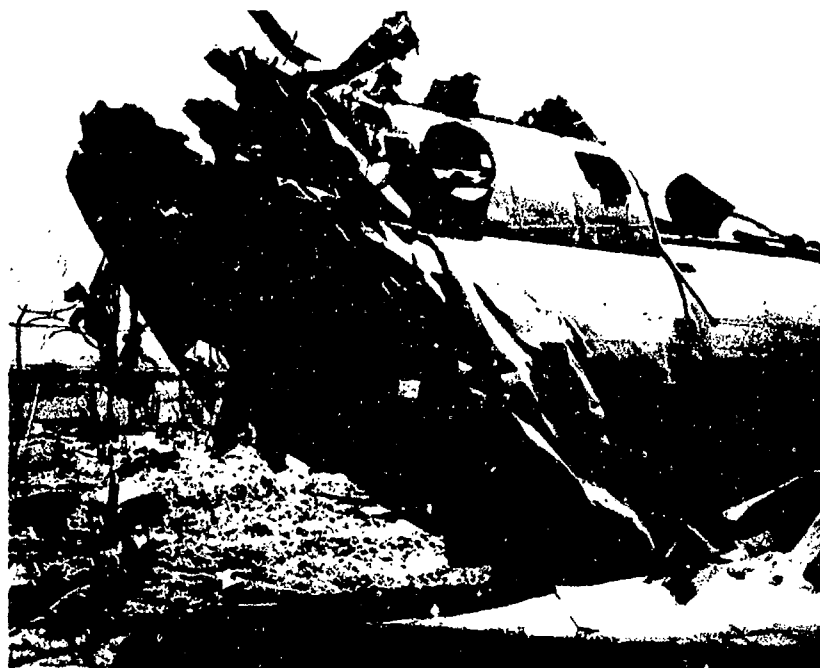
Figure 22. Two Views of a Crash-Damaged CH-46D Helicopter After a Tail First Impact.

Figure 22 shows an H-46 which impacted tail first (top view). When the nose section hit the ground, the transmission was torn loose, causing the cockpit to separate (bottom view). This figure illustrates the importance of a strong support structure for heavy components such as engines, transmissions, and rotor masts in helicopters. Figure 22 also indicates the need for strong framing members around doors and other fuselage openings.

A. Rear View

B. Front View
